## Survey of green building water systems reveals elevated water age and water quality concerns†

William J. Rhoads,\* Amy Pruden and Marc A. Edwards

Widespread adoption of innovative water conservation strategies has potential unintended consequences for aesthetics and public health. A cross-section of green buildings were surveyed and compared to typical conventional buildings in terms of water retention time (*i.e.*, water age), water chemistry, and levels of opportunistic pathogen genetic markers. Water age was estimated to be 2–6.7 months in an off-grid office, an average of 8 days in a Leadership in Environmental Engineering Design certified healthcare suite, and was increased to 2.7 days from 1 day due to installation of a solar “pre-heat” water tank in a net-zero energy house. Chlorine and chloramine residuals were often completely absent in the green building systems, decaying up to 144 times faster in premise plumbing with high water age when compared to distribution system water. Concentration of 16S rRNA and opportunistic pathogen genus level genetic markers were 1–4 orders of magnitude higher in green *versus* conventional buildings. This study raises concerns with re

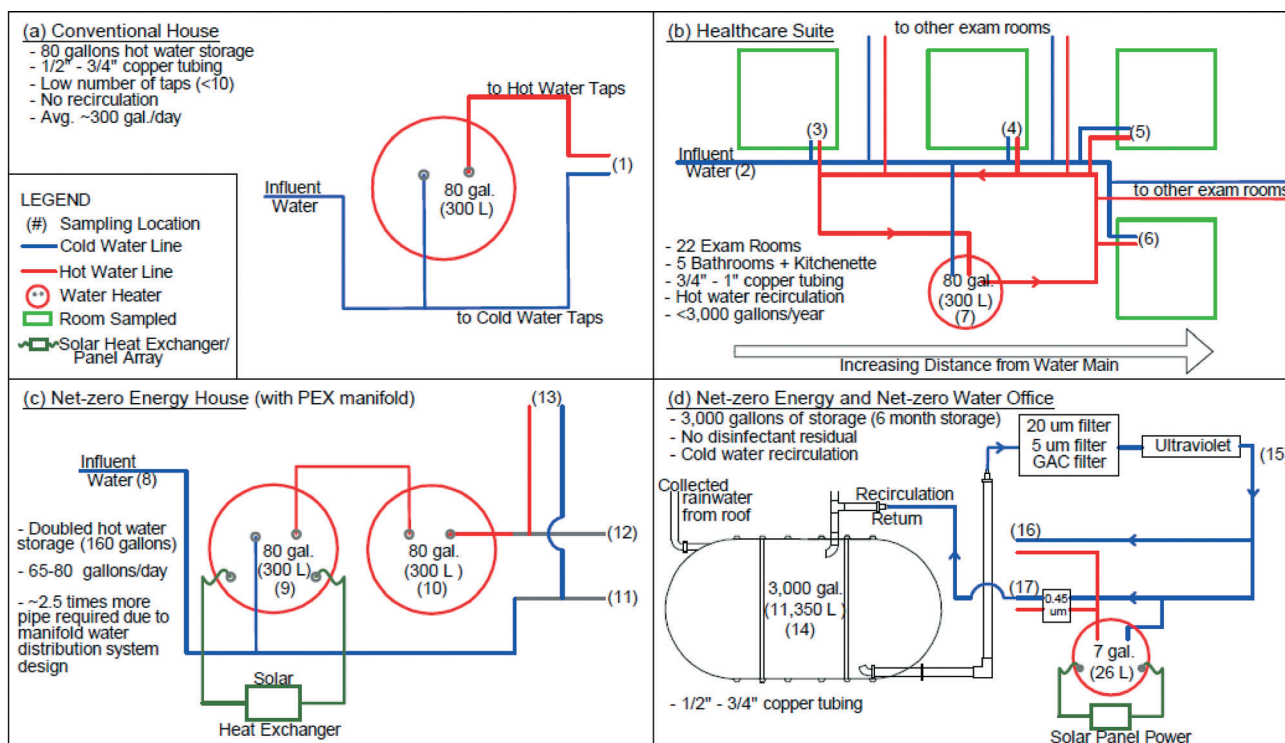
Fig. 1 Plumbing schematics and sampling locations for each field site.

Four buildings with a cross-section of energy and water conservation strategies were surveyed and sampled to explore effects of green plumbing systems on water quality (Table 1). The buildings included a conventional house with no conservation features (Fig. 1a), a healthcare suite (Fig. 1b), a net-zero energy house (Fig. 1c), and a net-zero energy and net-zero water office building (Fig. 1d).

Note: Numbers 1-17 in parentheses indicate sampling locations referred to in Table 2.

This study provided detailed documentation of the potable water systems in three innovative green buildings (Fig. 1). After reviewing the characteristics of each water system and closely examining trends in disinfectant residuals within the buildings, we provide an overview of microbial sampling from each building.

minutes of flushing was necessary to establish a chloramine residual similar to that present in the main distribution system (Fig. 2a). Taps at these locations are typically used for 15–30 seconds at a time; therefore, it is unlikely that a chloramine residual is ever present in portions of this plumbing system. Approximately 30 minutes of flushing was required at the net-zero energy house to establish a residual in the cold water system during the first site visit. In contrast, the conventional home had a residual of 0.71 mg L<sup>-1</sup> chlorine as Cl<sub>2</sub> in stagnant cold water. The water heaters at the net-zero house had <0.15 mg L<sup>-1</sup> chlorine as Cl<sub>2</sub> during a 20 minute flush due to the added storage volume and water age associated with the solar heater (Fig. 1c).

<sup>a</sup> Sampling location numbers refer to locations depicted in Fig. 1. <sup>b</sup> Average (and median) of the four exam rooms is reported. <sup>c</sup> BD = below detection. <sup>d</sup> BQL = below quantification limit.

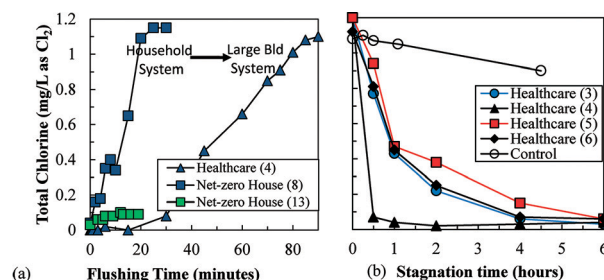
Note: Sampling locations indicated in parenthesis in the figure legends correspond to sample locations depicted in Figure 1.

The healthcare suite also showed evidence of very rapid disinfectant residual decay. In all four exam rooms monitored, the first-order decay rate of chloramine in the plumbing was 20–144 times greater than in well-flushed (>80 minutes) water collected from the same tap and placed into a glass container with no headspace (*i.e.*, “control,” Fig. 2b). The highest rate of decay (sample location 4) was observed in

a sink that had been recently replaced, where the newer plumbing material may have been more reactive than older materials.<sup>6</sup>
