Cite this: *Environ. Sci.: Water Res. Technol.*, 2021, 7, 274

## Drinking water contamination from the thermal degradation of plastics: implications for wildfire and structure fire response†

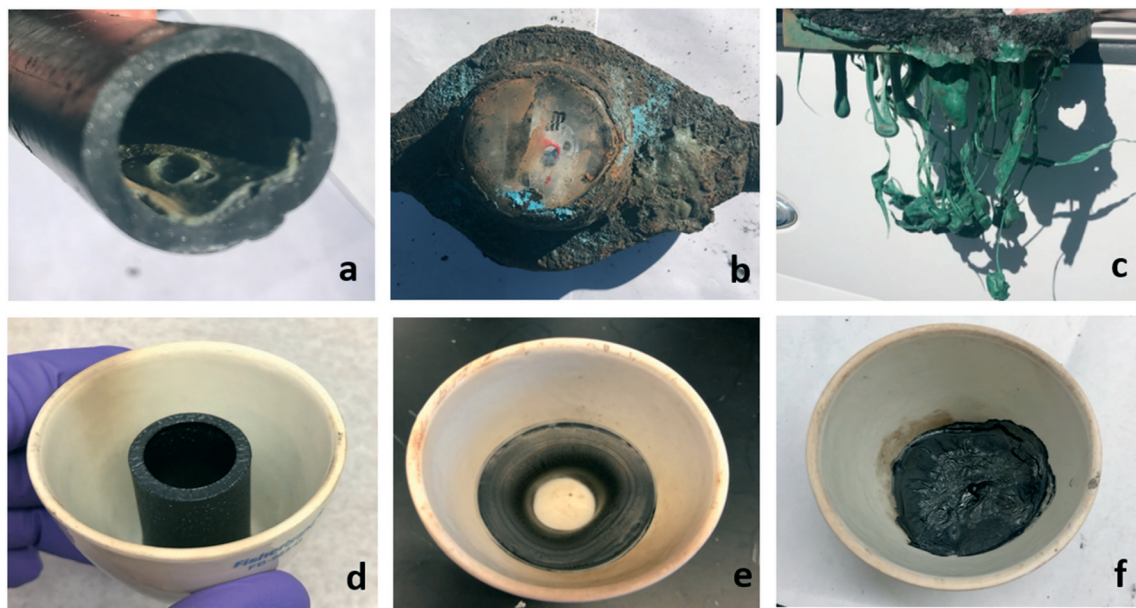
**Fig. 1** Images of fire-damaged water system components including (a) a HDPE plastic pipe, (b) a water meter, and (c) a water meter cover following the Camp Fire. Thermally degraded pipe samples in laboratory experiments include the (d) PEX-c pipe degraded at 300 °C, (e) HDPE pipe degraded at 300 °C, and (f) HDPE pipe degraded at 400 °C.
