Unravelling and quantifying the aging processes of commercial $\text{Li}(\text{Ni}_{0.5}\text{Co}_{0.2}\text{Mn}_{0.3})\text{O}_2/\text{graphite}$ lithium-ion batteries under constant current cycling

Cite this: *J. Mater. Chem. A*, 2023, **11**, 41Unravelling and quantifying the aging processes of commercial $\text{Li}(\text{Ni}_{0.5}\text{Co}_{0.2}\text{Mn}_{0.3})\text{O}_2/\text{graphite}$ lithium-ion batteries under constant current cycling†Jia Guo,^{a,b} Siyu Jin,^a Xin Sui,^a Xinrong Huang,^c Yaolin Xu,^{*d} Yaqi Li,^{a,b} Peter Kjær Kristensen,^b Deyong Wang,^b Kjeld Pedersen,^b Leonid Gurevich^b and Daniel-Ioan Stroe^a

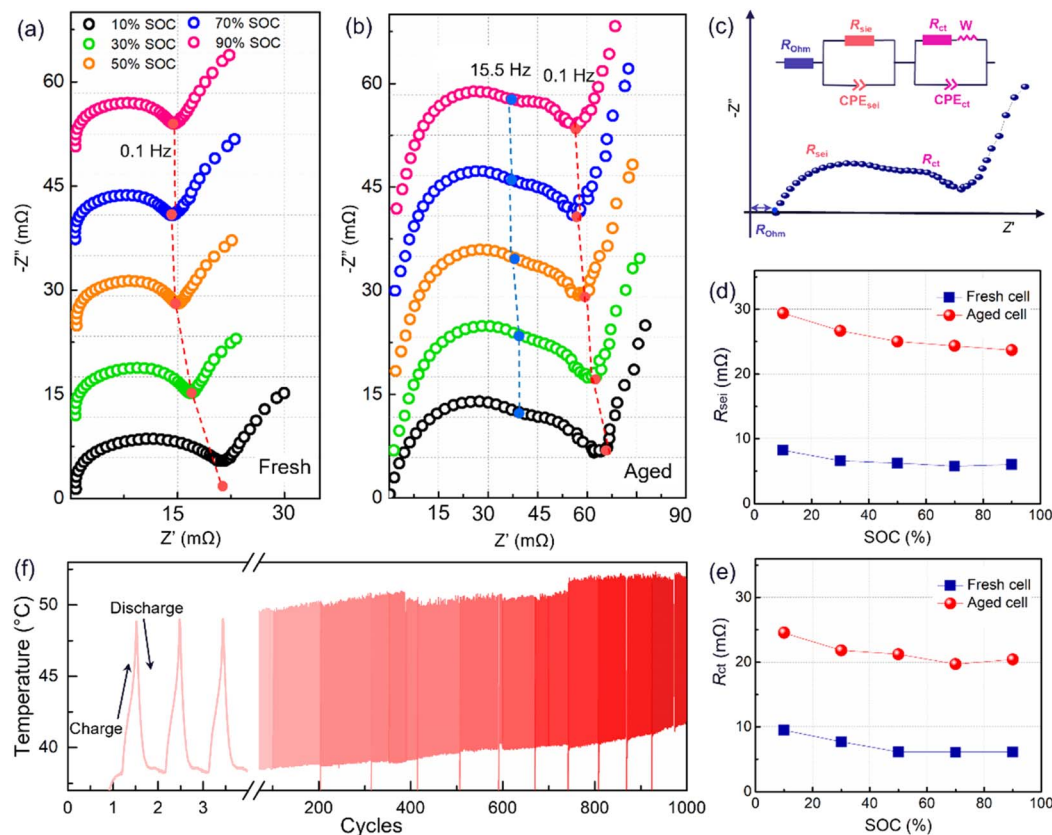
Fig. 2 EIS spectra at different SOC for (a) fresh cell and (b) an aged cell; (c) schematic illustration and an equivalent circuit used to fit the EIS Nyquist plots; the fitted results for (d) R_{sei} , and (e) R_{ct} . (f) the temperature tested using a temperature sensing probe on the outer surface of the cell.

The polarization was evaluated by performing an *operando* electrochemical impedance spectroscopy (EIS) test. As shown in Fig. 2a and b, the measured results are Nyquist plots, which are

composed of three parts with different frequency ranges, representing the bulk resistance (R_{ohm}), the solid electrolyte interface resistance (R_{sei}), and the charge transfer resistance (R_{ct}), respectively.³ The inserted equivalent circuit was employed to fit the Nyquist plots, as shown in Fig. 2c. The obtained results are presented in Fig. 2d and e. Here, the R_{ohm} will not be adopted due to an unstable ohmic impedance caused by the connector of the electrochemical workstation, and this always shows little change in battery aging.^{3,12} Therefore, the Nyquist plots were translated to the origin of the coordinates. After 1000 cycles, a four-fold increase in the R_{sei} from below 8 m Ω to about 30 m Ω is observed (Fig. 2c). Besides, R_{ct} has increased to over 20 m Ω (Fig. 2d), indicating an overall degradation at the electrode interface and charge transfer. Furthermore, R_{sei} and R_{ct} decrease with the battery charging. R_{sei} is related to the diffusion of Li ions at the interface and the R_{ct} is linked to the electrochemical reaction.²² As reported in ref.²² the SEI film is partially ruptured at high SOC due to the increased volume of lithiation graphite, and recovers in the followed discharge process. So, the R_{sei} decreased with battery charge. Furthermore, a high SOC is linked to a high voltage as well as an active state of the electrochemical reaction, resulting in a lower R_{ct} . The temperature of the battery surface was detected in the aging process, as shown in Fig. 2f. The temperature changes periodically with the charge–discharge cycle. Besides, the temperature

range fluctuates, due to an uncontrollable change in the sticking position or tightness of the thermal probe on the battery surface. With the increase in the cycle number, the temperature of the battery surface gradually increases (varying from a low temperature of 42 °C to a high temperature close to 55 °C). The temperature increment will lead to a series of side reactions inside the battery during electrochemical cycling, for example, the rupture and reformation of the interfacial film at high temperatures, resulting in a continuous increase of the internal impedance. This is consistent with the discharge cte-OCV trend, further illustrating that the internal impedance continues to increase with battery cycling.
