## CRITICAL REVIEW

## Ongoing legacy contamination from a military radar station in Iceland: a case study

This paper is a summary of environmental impacts from a former US military DEW line radar station in Iceland which operated from the mid-1950s to the 1970s. This station was one of four DEW line station stations that operated in Iceland during the Cold War era. During the time of operation and when dismantled, nearly all waste from the station was dumped in unlined pits on the mountain. Very limited cleaning of the site has been performed and the site is contaminated with PCBs, PHCs, PAHs and some inorganic elements.

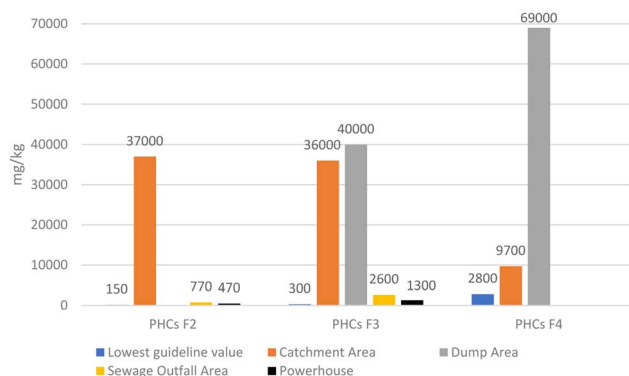
Fig. 6 PHCs (mg kg<sup>-1</sup>) detected above the lowest guideline value for F2, F3 and F4 (150, 300, and 2800, respectively) at four areas. The highest value in each area of the four is shown in the figure.
