Cite this: *Environ. Sci.: Water Res. Technol.*, 2016, 2, 164

Survey of green building water systems reveals elevated water age and water quality concerns†

William J. Rhoads,* Amy Pruden and Marc A. Edwards

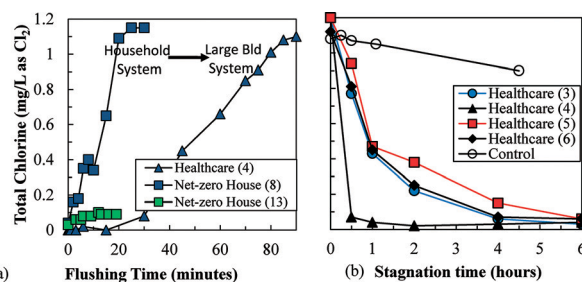
Note: Sampling locations indicated in parenthesis in the figure legends correspond to sample locations depicted in Figure 1.

Fig. 2 Total chlorine residual concentrations (a) as a function of stagnation in one room at the healthcare suite (large building system above), a tap near the head of the building at the net-zero house (household system above), and during three showering events at net-zero house, and (b) as a function of stagnation in several rooms at FS#1 (control represents identical water placed in a glass container with no head space).

minutes of flushing was necessary to establish a chloramine residual similar to that present in the main distribution system (Fig. 2a). Taps at these locations are typically used for 15–30 seconds at a time; therefore, it is unlikely that a chloramine residual is ever present in portions of this plumbing system. Approximately 30 minutes of flushing was required at the net-zero energy house to establish a residual in the cold water system during the first site visit. In contrast, the conventional home had a residual of 0.71 mg L⁻¹ chlorine as Cl₂ in stagnant cold water. The water heaters at the net-zero house had <0.15 mg L⁻¹ chlorine as Cl₂ during a 20 minute flush due to the added storage volume and water age associated with the solar heater (Fig. 1c).

The healthcare suite also showed evidence of very rapid disinfectant residual decay. In all four exam rooms monitored, the first-order decay rate of chloramine in the plumbing was 20–144 times greater than in well-flushed (>80 minutes) water collected from the same tap and placed into a glass container with no headspace (*i.e.*, “control,” Fig. 2b). The highest rate of decay (sample location 4) was observed in
