Cite this: *Environ. Sci.: Water Res. Technol.*, 2016, 2, 164

Survey of green building water systems reveals elevated water age and water quality concerns†

William J. Rhoads,* Amy Pruden and Marc A. Edwards

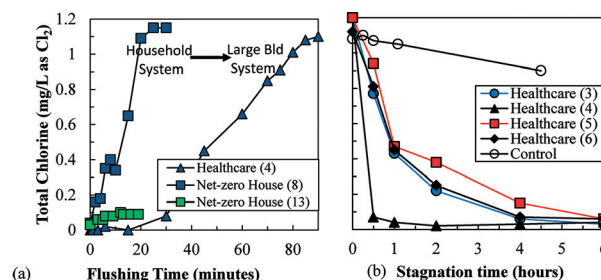
minutes of flushing was necessary to establish a chloramine residual similar to that present in the main distribution system (Fig. 2a). Taps at these locations are typically used for 15–30 seconds at a time; therefore, it is unlikely that a chloramine residual is ever present in portions of this plumbing system. Approximately 30 minutes of flushing was required at the net-zero energy house to establish a residual in the cold water system during the first site visit. In contrast, the conventional home had a residual of 0.71 mg L⁻¹ chlorine as Cl₂ in stagnant cold water. The water heaters at the net-zero house had <0.15 mg L⁻¹ chlorine as Cl₂ during a 20 minute flush due to the added storage volume and water age associated with the solar heater (Fig. 1c).

The healthcare suite also showed evidence of very rapid disinfectant residual decay. In all four exam rooms monitored, the first-order decay rate of chloramine in the plumbing was 20–144 times greater than in well-flushed (>80 minutes) water collected from the same tap and placed into a glass container with no headspace (*i.e.*, “control,” Fig. 2b). The highest rate of decay (sample location 4) was observed in

Note: Sampling locations indicated in parenthesis in the figure legends correspond to sample locations depicted in Figure 1.

a sink that had been recently replaced, where the newer plumbing material may have been more reactive than older materials.⁶
