# Failure behavior of nylon products for red phosphorus flame retardant electrical connectors

The failure behavior of red phosphorus flame retardant electrical connectors was investigated by their thermal degradation, changes of surface morphology and elements under an accelerating environmental experiment. The results showed that the nylon electrical connector degraded and cracks were generated on the surface. The temperature of maximum weight loss rate was advanced in the thermogravimetric analysis and the third weight loss peaks appeared after 28 days. The relative atomic content of O and P increased from 0 day to 28 days. The chemical environment of C changed. Partially, C–C bonds broke and became C–O bonds. The release of phosphine increased and this further oxidized to an acid with P=O and P–O groups in a warm and humid environment.

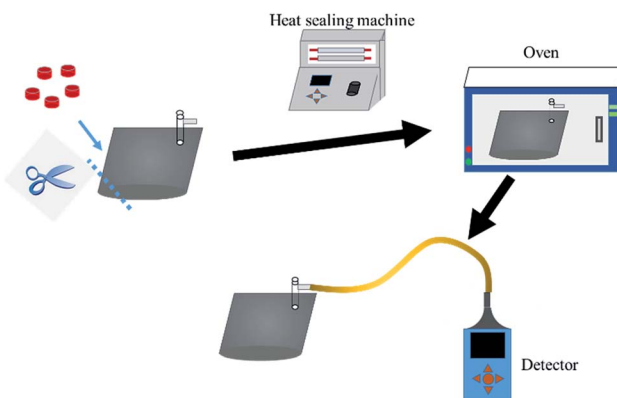
Fig. 2 Schematic diagram of phosphine detection.

Phosphine released by red phosphorus would rapidly reacts with air and water to form an acid under high temperature and humidity. In order to determine phosphine release, 2 g product was deposited in a sealed and dried 500 ml aluminum foil gas collection bag (Fig. 2). After 7 d, 14 d and 21 d, the concentration of phosphine gas in the bag was determined by the BH-90A phosphine detector.

Since the phosphine released by connectors reacted rapidly with water and air to form phosphoric acid, in order to determine the amount of phosphine, 2 gram connectors was placed in a dry gas sampling bag and tested by a phosphine detector. The results are shown in Table 5. Over time, the amount of phosphine released continued to increase.

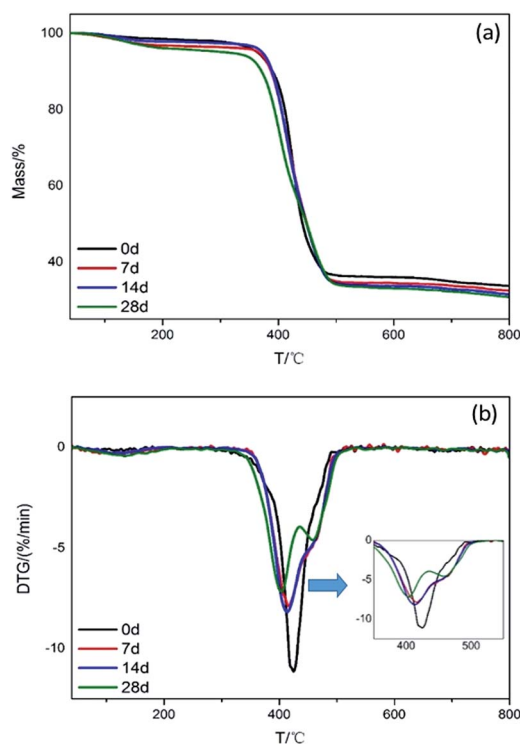
presented in Fig. 3 and summarized in Table 1. As the environmental test progressing, the initial decomposition temperature ( $T_{5\%}$ , temperature based on 5% mass loss), the maximum mass loss rate ( $R_{\max}$ ), temperature corresponding to the maximum mass loss rate ( $T_{\max}$ ) and the value of char residues (CR) for connectors at 800 °C all reduced, indicating that the thermal stability of connectors exposed to high temperature and humidity environment diminished. The appearance of the mass loss rate peak for 28 days indicates that the connector produced a new component in the high temperature and humidity environment. Reduced CR indicated that the phosphine released from red phosphorus reacted with water to form various oxygen-containing, phosphorus-based acids, such as phosphoric acid, phosphorous acid, and hypophosphorous acid,

Fig. 3 TGA and DTG curves of connectors in  $\text{N}_2$  atmosphere.

and then partially transferred to the copper sheet by corrosion, resulting in a reduced char forming ability.

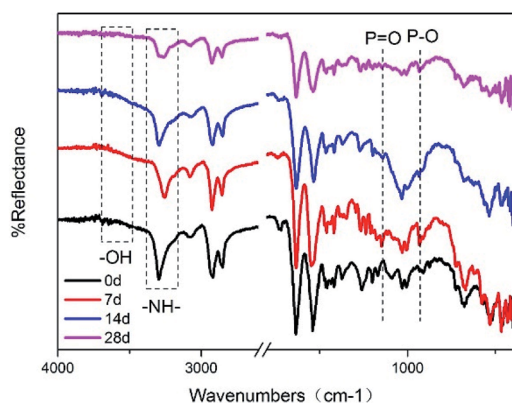
Fig. 4 is an FTIR spectrum of the connectors after environmental testing. Compared with the initial connectors, the intensity of stretching vibration of -OH for the connectors environmentally tested was enhanced. The peaks representing stretching vibration of P-O and P=O were found at 931 cm<sup>-1</sup> and 1143 cm<sup>-1</sup>,<sup>22</sup> illustrated that the red phosphorus in the product released PH<sub>3</sub> and then formed acids. At the same time, the generated phosphoric acid would accelerate the degradation of the polyamide. The peak representing -NH- shows significant changes, transferring to -NH<sub>2</sub>,<sup>23</sup> especially for connectors tested by 28 days.

Fig. 4 FTIR spectrum of environment tested connectors after different days.

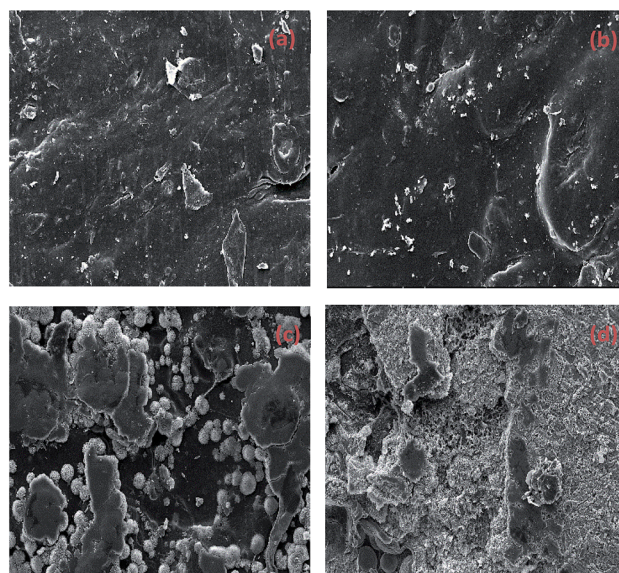
**Scanning electron microscopy.** Fig. 5 is SEM images of connectors and its surface under 80 °C, 75% RH environment for 0 d, 7 d, 14 d and 28 d respectively. The surface of the original sample was relatively smooth. However, with the high temperature and humidity environment test progressing, cracks appeared on the surface, resulting in many flaky layers and increasing the roughness. Green globular substances appeared on the surface and section area of the sample after a period of time. It can be observed that the globular substance dispersed on the edge of the cracks after 14 days. After 28 days,

the globes increased so much that it is too dense to observe a single sphere and the entire surface becomes shattered.

Fig. 5 SEM images of connectors tested for 0 d (a), 7 d (b), 14 d (c), 28 d (d).

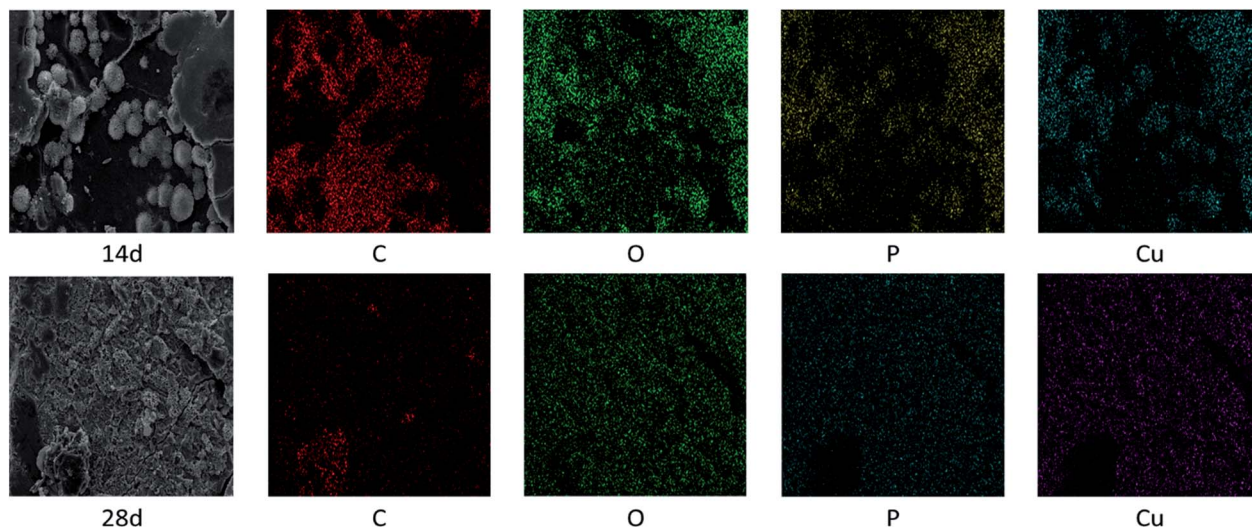
Fig. 6 and Table 2 exhibits the evolution of the elemental dispersion on the surface of connectors. As showed in Fig. 5, the spherical substance was mainly composed of P, O, and Cu elements. The elemental content given in Table 2 indicated that the substance was increasing over time. Phosphorus could not be detected on the surface at the beginning and after 7 days until the globular substance containing phosphorus was formed. With the time increase, the concentration gradient of phosphorus was produced from inside to surface. At the same time, the content of oxygen increased. It proved that phosphorus reacted with water and air to form phosphoric acid through these cracks in the high temperature and humidity environment and the phosphoric acid corroded the copper sheet attached to the connectors to form copper phosphate species on the surface.

Fig. 6 EDS images of connectors tested for 14 d and 28 d.

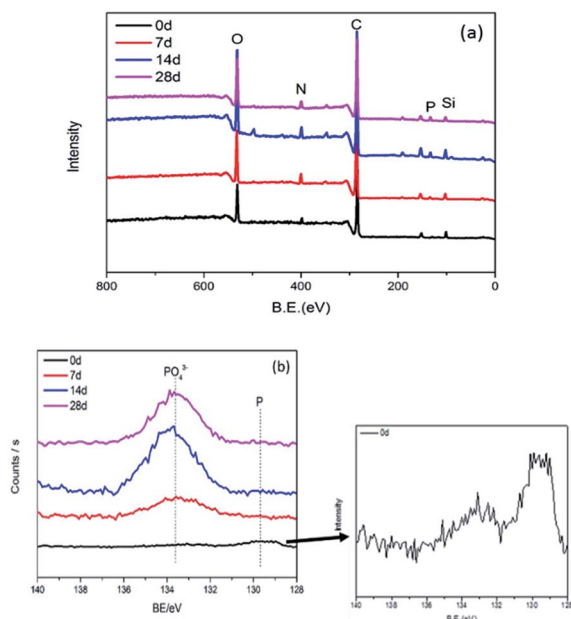
**X-ray photoelectron energy spectrum analysis.** XPS spectrum of survey scan for connectors is exhibited in Fig. 7 and elemental content of connectors tested for different days is showed in Table 3. The intensity of carbon and oxygen is very strong with traces of N and Si existing. Nevertheless, the signal intensity of phosphorus is very low.

The P 2p high-resolution spectra of connectors are exhibited in Fig. 7. There are two main peaks, 129.4 eV corresponding to red phosphorus; 133.4 eV corresponding to phosphate anion.<sup>24</sup> The presence of these peaks affirms that red phosphorus was

oxidized to phosphate. The intensities of peaks increases gradually and reaches a stable state, confirming that phosphate concentration increased with test prolonging, especially in the first 14 days.

Fig. 7 Wide-scan (a) and P 2p high-resolution (b) XPS spectra for connectors.

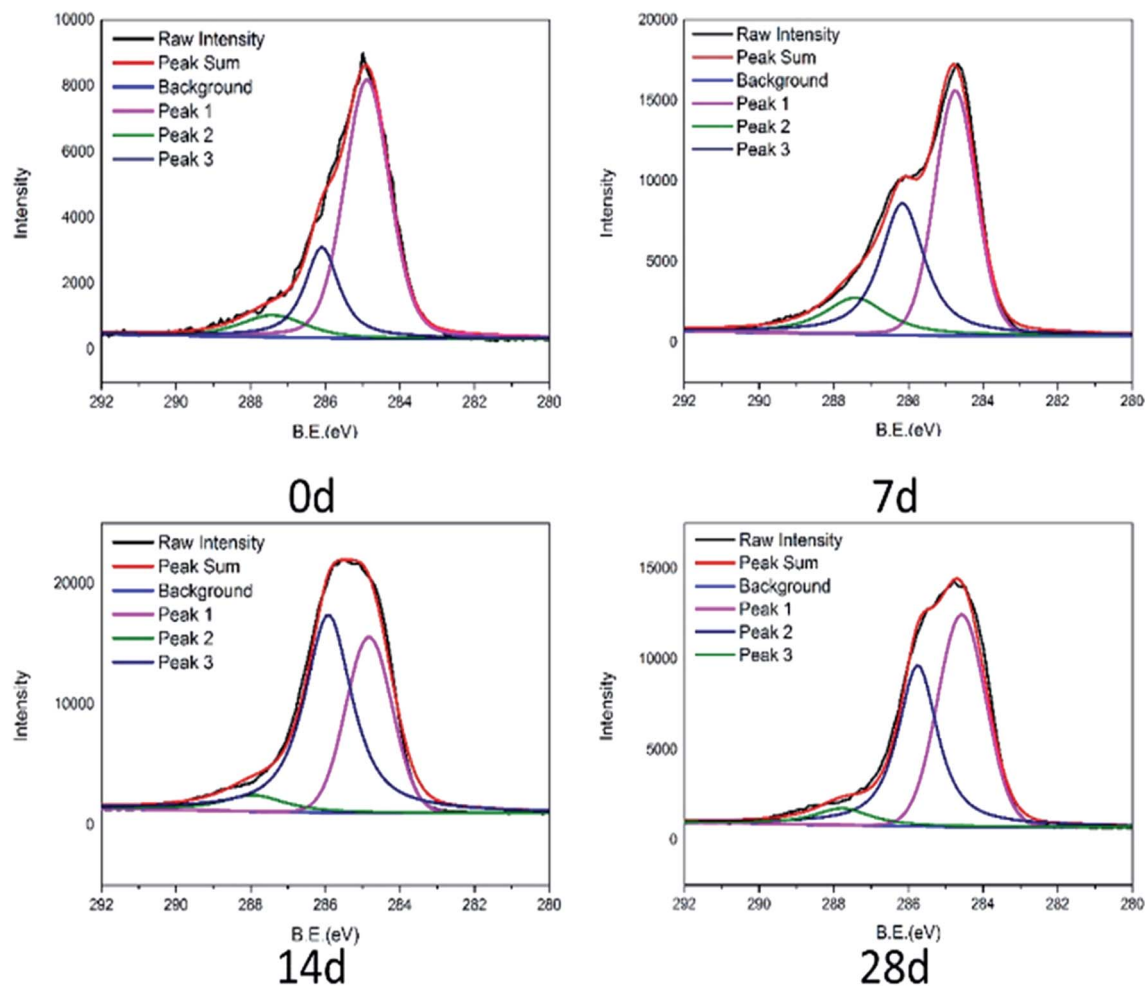
The C 1s spectra of tested connectors are fitted into three peaks to know the types of functional groups of PA66 from connectors in Fig. 8. The three peaks centered at 284.6 eV corresponding to C-C; 286.0–286.3 eV corresponding to C-O; 287.5–287.7 eV corresponding to C=O.<sup>25</sup> While compared with the C 1s of the initial product, the intensity of the carbon-oxygen bond significantly increased. It is expected that PA66 was degraded and carbon-carbon bonds partially were broken,

Fig. 8 C 1s high-resolution XPS element spectra of connectors.

oxidized to carbon–oxygen bonds. The degradation of PA66 is a complicated process, mainly involving not only the hydrolysis of amide bonds, but also the breakage of molecular chains, accompanied by the formation of various small molecular compounds. The carbon–carbon bond is broken further, accelerating oxidation to cause the rise of the carbon–oxygen bond. This would generate cracks and further reduce the thermal stability of the connector, making it flammability.<sup>26</sup>

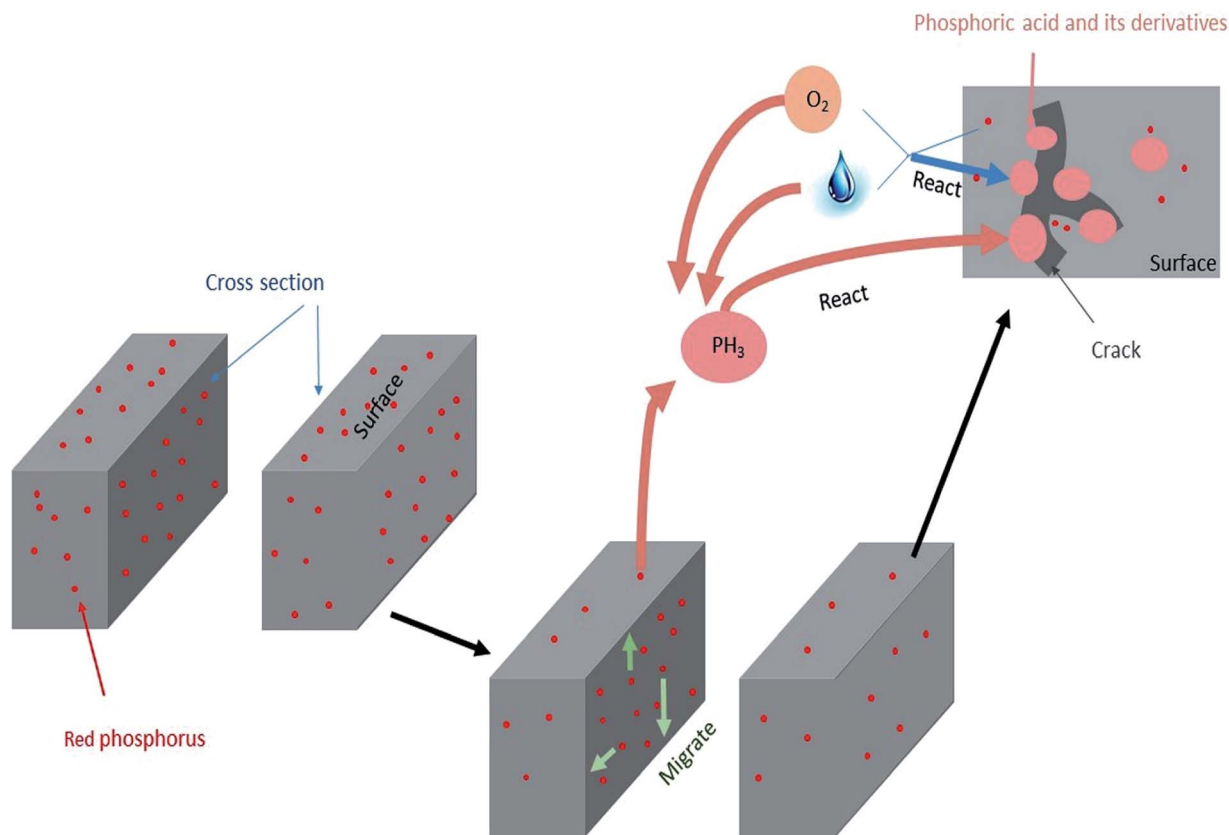
Fig. 9 Failure behaviour mechanism diagram.

The mechanism of failure behaviour is revealed in Fig. 9. After connectors had undergone high temperature and humidity environmental testing, red phosphorus migrated to the surface and accumulated into several areas. At the same time, significant degradation occurred, the decomposition temperature was advanced and  $-OH$  and phosphorus oxides were formed. The surface morphology of connector became rough with cracks increasing and the copper attached to connector formed copper phosphate. The content of phosphorus and oxygen on the surface increased and the chemical environment of phosphorus changed from elemental phosphorus to phosphoric acid derivatives. The amount of phosphine released increased and it reacted with water and oxygen to form acids. Correspondingly, the formation of phosphoric acid derivatives accelerated the degradation process of nylon. Surface cracks caused by degradation resulted in red phosphorus to be further oxidized to an acid. The mutual promotion caused the failure behavior of the red phosphorus flame retardant PA66 electrical connector.
