Cite this: *Environ. Sci.: Water Res. Technol.*, 2021, 7, 274

DOI: 10.1039/d0ew00836b

Drinking water contamination from the thermal degradation of plastics: implications for wildfire and structure fire response†

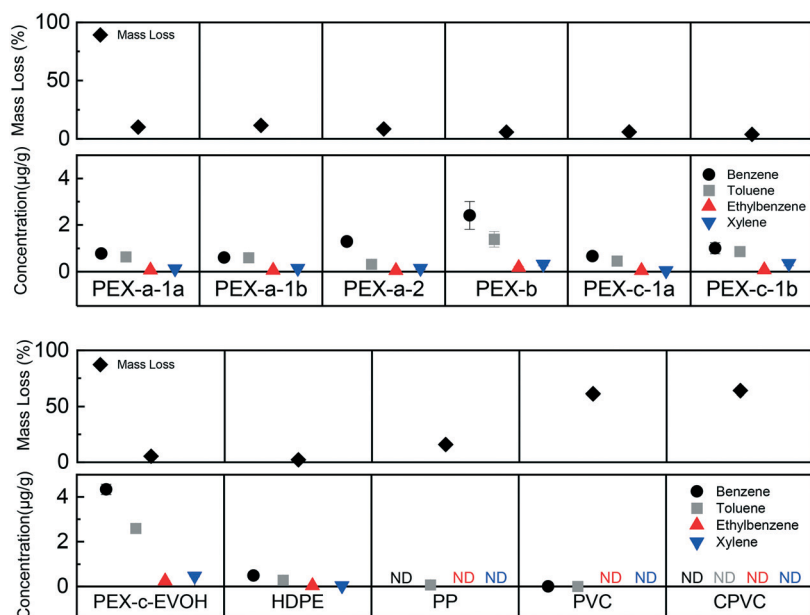
Fig. 2 Average amount of benzene, toluene, ethylbenzene, and xylene leaching observed after burning each material at 400 °C and extracting in water for 7 days. The error bars reflect the standard deviation of the measurements ($n = 3$). If no error bars are visible, this indicates the error bars are smaller than the symbol size. ND indicates the compound was not detected above the MDL.

Results showed that plastic pipe thermal exposure can generate BTEX, which can then leach from cooled plastics into water. BTEX was not found from new and non-thermally degraded plastics in water, while 10 of 11 thermally degraded plastic pipes leached at least one BTEX component (Fig. 2). The chemical leaching differences between products is likely attributed to differences between plastic characteristics and experimental conditions. PE materials lost less mass due to isothermal heating (5 wt% to 10 wt%) compared to the PVC and CPVC samples (61 wt% and 64 wt%, respectively) (Fig. 2). A detectable, but significantly lower amount of benzene and toluene was observed for the PVC pipe, and no BTEX was found for the CPVC pipe (Fig. 2). Additionally, there was a general trend of compound concentration leaching across the plastics where benzene > toluene > ethylbenzene ≈ xylene (Fig. 2). This trend could be attributed to several factors including compound production, water solubility, air volatilization, polymer solubility parameters, and/or partitioning into the aqueous phase. Octanol-water coefficients and solubility values mirror the trend of concentrations observed (Table S4†), indicating that benzene would most readily partition into the aqueous phase.
