Ongoing legacy contamination from a military radar station in Iceland: a case study

Cite this: *Environ. Sci.: Adv.*, 2024, 3, 972

DOI: 10.1039/d4va00049h

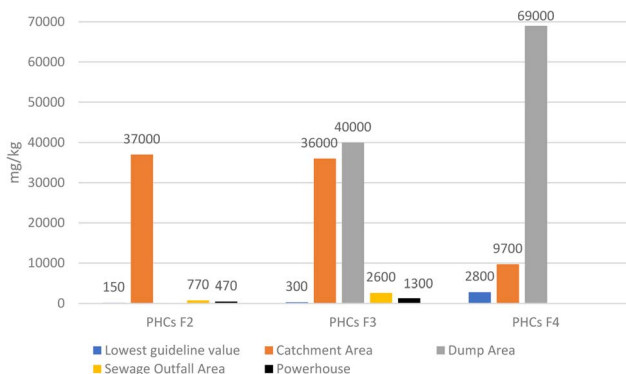
PHCs, used as fuels and lubricants, consist of a large number of hydrocarbon compounds, some of which can cause severe health issues. The ESG observed considerable remains of oil barrels, some of which were stained black, and some black tar like chunks around the Dump area and around the Powerhouse area. Oil barrels were also observed by the MHR in 1993, as mentioned previously.⁴³ PHCs are arranged into four categories (F1, F2, F3, F4) depending on the number of carbons, and their volatility decreases and persistence increases in the environment with a rising number of carbons. PHCs in F1 were not detected over the lowest guideline values whereas this was the case with the other three, to varying degrees. PHCs were tested at six areas and detected over the lowest standard at four areas: the Dump, Sewage outfall, Powerhouse and Catchment areas (Table 2 and Fig. 6). The highest concentration of PHCs ranged from 40 000 mg kg⁻¹ to 69 000 mg kg⁻¹ at the Dump area and was 9700 to 37 000 mg kg⁻¹ at the Catchment area. A similar case was at the DEW line site at Utqiagvik in Alaska where areas around the powerhouse site showed significant petroleum-derived contamination as mentioned earlier.⁵

Fig. 6 PHCs (mg kg⁻¹) detected above the lowest guideline value for F2, F3 and F4 (150, 300, and 2800, respectively) at four areas. The highest value in each area of the four is shown in the figure.
