Removal of residual contaminants by minute-level washing facilitates the direct regeneration of spent cathodes from retired EV Li-ion batteries†

Yi Guo,^{‡a} Yang Li,^{‡bcd} Kai Qiu,^d Yan Li,^e Weijing Yuan,^b Chenxi Li,^b Xinyu Rui,^a Lewei Shi,^b Yukun Hou,^a Saiyue Liu,^a Dongsheng Ren,^{*a} Tiening Tan,^{*d} Gaolong Zhu,^d Languang Lu,^a Shengming Xu,^{id f} Biao Deng,^g Xiang Liu^{id *b} and Minggao Ouyang^{id *a}

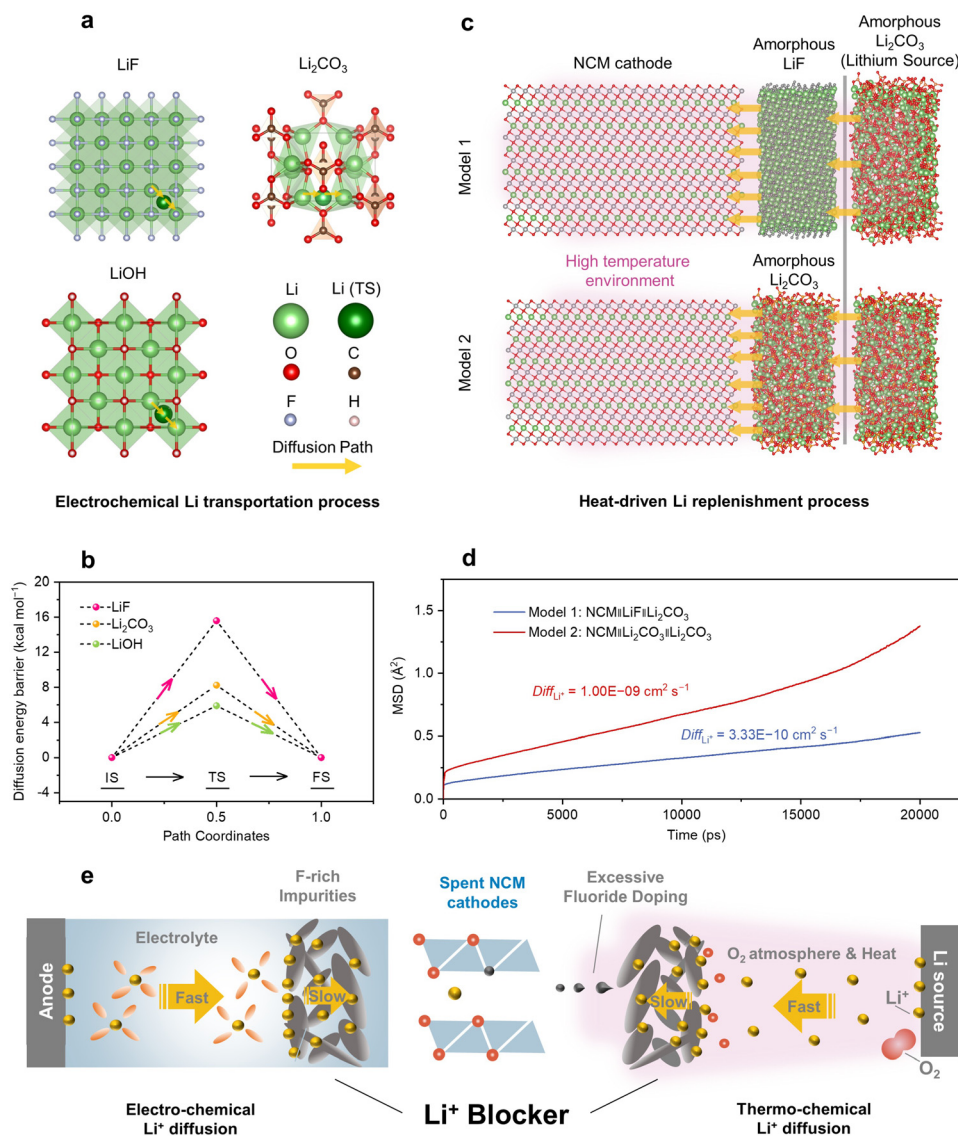
Fig. 5 Role of the F-rich impurities as a blocker in electrochemical and thermochemical Li^+ diffusion as ascertained from thermodynamic and kinetic simulations. (a) Illustrations of the selected migration pathways with a similar distance for Li^+ inside the crystal lattice of three common components. The initial state, transition state, and final state of Li^+ transportation are denoted as IS, TS, and FS, respectively. (b) Calculated energy diffusion barrier for Li ions in selected phases. (c) Two models for stimulating the kinetics of Li transportation in direct regeneration. Model 1 consists of the NCM cathode substrate, the amorphous LiF layer, and Li_2CO_3 as a lithium source in direct regeneration, which is denoted as NCM||LiF|| Li_2CO_3 . In Model 2 (NCM|| Li_2CO_3 || Li_2CO_3 in short), the middle LiF layer is replaced by a common residual alkali (Li_2CO_3), which is used to simulate the regeneration of NCM cathodes after cleaning pretreatment. Each shape symbol is the same as for Fig. 5a. (d) MSD of the Li atoms in 20 ns and calculated Li^+ diffusivity based on the above model. "E – 9" means 10^{-9} . (e) Mechanism diagram for preventing the NCM cathodes from reusing and directly regenerating under the influence of impurities.

According to the above results (Fig. 1d, Fig. S6, S16 (ESI†), and Fig. 4h, i), the migration rate of lithium ions was significantly influenced by the residual impurities; therefore it was crucial to theoretically investigate their influence on capacity delivery in the reuse case and during direct regeneration. Considering the impurities were mostly concentrated at the surface before and after regeneration, and that F-rich residuals could be observed, as shown in Fig. S9 and S10 (ESI†) and Fig. 3c, we chose three representative inorganic components (LiF, Li_2CO_3 , and LiOH) in the CEI layer⁴⁸ or residual alkali⁴⁹ to calculate the Li^+ diffusion from a thermodynamic perspective, and their structures are shown in Fig. 5a. By maintaining a similar distance and concentration of mobile Li-ions, the diffusion energy barrier of lithium ions (ΔE_{Li^+}) during the cycling of spent cathodes within the different crystal structures (Fig. 5b) allowed valid comparisons. We found that the ΔE_{Li^+} of the LiF phase, as a common inorganic component from CEI, was about 2 and 3 times higher than that of the LiOH and Li_2CO_3 phases from

Fig. 5b. Therefore, this result confirmed that the presence of fluoride-rich impurity residuals on the cathode surface significantly increased the diffusion resistance of Li ions when cycling, ultimately exacerbating the cell impedance and interfacial parasitic reactions (Fig. 1d). To comprehend the larger-scale kinetic characteristics and understand the effect of impurity coatings during heating for regeneration of the spent cathodes, two molecular dynamics models were established for simulating Li^+ transportation at 1000 K over 20 ns. Specifically, Model 1 was devised to include an impurity barrier consisting of a LiF layer (Fig. 5c and Fig. S33, ESI†). Through computing the mean square displacement (MSD) of Li atoms and fitting curves (Fig. 5d), we determined that the Li diffusivity ($\text{Diff}_{\text{Li}^+}$) of Model 1 was 3.33×10^{-10} , which was an order of magnitude lower than that of Model 2 (1.00×10^{-9}). The differences in molecular dynamics models under practical conditions suggest that fluoride-rich impurity coatings increase the resistance to Li-ion diffusion into spent cathodes with Li deficiencies during thermo-driven regeneration, leading to inadequate compositional and structural recovery.

As illustrated in Fig. 5e, the impurity phase containing the F element served as an electro- and thermo-diffusion blocker of Li ions hindering the reuse and direct regeneration of the spent cathode. In the spent cathodes collected by physical pretreatment and collection from used lithium-ion batteries, the ubiquitous electrolyte was decomposed to form an ion barrier with slow ion diffusivity. However, these impurities have long been overlooked in most studies (Table S2, ESI†), mainly due to the use of lab-scale degraded cathodes and fine manual separation pretreatment. In previous studies,^{12-16,42} the latent impact of the residual impurities on direct regeneration remains untouched because impurities are easily converted into other inconspicuous matter in extreme physical or chemical regeneration environments. Looking ahead, the direct regeneration of next-generation sensitive cathode materials, such as Li-rich Mn-based, Co-free, and ultra-high-Ni cathode materials, faces serious challenges from these latent impurities if they enter the recycling circle. From another perspective, establishing the controlling law for the inherent impurities doping within the closed-loop material flow could instructively enhance the performance of such recycled materials in the future. Moreover, only by revealing the effect of the overlooked impurities or by getting rid of impurities, can evolving technologies and mechanisms for direct regeneration and upcycling be reasonably evaluated.⁵⁰
