Cite this: *J. Mater. Chem. A*, 2020, **8**, 17399Received 17th July 2020
Accepted 11th August 2020

DOI: 10.1039/d0ta06985j

Characterization of mechanical degradation in an all-solid-state battery cathode†

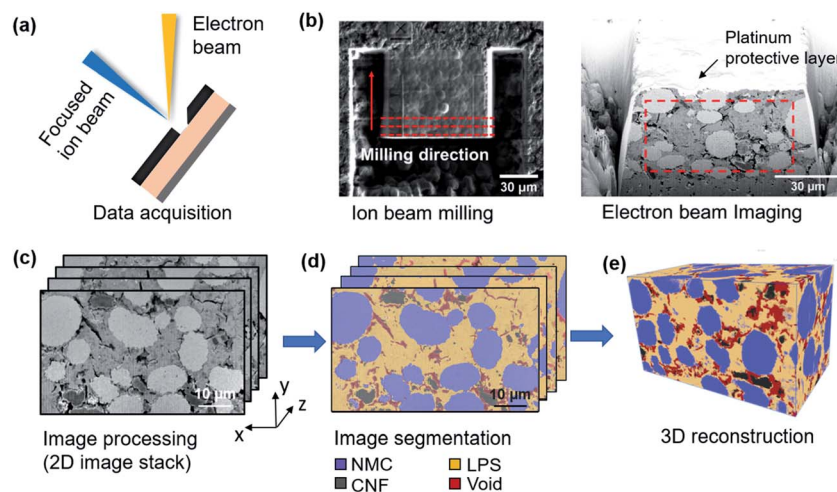
Fig. 2 Workflow for FIB-SEM tomography. (a) Schematic illustration of data acquisition set-up in FIB-SEM. (b) Ion-beam milling and BSE electron beam imaging were performed iteratively during serial sectioning. (c) 2D image stack obtained after image processing. (d) Corresponding four-phase segmentation results and (e) reconstructed 3D volume of the cathode composite (the final 3D volumes were slightly different for the three samples but were all $\sim 60 \times 40 \times 30 \mu\text{m}^3$).

To directly observe and verify the possible contact loss between the cathode and solid electrolyte, FIB-SEM tomography was used to characterize the microstructural evolution in the composite cathode during cycling. Three SSB cells (before cycling, after 10 cycles, and after 50 cycles) were extracted in the discharged state and evaluated using FIB-SEM tomography. The workflow for the FIB-SEM tomography experiment is presented in Fig. 2. The SSB full cell was tilted at a 52° angle with the cathode composite perpendicular to the ion beam. The ion beam was first used to mill trenches surrounding the area of interest, exposing the cross-section to the top-mounted electron beam at a 52° angle. A backscattered electron (BSE) image was acquired to provide 2D morphology information on the cathode composite. Then, a thin slice (50 nm) was milled away from the cross-section with the ion beam, and another BSE image was taken. After repeating this process several hundred times, the image stack was aligned, cropped, and combined into a 2D image stack (Fig. 2(c)) (see ESI Fig. S2 and S3† for the detailed image process procedures). The 2D image stack and corresponding four-phase segmentation image are presented in Fig. 2(c) and (d), respectively, whereby the NMC cathode (blue), LPS solid electrolyte (yellow), carbon (black), and void (red) can be accurately distinguished. The segmented image stacks were then reconstructed into a 3D volume. The reconstructed structures of the composite cathodes before and after electrochemical cycling are presented in Fig. 3.

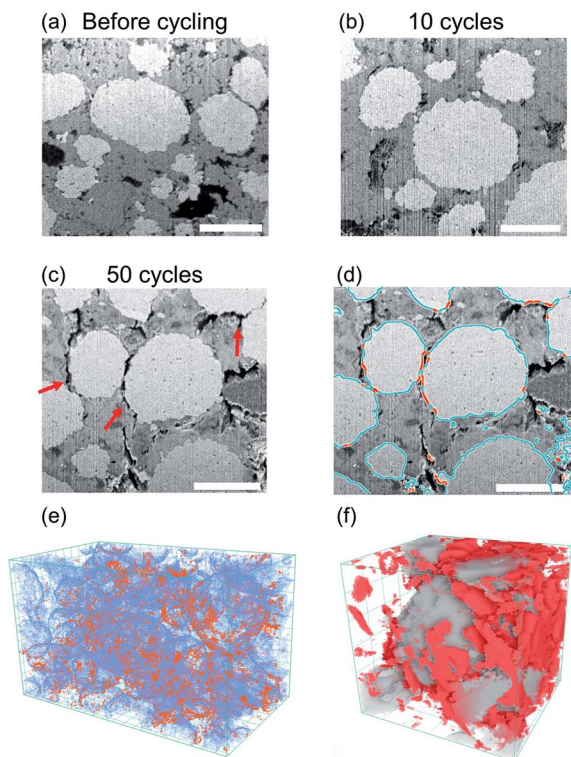
Fig. 4 Cross-sectional SEM images of composite cathode (a) before cycling, (b) after 10 cycles, and (c) after 50 cycles. Scale bar: 10 μm (d) NMC surfaces (blue) with void/NMC interfaces highlighted in red and (e) their 3D reconstruction. (f) Part of the 3D reconstruction of the after-50-cycles sample showing an isolated NMC particle (grey) with surrounding voids (red). Other components (LPS and carbon) are not shown. Box sizes for (e) and (f) are $64 \times 38 \times 36 \mu\text{m}^3$ and $18 \times 20 \times 18 \mu\text{m}^3$, respectively.

To better quantify the degree of contact loss at the cathode/solid electrolyte interface in the sample that was cycled 50 times, we divided the cathode surface into cathode surface in contact with voids (contact loss) and cathode surface in contact with other components such as other cathode, solid electrolyte, or carbon (with contact), based on the segmentation shown in Fig. 3. Fig. 4(d) demonstrates the labeling of the two categories in a 2D slice of Fig. 4(c) with the contact loss surfaces highlighted in red, and the other cathode surfaces shown in blue. This analysis was performed on all images of the sample, and the reconstructed 3D structure of the cathode surfaces with

contact (blue) and without contact (red) is presented in Fig. 4(e). Contact loss was observed at most of the cathode particle surfaces, demonstrating the severity of the mechanical problems caused by cathode volume change. The estimated contact loss area is 10.4% of the total cathode surface area.

To better visualize the local contact loss distribution around the cathode particles, a single NMC particle and its surrounding voids in the sample cycled 50 times were isolated from the larger volume and are shown in Fig. 4(f). The spherical NMC particle at the center is shown in grey, and the surrounding voids are shown in red. The voids are much more concentrated on the right side of the NMC particle, suggesting that the contact loss areas caused by the cathode particle volume shrinking will mostly be on one side of the particle, rather than uniformly distributed around the particle. This is expected because the presence of voids on one side of the particle is sufficient to release the strain caused by the particle volume change. This concentration of the decohered area in the cathode particle may aggravate its effect on capacity loss as now all the Li ions going in and out of the area under the contact loss have a much larger distance to travel before they reach the solid electrolyte. This is in contrast to if the contact loss area were homogeneously dispersed across the cathode particle. In the latter case, diffusion gradients parallel to the surface, resulting from blocked-out surface area for Li to enter or leave the particle, would rapidly fade out in the cathode particle.
