Energy & Environmental Science

washing facilitates the direct regeneration of spent cathodes from retired EV Li-ion batteries†

Removal of residual contaminants by minute-level

DOI: 10.1039/d4ee03021d

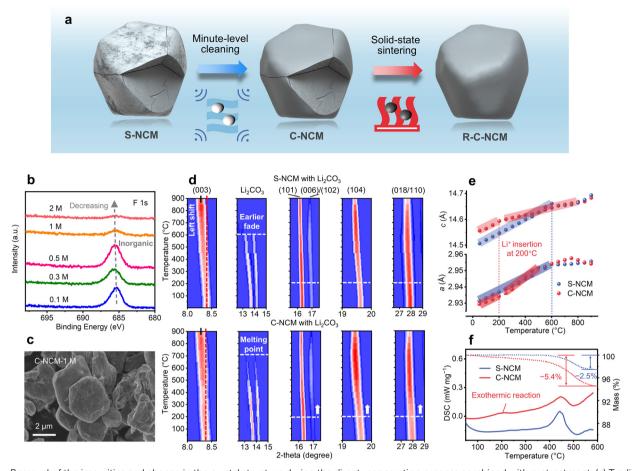
Fig. 2 Removal of the impurities and change in the crystal structure during the direct regeneration process combined with pretreatment. (a) Traditional direct regeneration path using solid-state sintering and the minute-level pretreatment introduced in an advanced path targeted to the critical obstacles within degraded cathode materials; (b) F 1s XPS fine patterns of C-NCM undergoing ultrasonic stirring in solutions with different concentrations; (c) SEM image of C-NCM obtained by soaking S-NCM in 1 M HNO₃ solution; (d) partial in situ XRD patterns of S-NCM and C-NCM mixed with a Li resource, keeping a constant heating rate (20 °C min⁻¹) and holding the temperature for diffraction at 50 °C intervals; (e) evolution of the unit cell parameters a and c for S-NCM (blue symbols) and C-NCM (red symbols) mixed with Li slate through Rietveld refinement. The earlier Li⁺ insertion at 200 °C changed the variation tendency of the unit parameters for the sample after cleaning. (f) Heat generation measured by DSC from mixtures.

morphology of the cathode remained unchanged, which may be related to the Li⁺/H⁺ exchange mechanism with the stabilizing lattice structure. 40,41 Moreover, as shown in Fig. 2b and Fig. S22 (ESI†), based on the charge/discharge efficiency, we further optimized the solution concentration as 1 M in the following investigations.

To reveal the effect of the residuals during the direct regeneration of the recycled cathode, in situ XRD characterizations were compared following the regeneration of S-NCM and C-NCM. During the heating, the unit cell lattice first nearly linearly expanded until there was a differentiation of the expansion ratio caused by the lithium insertion. As shown in Fig. 2d, the shift of the (003) peak of C-NCM was less pronounced than that of S-NCM when heating to 900 °C, indicating its unit cell lattice c was not expanded as much as for the S-NCM due to its more efficient lithium insertion. Therefore, more lithium insertion was observed for the C-NCM cathode. Correspondingly, the Li₂CO₃ in the mixture of S-NCM and C-NCM also performed differently, whereby the Li₂CO₃ in the

C-NCM cathode was consumed gradually until it disappeared at its melting point around 730 °C, while the Li₂CO₃ in the S-NCM cathode completely vanished at around only 600 °C, and this earlier consumption of the lithium source may be attributed to the reaction between Li₂CO₃ and the residual impurities (such as LiF, LiOH, and Li₃PO₄) by co-melting, vaporizing, and replenishing in S-NCM.42 Equivalently, the high angle reflection peak intensity spanning from (006) to (110), representing the layered structure, significantly increased starting from around 200 °C for the C-NCM cathode after the purifying treatment compared to there being no obvious enhancement for S-NCM, indicting the better repair of the layered structure during heating. To further unveil the underlying mechanism, Rietveld refinement of each XRD pattern was conducted, which can depict the continuous change of the unit cell parameters during regeneration. Generally, the unit cell parameter c decreases and a increases with the insertion of Li ions into a layered structure, similar to in the discharge process.²⁸ As shown in Fig. 2e, the lattice evolution of the S- and C-NCM

cathodes were compared. For C-NCM, the lattice c expansion slope became obviously flatter at 200 $^{\circ}$ C, denoting a lattice cshrinkage at this temperature induced by the Li-ion insertion and repairing. However, for the S-NCM without undergoing purifying treatment for the residuals, the lattice expanded still nearly linearly with no obvious lithium insertion until 600 °C. Concurrently, the lattice a expansion slope became steeper at 200 °C for C-NCM. Last but not least, Differential scanning calorimetry (DSC) characterization was also conducted during the regeneration process to confirm the lithium insertion pattern for the S- and C-NCM cathodes, which can trace the lithium replenishment associated with the exothermic reaction as reported by others. 43 As shown in Fig. 2f, the characteristic exothermic reaction at around 200 °C was only observed for C-NCM, confirmed the earlier lithium insertion after the purifying treatment. The earlier lithium insertion was also supported by the CO₂ gas release observed during Li₂CO₃ decomposition to supply the lithium source for the C-NCM cathode, as shown Fig. S23 (ESI†). Moreover, from the thermogravimetric results shown in Fig. 2f, the weight loss of C-NCM was 5.4%, which was significantly larger than that of S-NCM of 2.5%, indicating that more Li₂CO₃ was activated and decomposed to provide the lithium source for C-NCM. 43,44 To sum up, through multiple in situ and ex situ characterizations, we proved that, with a purifying pretreatment, the direct regeneration could be facilitated to start at a lower temperature of 200 °C from the spent cathode.

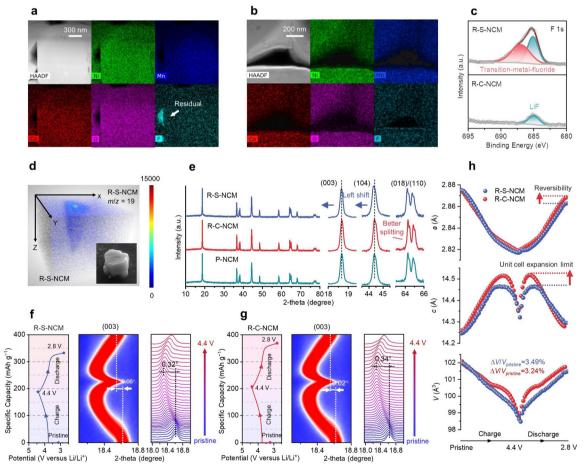
Fig. 3 Chemical and structural details of the regenerated cathode materials under the influence of impurities. (a) HAADF-STEM images and (b) corresponding EDS element mappings of R-S-NCM and R-C-NCM particles, focusing on the pores of the packing particles. (c) F 1s XPS high-resolution patterns of R-S-NCM and R-C-NCM powders. (d) Pseudo-three-dimensional distribution of F element and SEM image of the corresponding R-S-NCM particle. (e) Full patterns and characteristic peak comparison of the regenerated and pristine NCM cathodes with Cu Kα radiation at a scan rate of 8° min⁻¹. (f) 1st charge-discharge curves, corresponding XRD patterns of R-S-NCM, and (g) (003) peak position variation when the cell charge from pristine to 4.4 V and comparison with R-C-NCM. (h) Lattice parameters a, c, and the unit cell volume V of R-S-NCM and R-C-NCM in the 1st chargedischarge test according to the refinement.

the spent cathode could completely decompose in air with an O₂ atmosphere at 550 °C and 750 °C, which suggested these additives led to only minor residuals for the regenerated cathode after the high-temperature regeneration. Comparing the morphology (Fig. S25, ESI†) and element composition (Table S4, ESI†) showed that both the regenerated cathodes exhibited a smooth surface without cracks and possessed a similar composition as pristine P-NCM. However, the element distribution was distinct, as indicated by the corresponding EDS mapping shown in Fig. 3a and b, where it could be clearly seen that there were fluorine residuals aggregated in the nanopores inside the R-S-NCM cathode, while the R-C-NCM cathode did not show a F-rich area. Meanwhile, the XPS (Fig. 3c and Fig. S26, ESI†) results showed that the R-C-NCM cathode exhibited a much less intense F 1s characteristic peak and more similar C 1s and O 2p peaks with the P-NCM one compared with R-S-NCM without the purifying treatment. The SEM-ToF-SIMS results (Fig. 3d and Fig. S27 and Videos S5, S6, ESI†) also demonstrated that even though long-time calcination was applied, the F-rich residual impurities in R-S-NCM had hardly vaporized and were still concentrated on the surface and in the bulk due to their strong electronegativity.⁴⁵

Furthermore, the crystal structure of the regenerated cathode could also be affected by the residual impurities. As shown in Fig. 3e and Fig. S28 (ESI†), the XRD pattern indicated a layered structure with no impurities phase for both the R-S-NCM and R-C-NCM cathodes. However, the R-C-NCM cathode had a higher (003)/(104) intensity ratio and larger splitting degree for the (018)/(110) peaks compared to R-S-NCM, suggesting its more ideal layered structure similar to P-NCM cathodes. After regeneration accompanied by impurities, the diffraction peaks of R-S-NCM were shifted toward a low-angle direction, indicating the lattice expansion, as supported by the refined parameters (Table S11, ESI†) and in situ experiments (Fig. 2d). Furthermore, in situ XRD was performed during the 1st charge/ discharge process for both regenerated cathodes (see Fig. 3f and g). The R-C-NCM cathode showed a higher capacity with a smaller offset (0.02°) of the (003) peak position than the

57.5% for R-S-NCM, indicating the R-C-NCM cathode had better cycling stability, even compared to the pristine one. As for the rate performance, the R-C-NCM cathode demonstrated a better high-rate capability (Fig. 4c and Fig. S30, ESI†) at 3C (127.8 mA h g^{-1}) compared to R-S-NCM (69.8 mA h g^{-1}) and P-NCM (108.9 mA h g⁻¹), which was commonly observed on the regenerated NCM cathodes and may be attributed to appropriate F element doping. 12,47 The plateau at ~ 3.6 V in the voltage profiles (Fig. 4d and e and Fig. S30, ESI†) for R-S-NCM nearly disappears after 100 cycles, suggesting that R-S-NCM had a rising polarization after long-term cycling. Based on the cyclic voltammetry curves at different scan rates and calculations (Fig. S31 and Table S12, ESI†), the fitting line slope for R-S-NCM was found to be the lowest among all the samples. According to the equivalent circuit (Fig. 4f), the calculated impedance values ($R_{\rm ohm}$, $R_{\rm int}$, and $R_{\rm ct}$) of R-C-NCM (Fig. 4g and h) were 1.4, 51.1, and 307.1 Ω , respectively, and were smaller than that of R-S-NCM. These results indicate the deteriorated kinetics of Li⁺ transportation due to the residual impurities, especially on the surfaces of the regenerated cathodes. According to the chemical state of the electrode surface (Fig. S32, ESI†), R-C-NCM exposed less inorganic fluoride and more lattice oxide, leading to the suppressed interfacial resistance growing during the long-term cycling. Furthermore, the galvanostatic intermittent titration technique (GITT) test also revealed the kinetic characteristics of the solid phase. The current pulse profile and calculated Li-ion diffusion coefficient (D_{Li^+}) after activation are shown in Fig. 4i. The average D_{Li^+} values of R-C-NCM and R-S-NCM were calculated to be 5.78 \times 10^{-14} and 2.99×10^{-14} for the charge process (and 4.56×10^{-14} and 4.29×10^{-14} for the discharge process), suggesting that residual impurities penetrating the interior bulk after regeneration hamper Li⁺ hopping within the lattice of the NCM cathode, as supported by the observed F element (Fig. 3c and Fig. S27, ESI†).

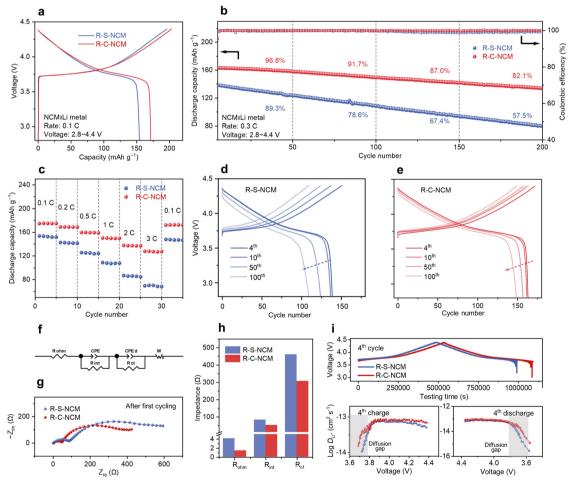
Fig. 4 Electrochemical deterioration for the regenerated NCM cathodes with impurity residue. (a) Initial galvanostatic charge-discharge curves of R-S-NCM and R-C-NCM at 0.1C (1C = 150 mA h g^{-1}) and (b) long cycling test and capacity retention in a half-cell. (c) Rate capabilities of R-S-NCM and R-C-NCM. Charge-discharge curves of (d) R-S-NCM, (e) R-C-NCM in the voltage range of 2.8-4.4 V (vs. Li/Li⁺) at different cycles. (f) Equivalent circuit applied in the EIS measurements. Nyquist plots of (g) R-S-NCM and R-C-NCM and (h) fitting results showing the Ohmic resistance (Rohm), interface resistance (R_{int}), and charge-transfer resistance (R_{Ct}). (i) GITT curves and the calculated Li⁺-diffusion rate of R-S-NCM and R-C-NCM for the 4th cycle number after activation in the same charge-discharge period. The shadow area indicates low Li⁺ diffusion in a certain voltage range.

As shown in Fig. 4a and Fig. S30 (ESI†), the initial discharge capacity increased from 154.1 mA h g⁻¹ for R-S-NCM to 171.4 mA h g^{-1} for R-C-NCM after the purifying treatment, although this was slightly lower than for P-NCM. In Fig. 4b and Fig. S31 (ESI†), the R-C-NCM cathode exhibit 91.7% and 82.1% capacity retention after 100 cycles and 200 cycles, respectively, compared with 91.6% and 78.3% for P-NCM, and 78.6% and

According to the above results (Fig. 1d, Fig. S6, S16 (ESI†), and Fig. 4h, i), the migration rate of lithium ions was significantly influenced by the residual impurities; therefore it was crucial to theoretically investigate their influence on capacity delivery in the reuse case and during direct regeneration. Considering the impurities were mostly concentrated at the surface before and after regeneration, and that F-rich residuals could be observed, as shown in Fig. S9 and S10 (ESI†) and Fig. 3c, we chose three representative inorganic components (LiF, Li2CO3, and LiOH) in the CEI layer⁴⁸ or residual alkali⁴⁹ to calculate the Li⁺ diffusion from a thermodynamic perspective, and their structures are shown in Fig. 5a. By maintaining a similar distance and concentration of mobile Li-ions, the diffusion energy barrier of lithium ions (ΔE_{Li^+}) during the cycling of spent cathodes within the different crystal structures (Fig. 5b) allowed valid comparisons. We found that the ΔE_{Li^+} of the LiF phase, as a common inorganic component from CEI, was about 2 and 3 times higher than that of the LiOH and Li₂CO₃ phases from

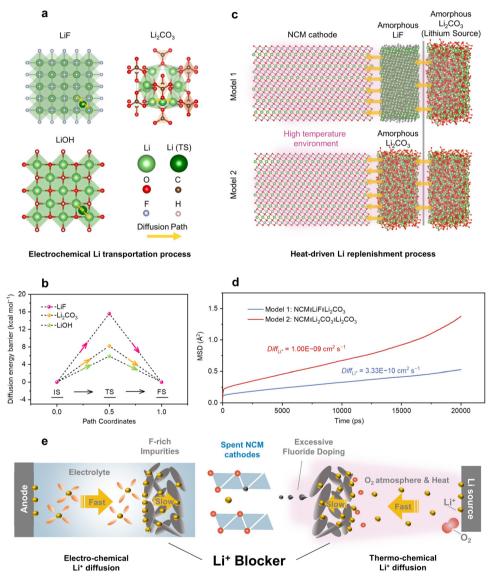
Fig. 5 Role of the F-rich impurities as a blocker in electrochemical and thermochemical Li⁺ diffusion as ascertained from thermodynamic and kinetic simulations. (a) Illustrations of the selected migration pathways with a similar distance for Li⁺ inside the crystal lattice of three common components. The initial state, transition state, and final state of Li⁺ transportation are denoted as IS, TS, and FS, respectively. (b) Calculated energy diffusion barrier for Li ions in selected phases. (c) Two models for stimulating the kinetics of Li transportation in direct regeneration. Model 1 consists of the NCM cathode substrate, the amorphous LiF layer, and Li_2CO_3 as a lithium source in direct regeneration, which is denoted as $\text{NCM} \| \text{Li}_F \| \text{Li}_2\text{CO}_3$. In Model 2 ($\text{NCM} \| \text{Li}_2\text{CO}_3 \| \text{Li}_$ short), the middle LiF layer is replaced by a common residual alkali (Li₂CO₃), which is used to simulate the regeneration of NCM cathodes after cleaning pretreatment. Each shape symbol is the same as for Fig. 5a. (d) MSD of the Li atoms in 20 ns and calculated Li⁺ diffusivity based on the above model. "E – $9^{\prime\prime}$ means 10^{-9} . (e) Mechanism diagram for preventing the NCM cathodes from reusing and directly regenerating under the influence of impurities.

Fig. 5b. Therefore, this result confirmed that the presence of fluoride-rich impurity residuals on the cathode surface significantly increased the diffusion resistance of Li ions when cycling, ultimately exacerbating the cell impedance and interfacial parasitic reactions (Fig. 1d). To comprehend the largerscale kinetic characteristics and understand the effect of impurity coatings during heating for regeneration of the spent cathodes, two molecular dynamics models were established for simulating Li⁺ transportation at 1000 K over 20 ns. Specifically, Model 1 was devised to include an impurity barrier consisting of a LiF layer (Fig. 5c and Fig. S33, ESI†). Through computing the mean square displacement (MSD) of Li atoms and fitting curves (Fig. 5d), we determined that the Li diffusivity (Diff_{Li}+) of Model 1 was 3.33×10^{-10} , which was an order of magnitude lower than that of Model 2 (1.00 \times 10⁻⁹). The differences in molecular dynamics models under practical conditions suggest that fluoride-rich impurity coatings increase the resistance to Li-ion diffusion into spent cathodes with Li deficiencies during thermo-driven regeneration, leading to inadequate compositional and structural recovery.

As illustrated in Fig. 5e, the impurity phase containing the F element served as an electro- and thermo-diffusion blocker of Li ions hindering the reuse and direct regeneration of the spent cathode. In the spent cathodes collected by physical pretreatment and collection from used lithium-ion batteries, the ubiquitous electrolyte was decomposed to form an ion barrier with slow ion diffusivity. However, these impurities have long been overlooked in most studies (Table S2, ESI†), mainly due to the use of lab-scale degraded cathodes and fine manual separation pretreatment. In previous studies, 12-16,42 the latent impact of the residual impurities on direct regeneration remains untouched because impurities are easily converted into other inconspicuous matter in extreme physical or chemical regeneration environments. Looking ahead, the direct regeneration of nextgeneration sensitive cathode materials, such as Li-rich Mnbased, Co-free, and ultra-high-Ni cathode materials, faces serious challenges from these latent impurities if they enter the recycling circle. From another perspective, establishing the controlling law for the inherent impurities doping within the closed-loop material flow could instructively enhance the performance of such recycled materials in the future. Moreover, only by revealing the effect of the overlooked impurities or by getting rid of impurities, can evolving technologies and mechanisms for direct regeneration and upcycling be reasonably evaluated.50
