Ongoing legacy contamination from a military radar station in Iceland: a case study

Contamination in and around military radar stations in the Arctic has been an ongoing concern since first identified in the 1980s. This study reports on the environmental impact from a DEW line US military station that was operated on Heiðarfjall mountain in northeast Iceland from 1957 to 1970. This review is conducted as a part of work of the POPs Expert Group of the Arctic Monitoring and Assessment Program (AMAP) for an assessment report on local sources vs. long-range transport of Persistent Organic Pollutants (POPs) in the Arctic. The main resource for this summary is an evaluation of results from several reports on Heiðarfjall Langanes, one from an Icelandic Environmental Authority in 1993 and another from the Canadian Environmental Science Group (ESG) at the Royal Military College of Canada, which was commissioned in 2017 by the owners of the land that was used for the station. The results are compared to findings in scientific papers and reports for contamination at other military radar stations in Canada and Alaska. This review shows considerable contamination on Heiðarfjall over 50 years a

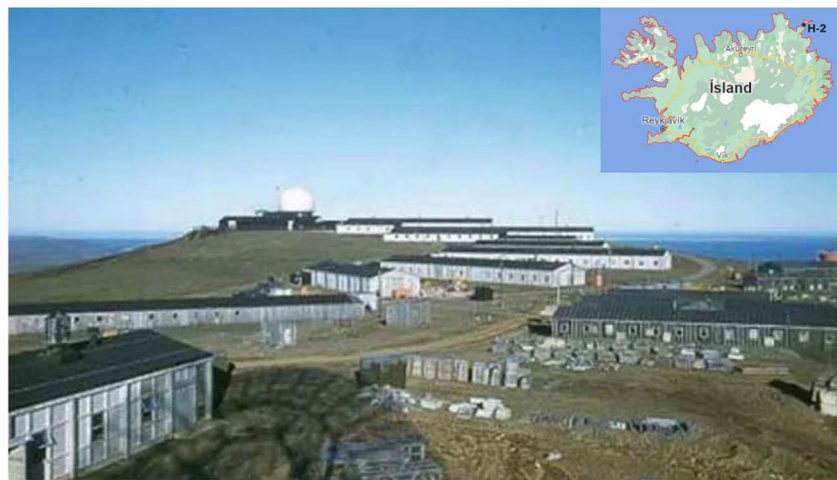
Fig. 1 The DEW line radar station at Heiðarfjall in 1958 (<https://www.radomes.org/museum/acwgrnland.php>).
