## PAPER

Removal of residual contaminants by minute-level

washing facilitates the direct regeneration of

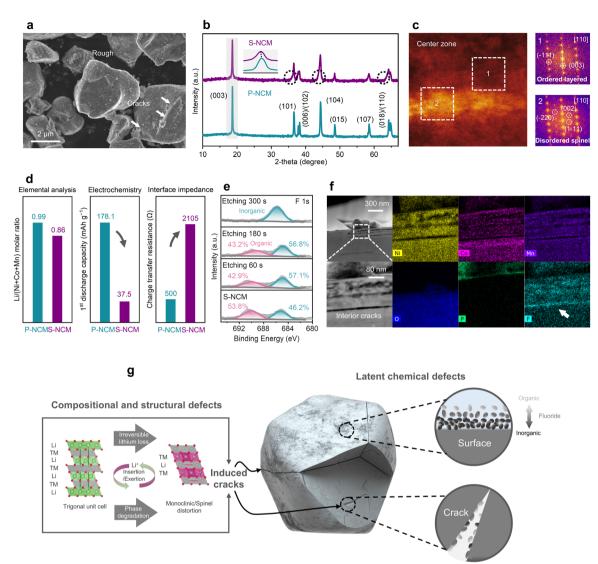
Fig. 1 Neglected chemical residuals on the 250k-miles-serviced cathode. (a) SEM image and (b) XRD pattern of the degraded S-NCM. The black dotted circle accentuates the subtle peaks that do not belong to the layered structure; (c) high-resolution HAADF-STEM images on the central area of the S-NCM particle and the FFT patterns of the selected dark and bright regions; (d) comprehensive comparison of lithium loss in degraded powders measured by ICP-OES, electrochemical capacity, and charge-transfer resistance analyses in the half-cell using S-NCM and P-NCM powders as cathode active materials; (e) F 1s XPS patterns of S-NCM powders for different sputtering times using an ion-beam. Based on the calculated integral area, the proportional values of the organics and inorganics in fluoride are presented in the patterns; (f) HAADF-STEM images based on focused ion beam cutting and an enlarged view displaying the interior microcracks. Corresponding EDS mapping analysis indicates the presence of F elements along these microcracks pointed out by a white arrow. (g) Deficiencies of S-NCM addressed before direct regeneration, including the compositional and structural aspects (e.g., irreversible lithium-ionic loss, phase degradation, internal and external cracks) and latent chemical defects (e.g., surface and crack-edge impurities enriching the F element).

four times larger than the P-NCM of 500  $\Omega$ . The increased impedance deteriorates the Li<sup>+</sup> diffusion, thus leading to the critical capacity decay. Therefore, the surface state of the spent cathode was recognized as the key issue limiting its capacity delivery, compared to compositional lithium loss and structural bulk defects.

To understand the surface state of the spent cathode, energy-dispersive spectroscopy (EDS) element mapping and X-ray photoelectron spectroscopy (XPS) were conducted. As shown in Fig. S7-S9, and Tables S5, S6 (ESI†), the S-NCM cathode surface residuals consisted of C, O, F, and P elements, and displayed a surface-rich gradient distribution, as revealed

by XPS with etching. The F 1s XPS peaks with etching for S-NCM are shown in Fig. 1e, where two F 1s peaks could be observed before sputtering, with the major peak centered at 685.5 eV, which was attributed to inorganic fluorides and the minor F 1s peak centered at 690.4 eV, which could be assigned to organic fluorides, with the ratio of 53.8% for organic flourides.<sup>29</sup> However, the organic-related F peak declined significantly after sputtering, and completely disappeared after 300 s Ar+ sputtering. The surface-rich distribution of organic fluoride was consistent with the cathode electrolyte interphase (CEI) composition previously reported.<sup>29,30</sup>

To further reveal the microscopic distribution of those F-rich residuals, SEM combined with time-of-flight secondary ion mass spectrometry (SEM-ToF-SIMS) characterization was conducted for the cycled cathode. The results are shown in Fig. S10 and Videos S1, S2 (ESI†). Based on the spatial distribution of F secondary ion fragments, it was confirmed that fluoride impurities were primarily deposited on the particle surface. Moreover, during the long-time battery service, it could be observed from the HAADF-STEM image and corresponding element mapping (see Fig. 1f) that, in the S-NCM cathode, the fluorides could spread into the interior of the cathode along the intragranular cracks. Coincidentally, from the selected FFT figure shown in Fig. S4 (ESI†), the existence of an amorphous ring was observed along the intragranular cracking, which may be related to the fluorides also observed in the bulk. To sum up, the collected S-NCM exhibited limited structural and compositional degradation, while preserving the fluoride-containing impurities aggregated on the surface and along the intragranular cracks, as illustrated in Fig. 1g.

Furthermore, it was previously widely accepted that the source of F-rich impurities in the spent cathode was due to decomposition of the PVDF binder during the heat delamination process at around 350 °C; 11,23-25,31 however, during the thermal decomposition of PVDF, most the fluoride-containing products were gas species (i.e., HF) and fragments (-CF- and -CH-CF-), 32-34 which are subject to ejection instead of propagating along the cathode intragranular cracks. To confirm the source of those observed residual impurities, four kinds of cathodes with varying cycling conditions were collected and examined, namely cathode laminates with/without electrolyte filling, and laminates from 125k and 250k miles-serviced batteries, as listed in Table S7 (ESI†). The SEM images and electrochemical performance are shown in Fig. S11 and S12 (ESI†). Compared with the pristine one (sample A), the other spent cathodes from battery formation and cycling exhibited a rough surface and limited discharge capacity. Notably, the laminate from formation only but with no cycling (sample B), which it was believed would retain the full lithium inventory and show negligible structural degradation since it had not undergone charge/discharge cycling, showed a poor discharge capacity, which was the same as the other long-cycled ones. Moreover, the heat exfoliation used to pyrolyze the adhesive binders deteriorated the original CEI layer on the spent cathodes and generated more harmful byproducts (e.g., Li<sub>2</sub>CO<sub>3</sub>, Li<sub>3</sub>PO<sub>4</sub>, LiF). This, combined with electrolyte decomposition during electrochemical cycling, exacerbates chemical degradation, resulting in a significant capacity decline. Therefore, the above comparison revealed that the cathode residual impurities should originate from the electrolyte components (such as LiPF<sub>6</sub>, DMC, ethylene carbonate (EC)) decomposition during battery formation, cycling, and common heat exfoliation, leading to severe capacity loss in spent cathodes (Fig. 1d).

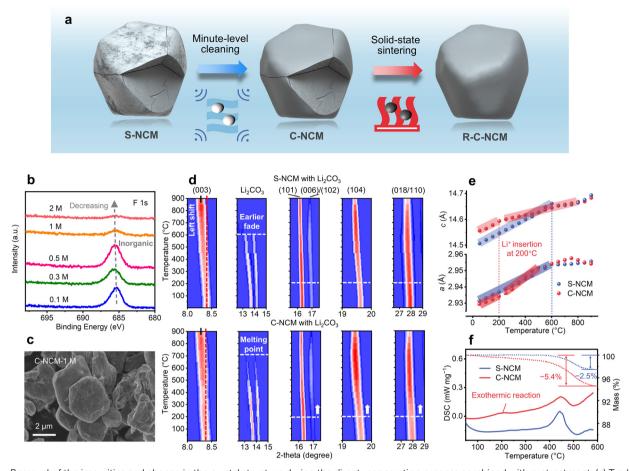
Fig. 2 Removal of the impurities and change in the crystal structure during the direct regeneration process combined with pretreatment. (a) Traditional direct regeneration path using solid-state sintering and the minute-level pretreatment introduced in an advanced path targeted to the critical obstacles within degraded cathode materials; (b) F 1s XPS fine patterns of C-NCM undergoing ultrasonic stirring in solutions with different concentrations; (c) SEM image of C-NCM obtained by soaking S-NCM in 1 M HNO<sub>3</sub> solution; (d) partial in situ XRD patterns of S-NCM and C-NCM mixed with a Li resource, keeping a constant heating rate (20 °C min<sup>-1</sup>) and holding the temperature for diffraction at 50 °C intervals; (e) evolution of the unit cell parameters a and c for S-NCM (blue symbols) and C-NCM (red symbols) mixed with Li slate through Rietveld refinement. The earlier Li<sup>+</sup> insertion at 200 °C changed the variation tendency of the unit parameters for the sample after cleaning. (f) Heat generation measured by DSC from mixtures.

morphology of the cathode remained unchanged, which may be related to the Li<sup>+</sup>/H<sup>+</sup> exchange mechanism with the stabilizing lattice structure. 40,41 Moreover, as shown in Fig. 2b and Fig. S22 (ESI†), based on the charge/discharge efficiency, we further optimized the solution concentration as 1 M in the following investigations.

To reveal the effect of the residuals during the direct regeneration of the recycled cathode, in situ XRD characterizations were compared following the regeneration of S-NCM and C-NCM. During the heating, the unit cell lattice first nearly linearly expanded until there was a differentiation of the expansion ratio caused by the lithium insertion. As shown in Fig. 2d, the shift of the (003) peak of C-NCM was less pronounced than that of S-NCM when heating to 900 °C, indicating its unit cell lattice c was not expanded as much as for the S-NCM due to its more efficient lithium insertion. Therefore, more lithium insertion was observed for the C-NCM cathode. Correspondingly, the Li<sub>2</sub>CO<sub>3</sub> in the mixture of S-NCM and C-NCM also performed differently, whereby the Li<sub>2</sub>CO<sub>3</sub> in the

C-NCM cathode was consumed gradually until it disappeared at its melting point around 730 °C, while the Li<sub>2</sub>CO<sub>3</sub> in the S-NCM cathode completely vanished at around only 600 °C, and this earlier consumption of the lithium source may be attributed to the reaction between Li<sub>2</sub>CO<sub>3</sub> and the residual impurities (such as LiF, LiOH, and Li<sub>3</sub>PO<sub>4</sub>) by co-melting, vaporizing, and replenishing in S-NCM.42 Equivalently, the high angle reflection peak intensity spanning from (006) to (110), representing the layered structure, significantly increased starting from around 200 °C for the C-NCM cathode after the purifying treatment compared to there being no obvious enhancement for S-NCM, indicting the better repair of the layered structure during heating. To further unveil the underlying mechanism, Rietveld refinement of each XRD pattern was conducted, which can depict the continuous change of the unit cell parameters during regeneration. Generally, the unit cell parameter c decreases and a increases with the insertion of Li ions into a layered structure, similar to in the discharge process.<sup>28</sup> As shown in Fig. 2e, the lattice evolution of the S- and C-NCM

cathodes were compared. For C-NCM, the lattice c expansion slope became obviously flatter at 200  $^{\circ}$ C, denoting a lattice cshrinkage at this temperature induced by the Li-ion insertion and repairing. However, for the S-NCM without undergoing purifying treatment for the residuals, the lattice expanded still nearly linearly with no obvious lithium insertion until 600 °C. Concurrently, the lattice a expansion slope became steeper at 200 °C for C-NCM. Last but not least, Differential scanning calorimetry (DSC) characterization was also conducted during the regeneration process to confirm the lithium insertion pattern for the S- and C-NCM cathodes, which can trace the lithium replenishment associated with the exothermic reaction as reported by others. 43 As shown in Fig. 2f, the characteristic exothermic reaction at around 200 °C was only observed for C-NCM, confirmed the earlier lithium insertion after the purifying treatment. The earlier lithium insertion was also supported by the CO<sub>2</sub> gas release observed during Li<sub>2</sub>CO<sub>3</sub> decomposition to supply the lithium source for the C-NCM cathode, as shown Fig. S23 (ESI†). Moreover, from the thermogravimetric results shown in Fig. 2f, the weight loss of C-NCM was 5.4%, which was significantly larger than that of S-NCM of 2.5%, indicating that more Li<sub>2</sub>CO<sub>3</sub> was activated and decomposed to provide the lithium source for C-NCM. 43,44 To sum up, through multiple in situ and ex situ characterizations, we proved that, with a purifying pretreatment, the direct regeneration could be facilitated to start at a lower temperature of 200 °C from the spent cathode.

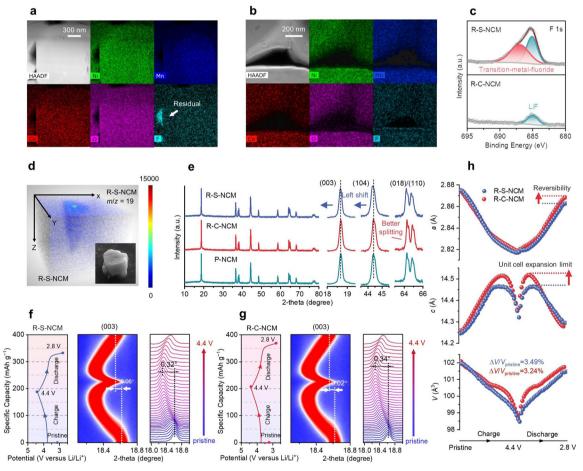
Fig. 3 Chemical and structural details of the regenerated cathode materials under the influence of impurities. (a) HAADF-STEM images and (b) corresponding EDS element mappings of R-S-NCM and R-C-NCM particles, focusing on the pores of the packing particles. (c) F 1s XPS high-resolution patterns of R-S-NCM and R-C-NCM powders. (d) Pseudo-three-dimensional distribution of F element and SEM image of the corresponding R-S-NCM particle. (e) Full patterns and characteristic peak comparison of the regenerated and pristine NCM cathodes with Cu Kα radiation at a scan rate of 8° min<sup>-1</sup>. (f) 1st charge-discharge curves, corresponding XRD patterns of R-S-NCM, and (g) (003) peak position variation when the cell charge from pristine to 4.4 V and comparison with R-C-NCM. (h) Lattice parameters a, c, and the unit cell volume V of R-S-NCM and R-C-NCM in the 1st chargedischarge test according to the refinement.

the spent cathode could completely decompose in air with an O<sub>2</sub> atmosphere at 550 °C and 750 °C, which suggested these additives led to only minor residuals for the regenerated cathode after the high-temperature regeneration. Comparing the morphology (Fig. S25, ESI†) and element composition (Table S4, ESI†) showed that both the regenerated cathodes exhibited a smooth surface without cracks and possessed a similar composition as pristine P-NCM. However, the element distribution was distinct, as indicated by the corresponding EDS mapping shown in Fig. 3a and b, where it could be clearly seen that there were fluorine residuals aggregated in the nanopores inside the R-S-NCM cathode, while the R-C-NCM cathode did not show a F-rich area. Meanwhile, the XPS (Fig. 3c and Fig. S26, ESI†) results showed that the R-C-NCM cathode exhibited a much less intense F 1s characteristic peak and more similar C 1s and O 2p peaks with the P-NCM one compared with R-S-NCM without the purifying treatment. The SEM-ToF-SIMS results (Fig. 3d and Fig. S27 and Videos S5, S6, ESI†) also demonstrated that even though long-time calcination was applied, the F-rich residual impurities in R-S-NCM had hardly vaporized and were still concentrated on the surface and in the bulk due to their strong electronegativity.<sup>45</sup>

Furthermore, the crystal structure of the regenerated cathode could also be affected by the residual impurities. As shown in Fig. 3e and Fig. S28 (ESI†), the XRD pattern indicated a layered structure with no impurities phase for both the R-S-NCM and R-C-NCM cathodes. However, the R-C-NCM cathode had a higher (003)/(104) intensity ratio and larger splitting degree for the (018)/(110) peaks compared to R-S-NCM, suggesting its more ideal layered structure similar to P-NCM cathodes. After regeneration accompanied by impurities, the diffraction peaks of R-S-NCM were shifted toward a low-angle direction, indicating the lattice expansion, as supported by the refined parameters (Table S11, ESI†) and in situ experiments (Fig. 2d). Furthermore, in situ XRD was performed during the 1st charge/ discharge process for both regenerated cathodes (see Fig. 3f and g). The R-C-NCM cathode showed a higher capacity with a smaller offset (0.02°) of the (003) peak position than the

57.5% for R-S-NCM, indicating the R-C-NCM cathode had better cycling stability, even compared to the pristine one. As for the rate performance, the R-C-NCM cathode demonstrated a better high-rate capability (Fig. 4c and Fig. S30, ESI†) at 3C (127.8 mA h  $g^{-1}$ ) compared to R-S-NCM (69.8 mA h  $g^{-1}$ ) and P-NCM (108.9 mA h g<sup>-1</sup>), which was commonly observed on the regenerated NCM cathodes and may be attributed to appropriate F element doping.  $^{12,47}$  The plateau at  $\sim 3.6$  V in the voltage profiles (Fig. 4d and e and Fig. S30, ESI†) for R-S-NCM nearly disappears after 100 cycles, suggesting that R-S-NCM had a rising polarization after long-term cycling. Based on the cyclic voltammetry curves at different scan rates and calculations (Fig. S31 and Table S12, ESI†), the fitting line slope for R-S-NCM was found to be the lowest among all the samples. According to the equivalent circuit (Fig. 4f), the calculated impedance values ( $R_{\rm ohm}$ ,  $R_{\rm int}$ , and  $R_{\rm ct}$ ) of R-C-NCM (Fig. 4g and h) were 1.4, 51.1, and 307.1  $\Omega$ , respectively, and were smaller than that of R-S-NCM. These results indicate the deteriorated kinetics of Li<sup>+</sup> transportation due to the residual impurities, especially on the surfaces of the regenerated cathodes. According to the chemical state of the electrode surface (Fig. S32, ESI†), R-C-NCM exposed less inorganic fluoride and more lattice oxide, leading to the suppressed interfacial resistance growing during the long-term cycling. Furthermore, the galvanostatic intermittent titration technique (GITT) test also revealed the kinetic characteristics of the solid phase. The current pulse profile and calculated Li-ion diffusion coefficient  $(D_{Li^+})$  after activation are shown in Fig. 4i. The average  $D_{Li^+}$ values of R-C-NCM and R-S-NCM were calculated to be 5.78  $\times$  $10^{-14}$  and  $2.99\times 10^{-14}$  for the charge process (and  $4.56\times 10^{-14}$ and  $4.29 \times 10^{-14}$  for the discharge process), suggesting that residual impurities penetrating the interior bulk after regeneration hamper Li<sup>+</sup> hopping within the lattice of the NCM cathode, as supported by the observed F element (Fig. 3c and Fig. S27, ESI†).
