Cite this: *Environ. Sci.: Water Res. Technol.*, 2021, 7, 274

DOI: 10.1039/d0ew00836b

Drinking water contamination from the thermal degradation of plastics: implications for wildfire and structure fire response†

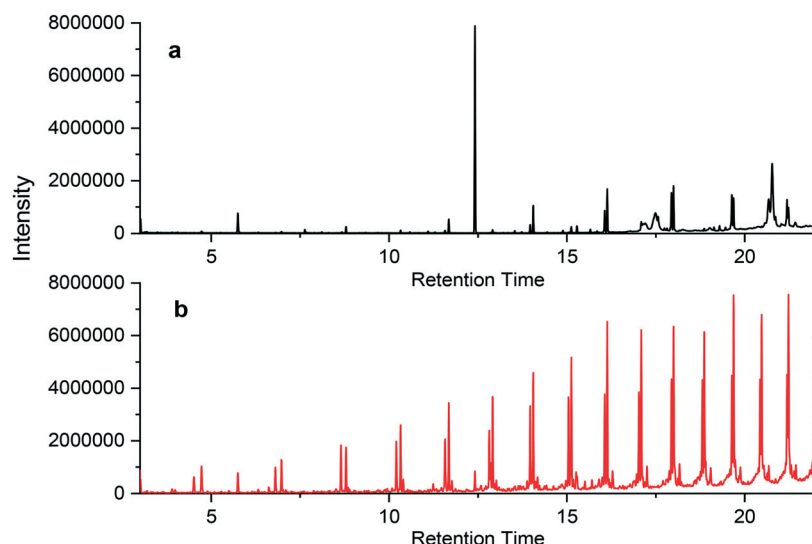
Fig. 4 Chromatographs of PEX-c-1a when (a) unburned and (b) burned at 400 °C, where samples were extracted in *n*-hexane. The internal standard is the peak at 5.8 minutes.

Leaching promoted by hexane extraction. As expected, a greater number of peaks were observed in the *n*-hexane extracts (32 to 134) compared to the water extracts (3 to 22) for all plastics (see example for PEX-c-1a in Fig. 4 and all other pipe types in Fig. S17–S26†). For the degraded PEX, HDPE, and PP pipes, between 100 to 134 unique compounds were leached into *n*-hexane, whereas for the degraded PVC and CPVC pipes between 30 to 41 compounds were leached (Fig. 4 and S17–S26†). While most compounds extracted from the new pipes were either straight chain or branched alkanes of varying lengths (Table S3†), thermal exposure led alkenes to represent the majority of compounds detected in the leachate (Table S5†). These aliphatic hydrocarbons are products of alkane hydrocarbon chain scission and are not typical drinking water contaminants. They have low aqueous solubility, which is why they were only detected in the hexane extracts and are generally less toxic than their cyclical or aromatic counterparts.^{56,57}

Generally, both the magnitude of the peak and the number of compounds increased after burning the materials. However, one notable exception occurred for the PEX-c pipes; one peak (retention time of 12.5 min) for the unburned pipe was significantly larger than that of any of the burned peaks (Fig. 4 and S21†). This peak likely represented the compound, di-*tert*-butylbenzene, which has been shown to be an ultraviolet light or radiolysis degradation product of the antioxidant Irgafos 168®.^{58,59} This compound was only observed in the leachate of the PEX-c materials, in which the crosslinking occurs using beta irradiation. This may explain why the magnitude of this degradation product was so large.⁶⁰ This peak decreased substantially in the burned plastic extract (Fig. 4 and S21†), indicating it may have been thermally decomposed.
