Cite this: *Environ. Sci.: Water Res. Technol.*, 2021, 7, 274

DOI: 10.1039/d0ew00836b

Drinking water contamination from the thermal degradation of plastics: implications for wildfire and structure fire response†

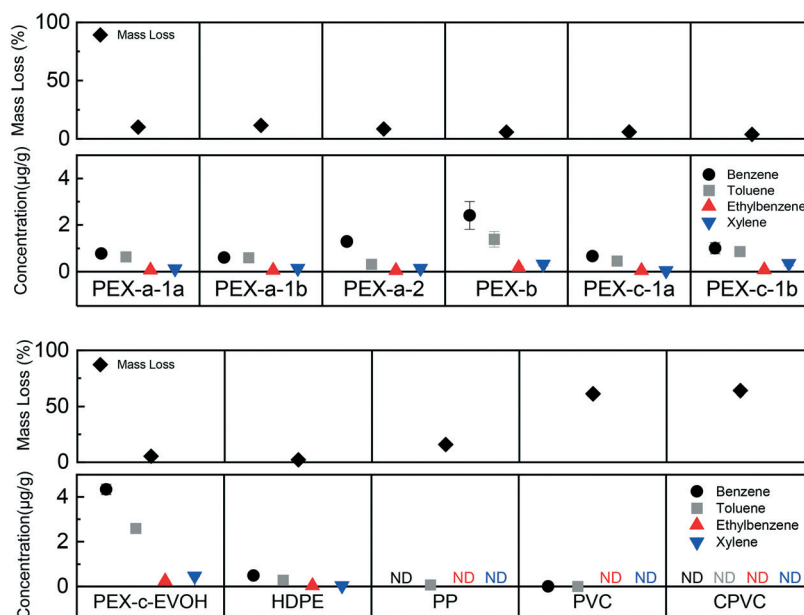
Fig. 2 Average amount of benzene, toluene, ethylbenzene, and xylene leaching observed after burning each material at 400 °C and extracting in water for 7 days. The error bars reflect the standard deviation of the measurements ($n = 3$). If no error bars are visible, this indicates the error bars are smaller than the symbol size. ND indicates the compound was not detected above the MDL.

Results showed that plastic pipe thermal exposure can generate BTEX, which can then leach from cooled plastics into water. BTEX was not found from new and non-thermally degraded plastics in water, while 10 of 11 thermally degraded plastic pipes leached at least one BTEX component (Fig. 2). The chemical leaching differences between products is likely attributed to differences between plastic characteristics and experimental conditions. PE materials lost less mass due to isothermal heating (5 wt% to 10 wt%) compared to the PVC and CPVC samples (61 wt% and 64 wt%, respectively) (Fig. 2). A detectable, but significantly lower amount of benzene and toluene was observed for the PVC pipe, and no BTEX was found for the CPVC pipe (Fig. 2). Additionally, there was a general trend of compound concentration leaching across the plastics where benzene > toluene > ethylbenzene ≈ xylene (Fig. 2). This trend could be attributed to several factors including compound production, water solubility, air volatilization, polymer solubility parameters, and/or partitioning into the aqueous phase. Octanol-water coefficients and solubility values mirror the trend of concentrations observed (Table S4[†]), indicating that benzene would most readily partition into the aqueous phase.
