Unravelling and quantifying the aging processes of commercial $\text{Li}(\text{Ni}_{0.5}\text{Co}_{0.2}\text{Mn}_{0.3})\text{O}_2/\text{graphite}$ lithium-ion batteries under constant current cycling†

Jia Guo,^{ab} Siyu Jin,^{ab*} Xin Sui,^a Xinrong Huang,^c Yaolin Xu,^{*d} Yaqi Li,^{ab} Peter Kjær Kristensen,^b Deyong Wang,^b Kjeld Pedersen,^b Leonid Gurevich^b and Daniel-Ioan Stroe^a

DOI: 10.1039/d2ta05960f

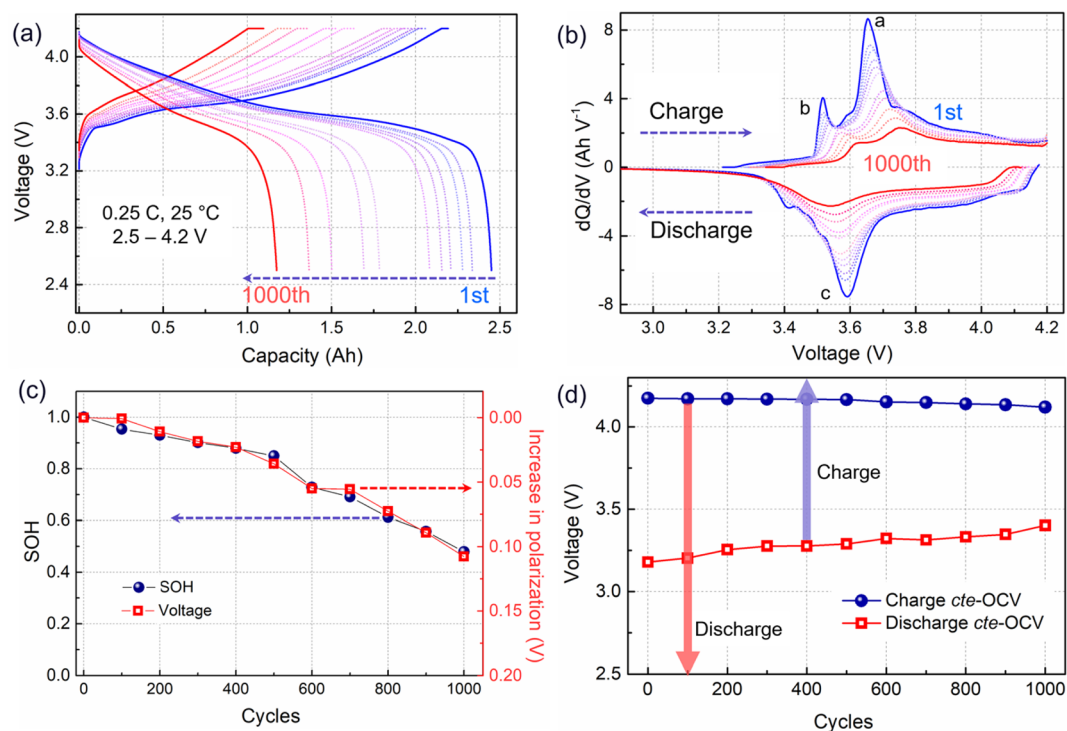
Fig. 1 Electrochemical behavior from the reference performance test (RPT) after every one hundred cycles at 0.25C (0.55 A) and 25 °C. (a) Charge and discharge curves, (b) IC curves, (c) SOH and polarization evolution (shift of the b peak in (b)) over cycling, and (d) charging and discharging cte-OCV. The arrows represent the real voltage window of discharging/charging.

ICA and cte-OCV techniques were employed to preliminarily diagnose the battery degradation mechanisms. The charging/discharging curves from eleven RPTs are presented in Fig. 1a. With the battery aging evolution, the charging plateau shows an increasing trend, whereas the discharge plateau becomes lower.

Then, the voltage gap between the charging and discharging plateaus, which is associated with the battery impedance, is gradually increasing. Meanwhile, the voltage plateau is significantly shortened, corresponding to a decrease in capacity. To further clarify the process of voltage plateau evolution, ICA was applied to the charging–discharging curves in Fig. 1a, and the obtained results are shown in Fig. 1b. The IC curves are associated with the phase transitions of active materials during the Li⁺ shuttle, corresponding to the a and b peaks in the charging process and c peak in the discharging process. Along with cycling, the IC peaks in the charging process show an obvious shift toward a higher voltage, implying a polarization increase.²⁰ Usually, the shift of the higher voltage peak a may be related to a disproportionate loss of the active material at the positive and negative electrodes.²¹ In this work, we choose the shift of the b peak at a lower potential to quantify the increase in polarization, as shown in Fig. 1c. The progression of the capacity fade (expressed as SOH) is clearly related to the increase in polarization.

A close-to-equilibrium open-circuit voltage (cte-OCV) measurement was carried out to analyze the OCV behavior with battery aging, as shown in Fig. 1d. The discharging cte-OCV increases gradually, due to the increase in polarization. As expected, the charging cte-OCV did not increase, instead a slightly decreasing trend is observed. This will lead to a decreased charging OCV range as well as a decreased charging capacity.

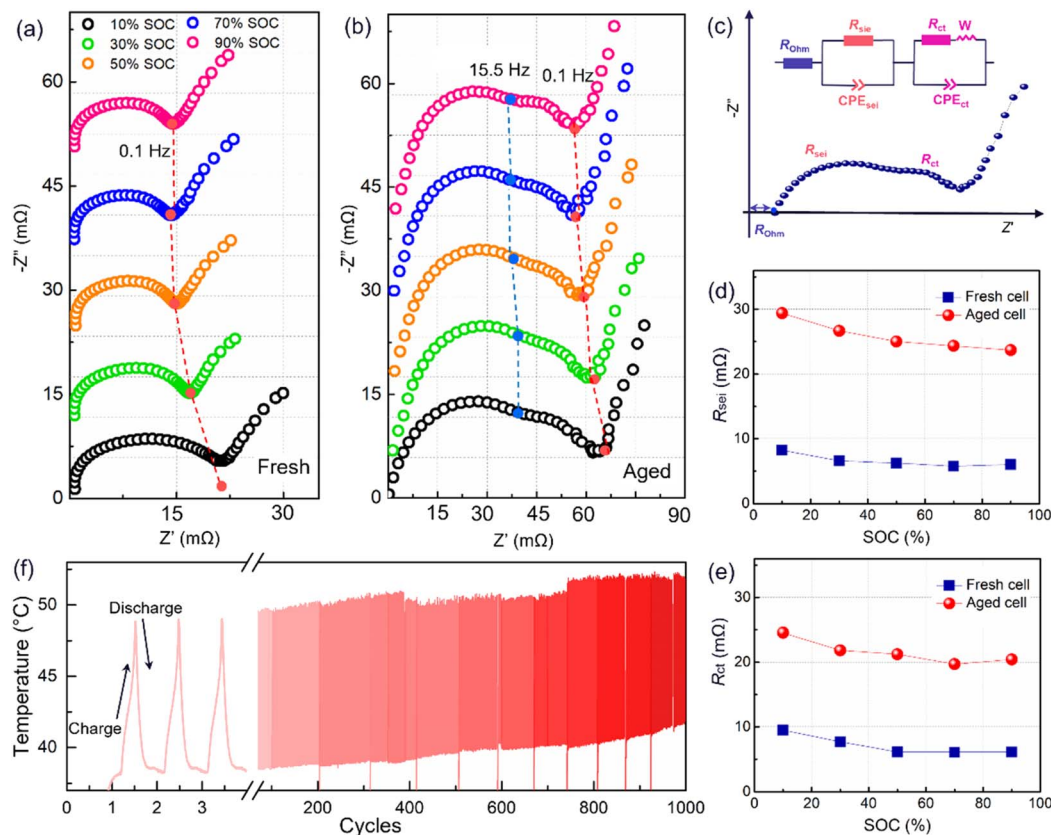
Fig. 2 EIS spectra at different SOC for (a) fresh cell and (b) an aged cell; (c) schematic illustration and an equivalent circuit used to fit the EIS Nyquist plots; the fitted results for (d) R_{sei} , and (e) R_{ct} . (f) the temperature tested using a temperature sensing probe on the outer surface of the cell.

The polarization was evaluated by performing an *operando* electrochemical impedance spectroscopy (EIS) test. As shown in Fig. 2a and b, the measured results are Nyquist plots, which are

composed of three parts with different frequency ranges, representing the bulk resistance (R_{ohm}), the solid electrolyte interface resistance (R_{sei}), and the charge transfer resistance (R_{ct}), respectively.³ The inserted equivalent circuit was employed to fit the Nyquist plots, as shown in Fig. 2c. The obtained results are presented in Fig. 2d and e. Here, the R_{ohm} will not be adopted due to an unstable ohmic impedance caused by the connector of the electrochemical workstation, and this always shows little change in battery aging.^{3,12} Therefore, the Nyquist plots were translated to the origin of the coordinates. After 1000 cycles, a four-fold increase in the R_{sei} from below 8 mΩ to about 30 mΩ is observed (Fig. 2c). Besides, R_{ct} has increased to over 20 mΩ (Fig. 2d), indicating an overall degradation at the electrode interface and charge transfer. Furthermore, R_{sei} and R_{ct} decrease with the battery charging. R_{sei} is related to the diffusion of Li ions at the interface and the R_{ct} is linked to the electrochemical reaction.²² As reported in ref.²² the SEI film is partially ruptured at high SOC due to the increased volume of lithiation graphite, and recovers in the followed discharge process. So, the R_{sei} decreased with battery charging. Furthermore, a high SOC is linked to a high voltage as well as an active state of the electrochemical reaction, resulting in a lower R_{ct} . The temperature of the battery surface was detected in the aging process, as shown in Fig. 2f. The temperature changes periodically with the charge–discharge cycle. Besides, the temperature

range fluctuates, due to an uncontrollable change in the sticking position or tightness of the thermal probe on the battery surface. With the increase in the cycle number, the temperature of the battery surface gradually increases (varying from a low temperature of 42 °C to a high temperature close to 55 °C). The temperature increment will lead to a series of side reactions inside the battery during electrochemical cycling, for example, the rupture and reformation of the interfacial film at high temperatures, resulting in a continuous increase of the internal impedance. This is consistent with the discharge cte-OCV trend, further illustrating that the internal impedance continues to increase with battery cycling.

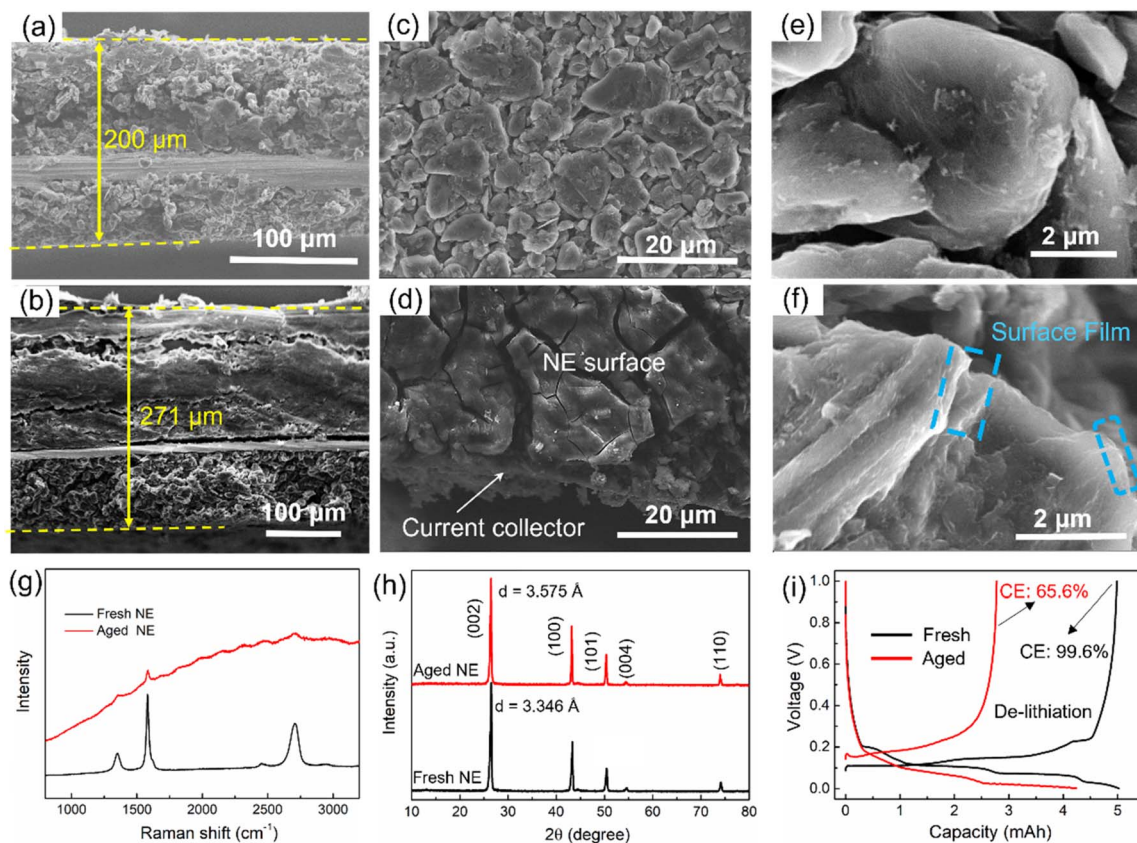
Fig. 5 Cross-section SEM images of (a) fresh negative electrode and (b) aged negative electrode; top surface SEM images of (c) fresh negative electrode and (d) aged negative electrode; SEM images of (e) fresh graphite particles and (f) aged graphite particles; (g) Raman spectra of the fresh and aged negative electrodes; (h) XRD patterns of aged and fresh negative electrodes; (i) charge and discharge voltage curves obtained by testing against Li in coin cells in a voltage range of 0.001–1.0 V at 0.05C.

Similarly, the negative electrode also becomes thicker after aging. The thickness of the fresh negative electrode is $200\text{ }\mu\text{m}$ (Fig. 5a), which increased to $271\text{ }\mu\text{m}$ (*i.e.*, 30.5% increase) after aging (Fig. 5b). There are a lot of cracks and exfoliated pieces in the aged negative electrode, which is a key reason for the thickening of the negative electrode. Besides, the materials are stripped from the current collector, leading to an increase in R_{ct} , as illustrated in Fig. 2e. From the top view, the surface film, which has a thick and cracked surface, can be observed on the top of the aged negative electrode (Fig. 5d), and a surface film also can be observed from the edges of the graphite particles in the SEM image (Fig. 5f), which is the main reason for surface
