Energy & Environmental Science

Cite this: Energy Environ. Sci., 2025, 18, 264

Removal of residual contaminants by minute-level washing facilitates the direct regeneration of spent cathodes from retired EV Li-ion batteries†

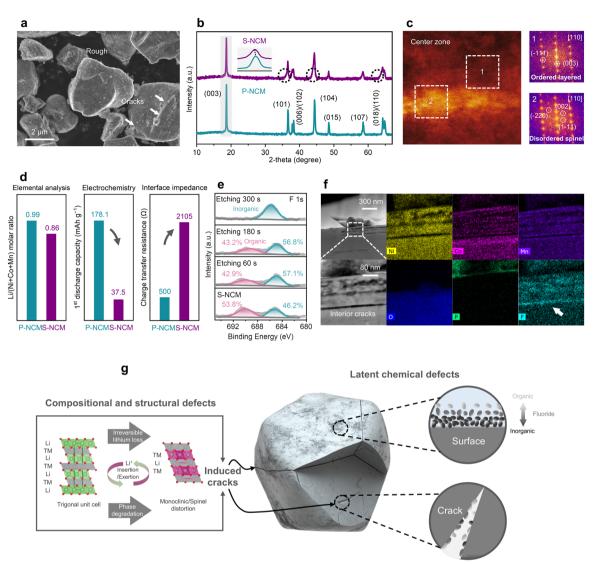
Fig. 1 Neglected chemical residuals on the 250k-miles-serviced cathode. (a) SEM image and (b) XRD pattern of the degraded S-NCM. The black dotted circle accentuates the subtle peaks that do not belong to the layered structure; (c) high-resolution HAADF-STEM images on the central area of the S-NCM particle and the FFT patterns of the selected dark and bright regions; (d) comprehensive comparison of lithium loss in degraded powders measured by ICP-OES, electrochemical capacity, and charge-transfer resistance analyses in the half-cell using S-NCM and P-NCM powders as cathode active materials; (e) F 1s XPS patterns of S-NCM powders for different sputtering times using an ion-beam. Based on the calculated integral area, the proportional values of the organics and inorganics in fluoride are presented in the patterns; (f) HAADF-STEM images based on focused ion beam cutting and an enlarged view displaying the interior microcracks. Corresponding EDS mapping analysis indicates the presence of F elements along these microcracks pointed out by a white arrow. (g) Deficiencies of S-NCM addressed before direct regeneration, including the compositional and structural aspects (e.g., irreversible lithium-ionic loss, phase degradation, internal and external cracks) and latent chemical defects (e.g., surface and crack-edge impurities enriching the F element).

To further reveal the microscopic distribution of those F-rich residuals, SEM combined with time-of-flight secondary ion mass spectrometry (SEM-ToF-SIMS) characterization was conducted for the cycled cathode. The results are shown in Fig. S10 and Videos S1, S2 (ESI⁺). Based on the spatial distribution of F⁻ secondary ion fragments, it was confirmed that fluoride impurities were primarily deposited on the particle surface. Moreover, during the long-time battery service, it could be observed from the HAADF-STEM image and corresponding element mapping (see Fig. 1f) that, in the S-NCM cathode, the fluorides could spread into the interior of the cathode along the intragranular cracks. Coincidentally, from the selected FFT figure shown in Fig. S4 (ESI⁺), the existence of an amorphous ring was observed along the intragranular cracking, which may be related to the fluorides also observed in the bulk. To sum up, the collected S-NCM exhibited limited structural and compositional degradation, while preserving the fluoride-containing impurities aggregated on the surface and along the intragranular cracks, as illustrated in Fig. 1g.

Furthermore, it was previously widely accepted that the source of F-rich impurities in the spent cathode was due to decomposition of the PVDF binder during the heat delamination process at around 350 °C;^{11,23-25,31} however, during the thermal decomposition of PVDF, most the fluoride-containing products were gas species (i.e., HF) and fragments (-CF- and -CH-CF-),³²⁻³⁴ which are subject to ejection instead of propagating along the cathode intragranular cracks. To confirm the source of those observed residual impurities, four kinds of cathodes with varying cycling conditions were collected and examined, namely cathode laminates with/without electrolyte filling, and laminates from 125k and 250k miles-serviced batteries, as listed in Table S7 (ESI[†]). The SEM images and electrochemical performance are shown in Fig. S11 and S12 (ESI⁺). Compared with the pristine one (sample A), the other spent cathodes from battery formation and cycling exhibited a rough surface and limited discharge capacity. Notably, the laminate from formation only but with no cycling (sample B), which it was believed would retain the full lithium inventory and show negligible structural degradation since it had not undergone charge/discharge cycling, showed a poor discharge capacity, which was the same as the other long-cycled ones. Moreover, the heat exfoliation used to pyrolyze the adhesive binders deteriorated the original CEI layer on the spent cathodes and generated more harmful byproducts (e.g., Li₂CO₃, Li₃PO₄, LiF). This, combined with electrolyte decomposition during electrochemical cycling, exacerbates chemical degradation, resulting in a significant capacity decline. Therefore, the above comparison revealed that the cathode residual impurities should originate from the electrolyte components (such as LiPF₆, DMC, ethylene carbonate (EC)) decomposition during battery formation, cycling, and common heat exfoliation, leading to severe capacity loss in spent cathodes (Fig. 1d).

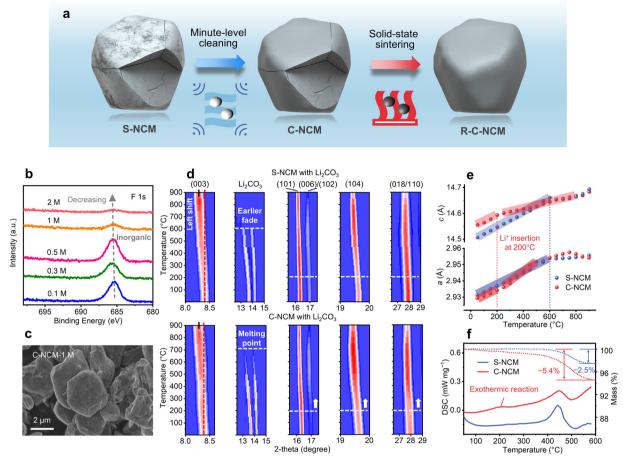
Fig. 2 Removal of the impurities and change in the crystal structure during the direct regeneration process combined with pretreatment. (a) Traditional direct regeneration path using solid-state sintering and the minute-level pretreatment introduced in an advanced path targeted to the critical obstacles within degraded cathode materials; (b) F 1s XPS fine patterns of C-NCM undergoing ultrasonic stirring in solutions with different concentrations; (c) SEM image of C-NCM obtained by soaking S-NCM in 1 M HNO₃ solution; (d) partial *in situ* XRD patterns of S-NCM and C-NCM mixed with a Li resource, keeping a constant heating rate (20 °C min⁻¹) and holding the temperature for diffraction at 50 °C intervals; (e) evolution of the unit cell parameters *a* and *c* for S-NCM (blue symbols) and C-NCM (red symbols) mixed with Li slate through Rietveld refinement. The earlier Li⁺ insertion at 200 °C changed the variation tendency of the unit parameters for the sample after cleaning. (f) Heat generation measured by DSC from mixtures.

C-NCM cathode was consumed gradually until it disappeared at its melting point around 730 °C, while the Li₂CO₃ in the S-NCM cathode completely vanished at around only 600 °C, and this earlier consumption of the lithium source may be attributed to the reaction between Li₂CO₃ and the residual impurities (such as LiF, LiOH, and Li_3PO_4) by co-melting, vaporizing, and replenishing in S-NCM.⁴² Equivalently, the high angle reflection peak intensity spanning from (006) to (110), representing the layered structure, significantly increased starting from around 200 °C for the C-NCM cathode after the purifying treatment compared to there being no obvious enhancement for S-NCM, indicting the better repair of the layered structure during heating. To further unveil the underlying mechanism, Rietveld refinement of each XRD pattern was conducted, which can depict the continuous change of the unit cell parameters during regeneration. Generally, the unit cell parameter cdecreases and a increases with the insertion of Li ions into a layered structure, similar to in the discharge process.²⁸ As shown in Fig. 2e, the lattice evolution of the S- and C-NCM

cathodes were compared. For C-NCM, the lattice c expansion slope became obviously flatter at 200 $^{\circ}$ C, denoting a lattice *c* shrinkage at this temperature induced by the Li-ion insertion and repairing. However, for the S-NCM without undergoing purifying treatment for the residuals, the lattice expanded still nearly linearly with no obvious lithium insertion until 600 °C. Concurrently, the lattice *a* expansion slope became steeper at 200 °C for C-NCM. Last but not least. Differential scanning calorimetry (DSC) characterization was also conducted during the regeneration process to confirm the lithium insertion pattern for the S- and C-NCM cathodes, which can trace the lithium replenishment associated with the exothermic reaction as reported by others.⁴³ As shown in Fig. 2f, the characteristic exothermic reaction at around 200 °C was only observed for C-NCM, confirmed the earlier lithium insertion after the purifying treatment. The earlier lithium insertion was also supported by the CO₂ gas release observed during Li₂CO₃ decomposition to supply the lithium source for the C-NCM cathode, as shown Fig. S23 (ESI[†]). Moreover, from the thermogravimetric results shown in Fig. 2f, the weight loss of C-NCM was 5.4%, which was significantly larger than that of S-NCM of 2.5%, indicating that more Li_2CO_3 was activated and decomposed to provide the lithium source for C-NCM.^{43,44} To sum up, through multiple *in situ* and *ex situ* characterizations, we proved that, with a purifying pretreatment, the direct regeneration could be facilitated to start at a lower temperature of 200 °C from the spent cathode.

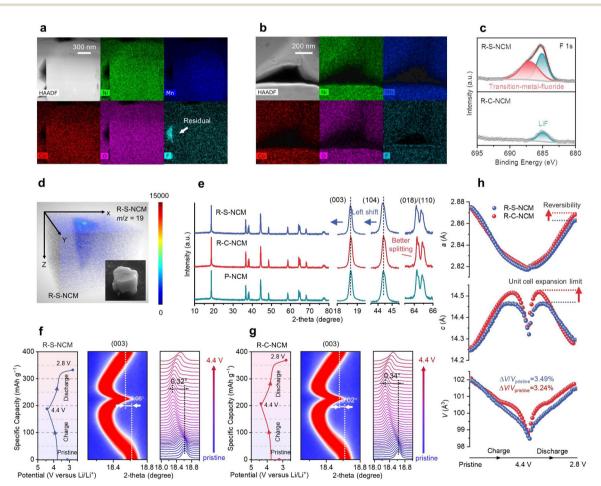
Fig. 3 Chemical and structural details of the regenerated cathode materials under the influence of impurities. (a) HAADF-STEM images and (b) corresponding EDS element mappings of R-S-NCM and R-C-NCM particles, focusing on the pores of the packing particles. (c) F 1s XPS high-resolution patterns of R-S-NCM and R-C-NCM powders. (d) Pseudo-three-dimensional distribution of F element and SEM image of the corresponding R-S-NCM particle. (e) Full patterns and characteristic peak comparison of the regenerated and pristine NCM cathodes with Cu K α radiation at a scan rate of 8° min⁻¹. (f) 1st charge–discharge curves, corresponding XRD patterns of R-S-NCM, and (g) (003) peak position variation when the cell charge from pristine to 4.4 V and comparison with R-C-NCM. (h) Lattice parameters *a*, *c*, and the unit cell volume *V* of R-S-NCM and R-C-NCM in the 1st charge–discharge test according to the refinement.

Furthermore, the crystal structure of the regenerated cathode could also be affected by the residual impurities. As shown in Fig. 3e and Fig. S28 (ESI⁺), the XRD pattern indicated a layered structure with no impurities phase for both the R-S-NCM and R-C-NCM cathodes. However, the R-C-NCM cathode had a higher (003)/(104) intensity ratio and larger splitting degree for the (018)/(110) peaks compared to R-S-NCM, suggesting its more ideal layered structure similar to P-NCM cathodes. After regeneration accompanied by impurities, the diffraction peaks of R-S-NCM were shifted toward a low-angle direction, indicating the lattice expansion, as supported by the refined parameters (Table S11, ESI[†]) and in situ experiments (Fig. 2d). Furthermore, in situ XRD was performed during the 1st charge/ discharge process for both regenerated cathodes (see Fig. 3f and g). The R-C-NCM cathode showed a higher capacity with a smaller offset (0.02°) of the (003) peak position than the

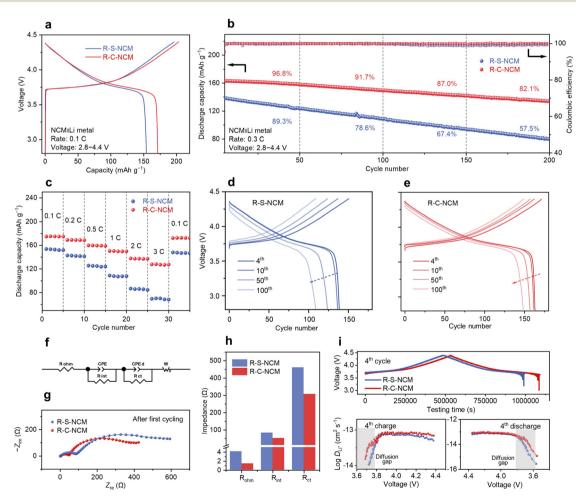
Fig. 4 Electrochemical deterioration for the regenerated NCM cathodes with impurity residue. (a) Initial galvanostatic charge–discharge curves of R-S-NCM and R-C-NCM at 0.1C (1C = 150 mA h g⁻¹) and (b) long cycling test and capacity retention in a half-cell. (c) Rate capabilities of R-S-NCM and R-C-NCM. Charge–discharge curves of (d) R-S-NCM, (e) R-C-NCM in the voltage range of 2.8-4.4 V (vs. Li/Li⁺) at different cycles. (f) Equivalent circuit applied in the EIS measurements. Nyquist plots of (g) R-S-NCM and R-C-NCM and (h) fitting results showing the Ohmic resistance (R_{ohm}), interface resistance (R_{int}), and charge–transfer resistance (R_{ct}). (i) GITT curves and the calculated Li⁺-diffusion rate of R-S-NCM and R-C-NCM for the 4th cycle number after activation in the same charge–discharge period. The shadow area indicates low Li⁺ diffusion in a certain voltage range.

As shown in Fig. 4a and Fig. S30 (ESI[†]), the initial discharge capacity increased from 154.1 mA h g⁻¹ for R-S-NCM to 171.4 mA h g⁻¹ for R-C-NCM after the purifying treatment, although this was slightly lower than for P-NCM. In Fig. 4b and Fig. S31 (ESI[†]), the R-C-NCM cathode exhibit 91.7% and 82.1% capacity retention after 100 cycles and 200 cycles, respectively, compared with 91.6% and 78.3% for P-NCM, and 78.6% and

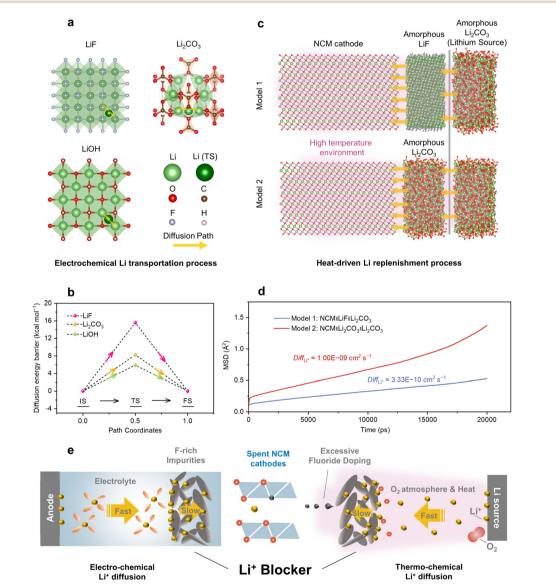
Fig. 5 Role of the F-rich impurities as a blocker in electrochemical and thermochemical Li⁺ diffusion as ascertained from thermodynamic and kinetic simulations. (a) Illustrations of the selected migration pathways with a similar distance for Li⁺ inside the crystal lattice of three common components. The initial state, transition state, and final state of Li⁺ transportation are denoted as IS, TS, and FS, respectively. (b) Calculated energy diffusion barrier for Li ions in selected phases. (c) Two models for stimulating the kinetics of Li transportation in direct regeneration. Model 1 consists of the NCM cathode substrate, the amorphous LiF layer, and Li₂CO₃ as a lithium source in direct regeneration, which is denoted as NCM $\|LiF\|Li_2CO_3$. In Model 2 (NCM $\|Li_2CO_3\|Li_2CO_3\|Li_2CO_3\|$ in short), the middle LiF layer is replaced by a common residual alkali (Li₂CO₃), which is used to simulate the regeneration of NCM cathodes after cleaning pretreatment. Each shape symbol is the same as for Fig. 5a. (d) MSD of the Li atoms in 20 ns and calculated Li⁺ diffusivity based on the above model. "E – 9" means 10⁻⁹. (e) Mechanism diagram for preventing the NCM cathodes from reusing and directly regenerating under the influence of impurities.

Fig. 5b. Therefore, this result confirmed that the presence of fluoride-rich impurity residuals on the cathode surface significantly increased the diffusion resistance of Li ions when cycling, ultimately exacerbating the cell impedance and interfacial parasitic reactions (Fig. 1d). To comprehend the largerscale kinetic characteristics and understand the effect of impurity coatings during heating for regeneration of the spent cathodes, two molecular dynamics models were established for simulating Li⁺ transportation at 1000 K over 20 ns. Specifically, Model 1 was devised to include an impurity barrier consisting of a LiF layer (Fig. 5c and Fig. S33, ESI[†]). Through computing the mean square displacement (MSD) of Li atoms and fitting curves (Fig. 5d), we determined that the Li diffusivity (Diff_{Li⁺}) of Model 1 was 3.33×10^{-10} , which was an order of magnitude lower than that of Model 2 (1.00×10^{-9}). The differences in molecular dynamics models under practical conditions suggest that fluoride-rich impurity coatings increase the resistance to Li-ion diffusion into spent cathodes with Li deficiencies during thermo-driven regeneration, leading to inadequate compositional and structural recovery.

As illustrated in Fig. 5e, the impurity phase containing the F element served as an electro- and thermo-diffusion blocker of Li ions hindering the reuse and direct regeneration of the spent cathode. In the spent cathodes collected by physical pretreatment and collection from used lithium-ion batteries, the ubiquitous electrolyte was decomposed to form an ion barrier with slow ion diffusivity. However, these impurities have long been overlooked in most studies (Table S2, ESI⁺), mainly due to the use of lab-scale degraded cathodes and fine manual separation pretreatment. In previous studies,^{12-16,42} the latent impact of the residual impurities on direct regeneration remains untouched because impurities are easily converted into other inconspicuous matter in extreme physical or chemical regeneration environments. Looking ahead, the direct regeneration of nextgeneration sensitive cathode materials, such as Li-rich Mnbased, Co-free, and ultra-high-Ni cathode materials, faces serious challenges from these latent impurities if they enter the recycling circle. From another perspective, establishing the controlling law for the inherent impurities doping within the closed-loop material flow could instructively enhance the performance of such recycled materials in the future. Moreover, only by revealing the effect of the overlooked impurities or by getting rid of impurities, can evolving technologies and mechanisms for direct regeneration and upcycling be reasonably evaluated.⁵⁰
