Ongoing legacy contamination from a military radar station in Iceland: a case study

Cite this: *Environ. Sci.: Adv.*, 2024, 3, 972

DOI: 10.1039/d4va00049h

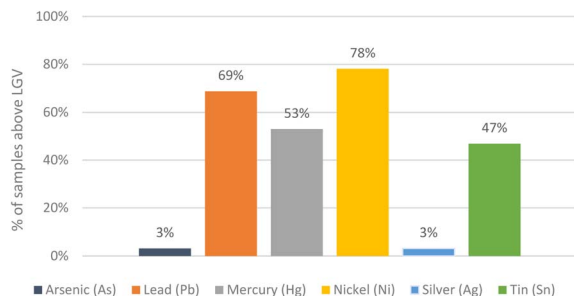
Fig. 8 Non-compliance with the lowest guideline value in samples of 6 primary trace elements, measured in 32 samples from the 10 areas chosen by the ESG for investigation at the H-2 area.¹⁰

aluminium, antimony, cobalt, copper, iron, manganese, vanadium, and zinc were frequently above the guideline values. None of the six primary inorganic elements were above the guideline values at the Eiði farm area. However, ten other inorganic elements (not shown here) exceeded the lowest guidelines at the Eiði farm area, especially vanadium and antimony which were 50 and 20-fold higher than the lowest guideline values. Others were aluminium, chromium, cobalt, copper, iron, manganese, sulphur, and zinc, ranging from 2 to 7-fold higher (Fig. 8).
