Removal of residual contaminants by minute-level washing facilitates the direct regeneration of spent cathodes from retired EV Li-ion batteries†

Yi Guo,^{‡a} Yang Li,^{‡bcd} Kai Qiu,^d Yan Li,^e Weijing Yuan,^b Chenxi Li,^b Xinyu Rui,^a Lewei Shi,^b Yukun Hou,^a Saiyue Liu,^a Dongsheng Ren,^{*a} Tiening Tan,^{*d} Gaolong Zhu,^d Languang Lu,^a Shengming Xu,^{id f} Biao Deng,^g Xiang Liu^{id *b} and Minggao Ouyang^{id *a}

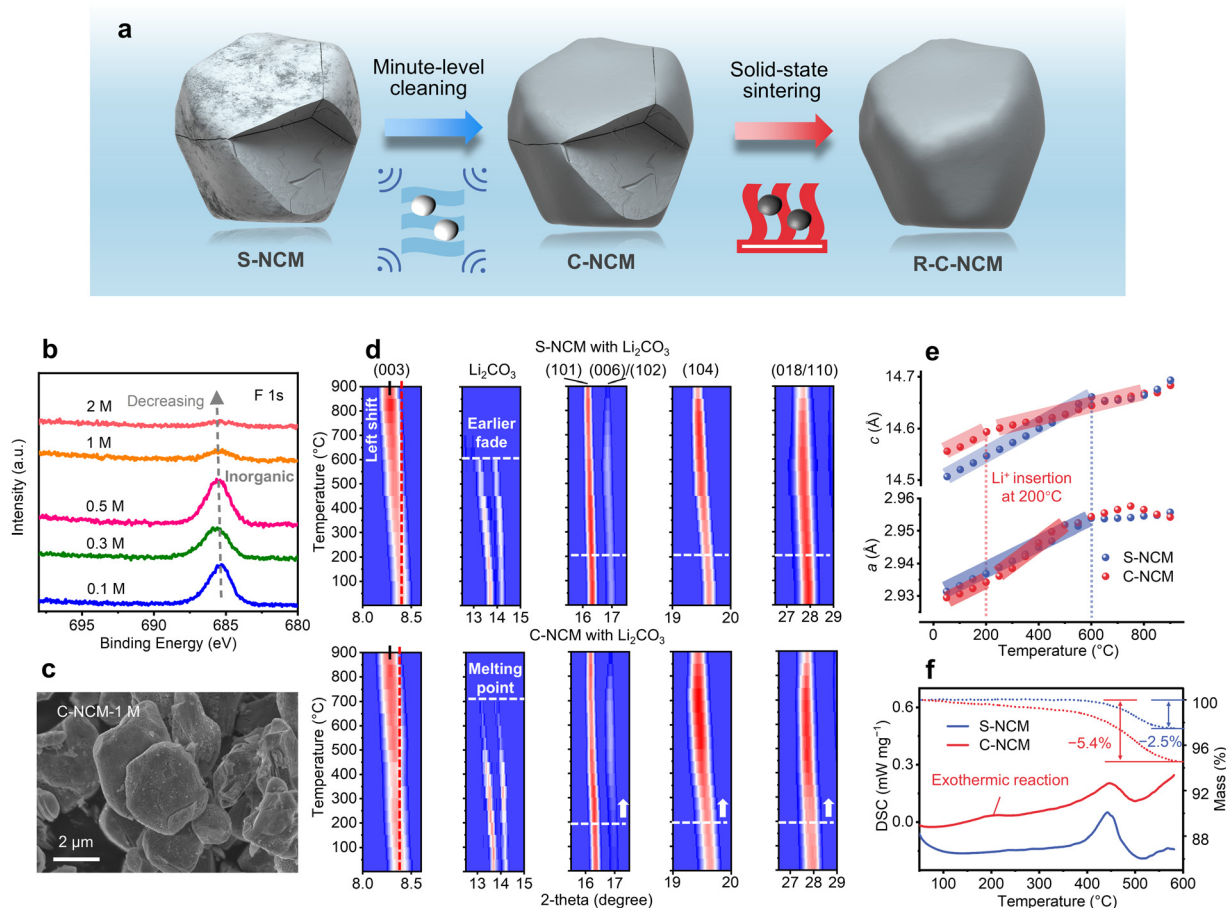
Fig. 2 Removal of the impurities and change in the crystal structure during the direct regeneration process combined with pretreatment. (a) Traditional direct regeneration path using solid-state sintering and the minute-level pretreatment introduced in an advanced path targeted to the critical obstacles within degraded cathode materials; (b) F 1s XPS fine patterns of C-NCM undergoing ultrasonic stirring in solutions with different concentrations; (c) SEM image of C-NCM obtained by soaking S-NCM in 1 M HNO₃ solution; (d) partial *in situ* XRD patterns of S-NCM and C-NCM mixed with a Li resource, keeping a constant heating rate (20 °C min⁻¹) and holding the temperature for diffraction at 50 °C intervals; (e) evolution of the unit cell parameters *a* and *c* for S-NCM (blue symbols) and C-NCM (red symbols) mixed with Li slate through Rietveld refinement. The earlier Li⁺ insertion at 200 °C changed the variation tendency of the unit parameters for the sample after cleaning. (f) Heat generation measured by DSC from mixtures.

morphology of the cathode remained unchanged, which may be related to the Li⁺/H⁺ exchange mechanism with the stabilizing lattice structure.^{40,41} Moreover, as shown in Fig. 2b and Fig. S22 (ESI[†]), based on the charge/discharge efficiency, we further optimized the solution concentration as 1 M in the following investigations.

To reveal the effect of the residuals during the direct regeneration of the recycled cathode, *in situ* XRD characterizations were compared following the regeneration of S-NCM and C-NCM. During the heating, the unit cell lattice first nearly linearly expanded until there was a differentiation of the expansion ratio caused by the lithium insertion. As shown in Fig. 2d, the shift of the (003) peak of C-NCM was less pronounced than that of S-NCM when heating to 900 °C, indicating its unit cell lattice *c* was not expanded as much as for the S-NCM due to its more efficient lithium insertion. Therefore, more lithium insertion was observed for the C-NCM cathode. Correspondingly, the Li₂CO₃ in the mixture of S-NCM and C-NCM also performed differently, whereby the Li₂CO₃ in the

C-NCM cathode was consumed gradually until it disappeared at its melting point around 730 °C, while the Li₂CO₃ in the S-NCM cathode completely vanished at around only 600 °C, and this earlier consumption of the lithium source may be attributed to the reaction between Li₂CO₃ and the residual impurities (such as LiF, LiOH, and Li₃PO₄) by co-melting, vaporizing, and replenishing in S-NCM.⁴² Equivalently, the high angle reflection peak intensity spanning from (006) to (110), representing the layered structure, significantly increased starting from around 200 °C for the C-NCM cathode after the purifying treatment compared to there being no obvious enhancement for S-NCM, indicating the better repair of the layered structure during heating. To further unveil the underlying mechanism, Rietveld refinement of each XRD pattern was conducted, which can depict the continuous change of the unit cell parameters during regeneration. Generally, the unit cell parameter *c* decreases and *a* increases with the insertion of Li ions into a layered structure, similar to in the discharge process.²⁸ As shown in Fig. 2e, the lattice evolution of the S- and C-NCM

cathodes were compared. For C-NCM, the lattice c expansion slope became obviously flatter at 200 °C, denoting a lattice c shrinkage at this temperature induced by the Li-ion insertion and repairing. However, for the S-NCM without undergoing purifying treatment for the residuals, the lattice expanded still nearly linearly with no obvious lithium insertion until 600 °C. Concurrently, the lattice a expansion slope became steeper at 200 °C for C-NCM. Last but not least, Differential scanning calorimetry (DSC) characterization was also conducted during the regeneration process to confirm the lithium insertion pattern for the S- and C-NCM cathodes, which can trace the lithium replenishment associated with the exothermic reaction as reported by others.⁴³ As shown in Fig. 2f, the characteristic exothermic reaction at around 200 °C was only observed for C-NCM, confirmed the earlier lithium insertion after the purifying treatment. The earlier lithium insertion was also supported by the CO₂ gas release observed during Li₂CO₃ decomposition to supply the lithium source for the C-NCM cathode, as shown Fig. S23 (ESI[†]). Moreover, from the thermogravimetric results

shown in Fig. 2f, the weight loss of C-NCM was 5.4%, which was significantly larger than that of S-NCM of 2.5%, indicating that more Li₂CO₃ was activated and decomposed to provide the lithium source for C-NCM.^{43,44} To sum up, through multiple *in situ* and *ex situ* characterizations, we proved that, with a purifying pretreatment, the direct regeneration could be facilitated to start at a lower temperature of 200 °C from the spent cathode.

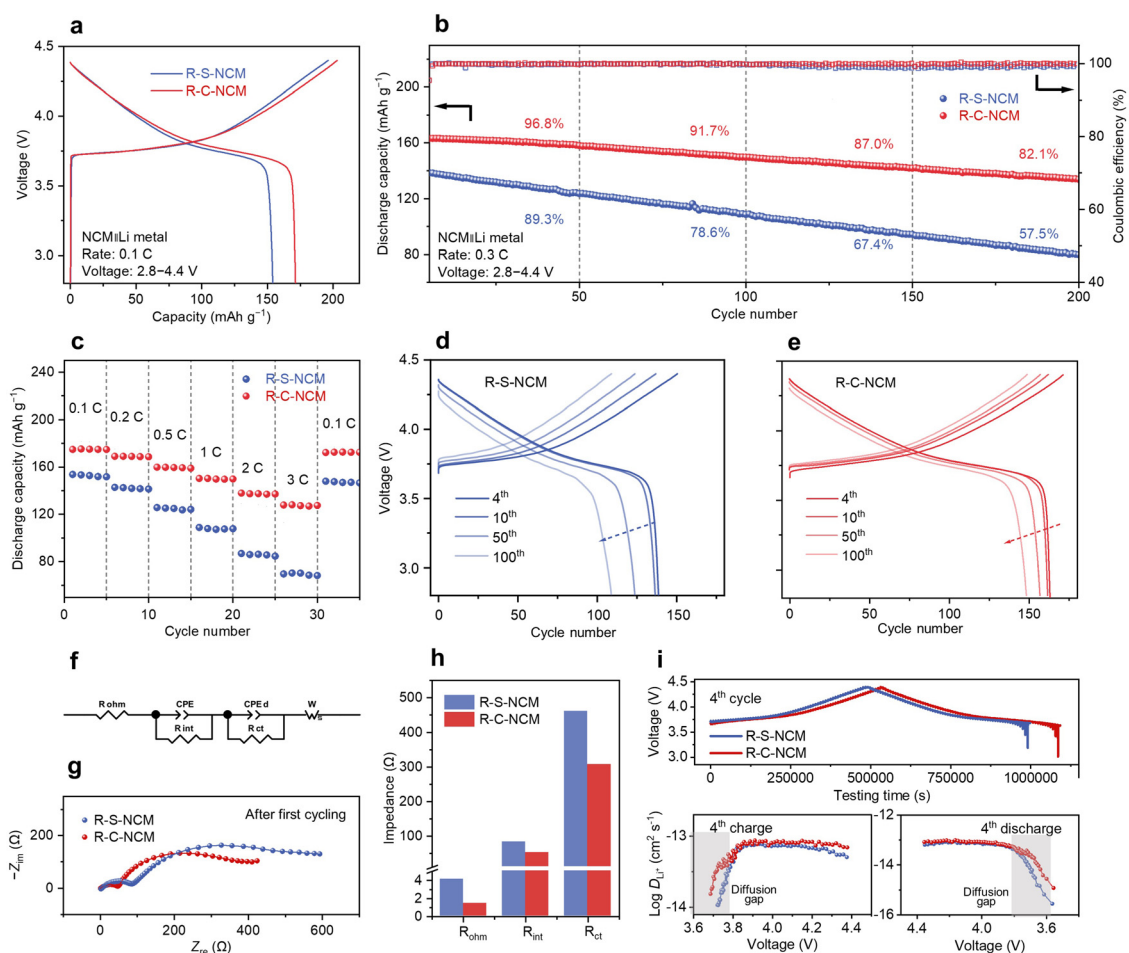
Fig. 4 Electrochemical deterioration for the regenerated NCM cathodes with impurity residue. (a) Initial galvanostatic charge–discharge curves of R-S-NCM and R-C-NCM at 0.1C (1C = 150 mA h g⁻¹) and (b) long cycling test and capacity retention in a half-cell. (c) Rate capabilities of R-S-NCM and R-C-NCM. Charge–discharge curves of (d) R-S-NCM, (e) R-C-NCM in the voltage range of 2.8–4.4 V (vs. Li/Li⁺) at different cycles. (f) Equivalent circuit applied in the EIS measurements. Nyquist plots of (g) R-S-NCM and R-C-NCM and (h) fitting results showing the Ohmic resistance (R_{ohm}), interface resistance (R_{int}), and charge-transfer resistance (R_{ct}). (i) GITT curves and the calculated Li⁺-diffusion rate of R-S-NCM and R-C-NCM for the 4th cycle number after activation in the same charge–discharge period. The shadow area indicates low Li⁺ diffusion in a certain voltage range.

As shown in Fig. 4a and Fig. S30 (ESI[†]), the initial discharge capacity increased from $154.1 \text{ mA h g}^{-1}$ for R-S-NCM to $171.4 \text{ mA h g}^{-1}$ for R-C-NCM after the purifying treatment, although this was slightly lower than for P-NCM. In Fig. 4b and Fig. S31 (ESI[†]), the R-C-NCM cathode exhibit 91.7% and 82.1% capacity retention after 100 cycles and 200 cycles, respectively, compared with 91.6% and 78.3% for P-NCM, and 78.6% and

According to the above results (Fig. 1d, Fig. S6, S16 (ESI†), and Fig. 4h, i), the migration rate of lithium ions was significantly influenced by the residual impurities; therefore it was crucial to theoretically investigate their influence on capacity delivery in the reuse case and during direct regeneration. Considering the impurities were mostly concentrated at the surface before and after regeneration, and that F-rich residuals could be observed, as shown in Fig. S9 and S10 (ESI†) and Fig. 3c, we chose three representative inorganic components (LiF , Li_2CO_3 , and LiOH) in the CEI layer⁴⁸ or residual alkali⁴⁹ to calculate the Li^+ diffusion from a thermodynamic perspective, and their structures are shown in Fig. 5a. By maintaining a similar distance and concentration of mobile Li-ions, the diffusion energy barrier of lithium ions (ΔE_{Li^+}) during the cycling of spent cathodes within the different crystal structures (Fig. 5b) allowed valid comparisons. We found that the ΔE_{Li^+} of the LiF phase, as a common inorganic component from CEI, was about 2 and 3 times higher than that of the LiOH and Li_2CO_3 phases from
