CRITICAL REVIEW

Ongoing legacy contamination from a military radar station in Iceland: a case study

María J. Gunnarsdottir

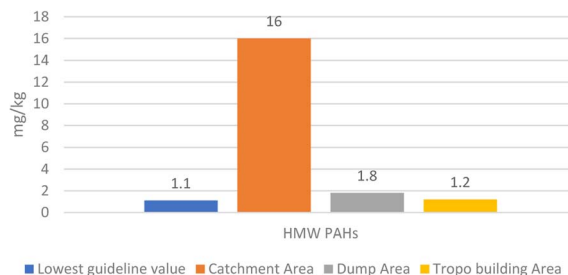
Fig. 7 HMW PAHs (mg kg⁻¹) tested in five areas with the content exceeding the lowest guideline value (1.1 mg kg⁻¹) in three areas. The highest values detected in the three areas are shown.

PAHs are released during incomplete combustion of petroleum products or from petroleum spill. They are persistent in the environment and several have multiple adverse health effects.²⁷ PAHs were summarized in two categories, low molecular weight PAHs (LMW PAHs) and high molecular weight PAHs (HMW PAHs), with the latter being more toxic and carcinogenic.⁵¹ Fifteen PAHs were tested (5 LMW and 10 HMW) in nine samples from five areas (Dump, Tropo, Sewage outfall, Powerhouse and Catchment), see Table 1, and found to exceed the lowest guideline value at three areas: Catchment, Dump and Tropo areas. The highest values in both categories (LMW and HMW) were found at the Catchment area (Table 2). See Fig. 7 for results for HMW PAHs.
