Energy & Environmental Science

washing facilitates the direct regeneration of spent cathodes from retired EV Li-ion batteries†

Removal of residual contaminants by minute-level

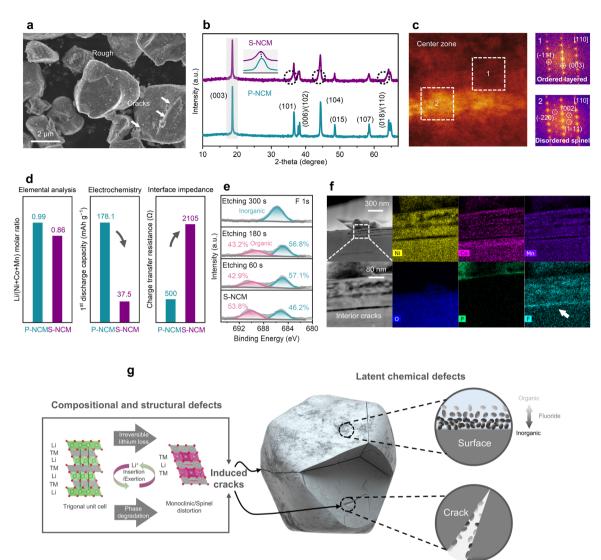
Fig. 1 Neglected chemical residuals on the 250k-miles-serviced cathode. (a) SEM image and (b) XRD pattern of the degraded S-NCM. The black dotted circle accentuates the subtle peaks that do not belong to the layered structure; (c) high-resolution HAADF-STEM images on the central area of the S-NCM particle and the FFT patterns of the selected dark and bright regions; (d) comprehensive comparison of lithium loss in degraded powders measured by ICP-OES, electrochemical capacity, and charge-transfer resistance analyses in the half-cell using S-NCM and P-NCM powders as cathode active materials; (e) F 1s XPS patterns of S-NCM powders for different sputtering times using an ion-beam. Based on the calculated integral area, the proportional values of the organics and inorganics in fluoride are presented in the patterns; (f) HAADF-STEM images based on focused ion beam cutting and an enlarged view displaying the interior microcracks. Corresponding EDS mapping analysis indicates the presence of F elements along these microcracks pointed out by a white arrow. (g) Deficiencies of S-NCM addressed before direct regeneration, including the compositional and structural aspects (e.g., irreversible lithium-ionic loss, phase degradation, internal and external cracks) and latent chemical defects (e.g., surface and crack-edge impurities enriching the F element).

As shown in the Materials and methods and Fig. S1 (ESI†), a series of pretreatments, such as sorting, dismantling, crushing, and shredding, were employed to collect the spent NCM cathode (denoted as S-NCM) with minor metal and polyvinylidene fluoride (PVDF) binder (Table S3 and Fig. S2, ESI†). First, a comprehensive comparison between S-NCM and pristine NCM cathodes (P-NCM) was conducted to identify the failure mechanism of the S-NCM materials. As shown in scanning electron microscope (SEM) images (Fig. 1a and Fig. S3, ESI†), the end-oflife battery S-NCM cathode showed intensive rough surface residuals with minor cracks after 250 000-mile service, with the planar gliding degradation and cracks in the single-crystal cathode consistent with previous reports. 26,27 The X-ray diffraction (XRD) analysis, shown in Fig. 1b, demonstrated that the S-NCM still preserved an ordered layered $R\bar{3}m$ structure with a minor degraded phase near the (101), (104), and (018) peaks, possibly corresponding to the subtle monoclinic phase transition due to lithium loss. 28 According to the high angle annular dark field scanning transmission electron microscopy (HAADF-STEM) analysis and fast Fourier transform (FFT) pattern (Fig. 1c and Fig. S4, ESI†), the degraded S-NCM cathode showed a spinel phase in zone 2 and exhibited significant spatial heterogeneity. Besides the structural degradation, the inductively coupled plasma optical emission spectrometry (ICP-OES) result (Fig. 1d and Table S4, ESI†) indicated that, even after the longterm cycling, the end-of-life S-NCM cathode showed only 13.1% loss of Li inventory compared to the pristine P-NCM. Contradictorily, the specific capacity of S-NCM significantly declined to 37.5 mA h g^{-1} compared to 178.1 mA h g^{-1} for the P-NCM, as shown in Fig. 1d. Especially in the follow-up cycle, see Fig. S5 (ESI†), the S-NCM cathode exhibited a capacity of less than 10 mA h g^{-1} after 100 cycles. Note that, there was only 13.1% Li deficiencies, which could not sufficiently account for the 78.9% capacity fading of S-NCM. Therefore, to further reveal the origin of the poor electrochemical performance, electrochemical impedance spectroscopy (EIS) characterization was conducted, as shown in Fig. 1d and Fig. S6 (ESI†), the charge-transfer resistance ($R_{\rm ct}$) for S-NCM steeply climbed to 2105 Ω and was

four times larger than the P-NCM of 500 Ω . The increased impedance deteriorates the Li⁺ diffusion, thus leading to the critical capacity decay. Therefore, the surface state of the spent cathode was recognized as the key issue limiting its capacity delivery, compared to compositional lithium loss and structural bulk defects.

To understand the surface state of the spent cathode, energy-dispersive spectroscopy (EDS) element mapping and X-ray photoelectron spectroscopy (XPS) were conducted. As shown in Fig. S7-S9, and Tables S5, S6 (ESI†), the S-NCM cathode surface residuals consisted of C, O, F, and P elements, and displayed a surface-rich gradient distribution, as revealed

by XPS with etching. The F 1s XPS peaks with etching for S-NCM are shown in Fig. 1e, where two F 1s peaks could be observed before sputtering, with the major peak centered at 685.5 eV, which was attributed to inorganic fluorides and the minor F 1s peak centered at 690.4 eV, which could be assigned to organic fluorides, with the ratio of 53.8% for organic flourides.²⁹ However, the organic-related F peak declined significantly after sputtering, and completely disappeared after 300 s Ar+ sputtering. The surface-rich distribution of organic fluoride was consistent with the cathode electrolyte interphase (CEI) composition previously reported.^{29,30}

To further reveal the microscopic distribution of those F-rich residuals, SEM combined with time-of-flight secondary ion mass spectrometry (SEM-ToF-SIMS) characterization was conducted for the cycled cathode. The results are shown in Fig. S10 and Videos S1, S2 (ESI†). Based on the spatial distribution of F secondary ion fragments, it was confirmed that fluoride impurities were primarily deposited on the particle surface. Moreover, during the long-time battery service, it could be observed from the HAADF-STEM image and corresponding element mapping (see Fig. 1f) that, in the S-NCM cathode, the fluorides could spread into the interior of the cathode along the intragranular cracks. Coincidentally, from the selected FFT figure shown in Fig. S4 (ESI†), the existence of an amorphous ring was observed along the intragranular cracking, which may be related to the fluorides also observed in the bulk. To sum up, the collected S-NCM exhibited limited structural and compositional degradation, while preserving the fluoride-containing impurities aggregated on the surface and along the intragranular cracks, as illustrated in Fig. 1g.

Furthermore, it was previously widely accepted that the source of F-rich impurities in the spent cathode was due to decomposition of the PVDF binder during the heat delamination process at around 350 °C; 11,23-25,31 however, during the thermal decomposition of PVDF, most the fluoride-containing products were gas species (i.e., HF) and fragments (-CF- and -CH-CF-), 32-34 which are subject to ejection instead of propagating along the cathode intragranular cracks. To confirm the source of those observed residual impurities, four kinds of cathodes with varying cycling conditions were collected and examined, namely cathode laminates with/without electrolyte filling, and laminates from 125k and 250k miles-serviced batteries, as listed in Table S7 (ESI†). The SEM images and electrochemical performance are shown in Fig. S11 and S12 (ESI†). Compared with the pristine one (sample A), the other spent cathodes from battery formation and cycling exhibited a rough surface and limited discharge capacity. Notably, the laminate from formation only but with no cycling (sample B), which it was believed would retain the full lithium inventory and show negligible structural degradation since it had not undergone charge/discharge cycling, showed a poor discharge capacity, which was the same as the other long-cycled ones. Moreover, the heat exfoliation used to pyrolyze the adhesive binders deteriorated the original CEI layer on the spent cathodes and generated more harmful byproducts (e.g., Li₂CO₃, Li₃PO₄, LiF). This, combined with electrolyte decomposition during electrochemical cycling, exacerbates chemical degradation, resulting in a significant capacity decline. Therefore, the above comparison revealed that the cathode residual impurities should originate from the electrolyte components (such as LiPF₆, DMC, ethylene carbonate (EC)) decomposition during battery formation, cycling, and common heat exfoliation, leading to severe capacity loss in spent cathodes (Fig. 1d).

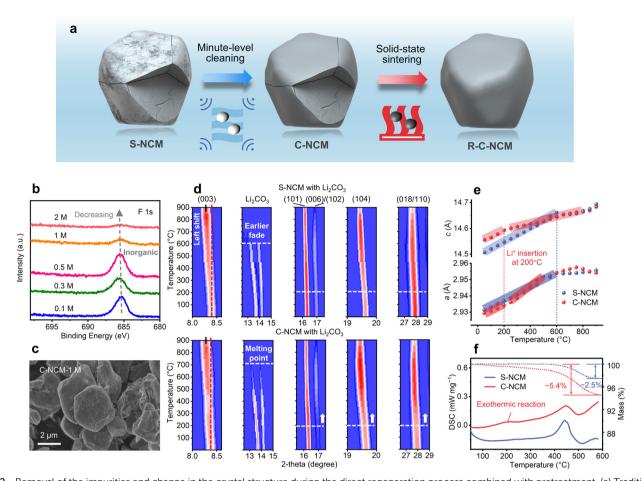
Fig. 2 Removal of the impurities and change in the crystal structure during the direct regeneration process combined with pretreatment. (a) Traditional direct regeneration path using solid-state sintering and the minute-level pretreatment introduced in an advanced path targeted to the critical obstacles within degraded cathode materials; (b) F 1s XPS fine patterns of C-NCM undergoing ultrasonic stirring in solutions with different concentrations; (c) SEM image of C-NCM obtained by soaking S-NCM in 1 M HNO₃ solution; (d) partial in situ XRD patterns of S-NCM and C-NCM mixed with a Li resource, keeping a constant heating rate (20 °C min⁻¹) and holding the temperature for diffraction at 50 °C intervals; (e) evolution of the unit cell parameters a and c for S-NCM (blue symbols) and C-NCM (red symbols) mixed with Li slate through Rietveld refinement. The earlier Li⁺ insertion at 200 °C changed the variation tendency of the unit parameters for the sample after cleaning. (f) Heat generation measured by DSC from mixtures.

electrolyte residuals covered the surface and penetrated along the microcracks and could not be separated by a physical method. Moreover, the inorganic residual component could not be burned out due to its high decomposition temperature, such as LiF. Therefore, the impact and role of the residual impurity elements in the following regeneration process were investigated. As illustrated in Fig. 2a, inspired by the high solubility of F-rich compounds in acid solution, 35,36 a homogeneous minute-level acid solution pretreatment was developed prior to the high-temperature regeneration sintering. Moreover, the purifying acid solution can disperse on the cathode surface and along the microcracks, and therefore can effectively erase the residuals. XPS characterization was conducted to confirm the effect of the pretreatment, as shown in Fig. 2b, where the F 1s peak was found to decrease significantly with the acid concentration above 1 M, indicating the effectiveness of this pretreatment. Moreover, compositional analyses (Fig. S8, S13 and Tables S4-S6 and S8, ESI†) indicated that the ratio of the transition metal elements of S-NCM after cleaning in 1 M HNO₃ solution (C-NCM) remained unchanged and the P and F elemental contents of C-NCM decreased to levels close to that of P-NCM. In the Fourier Transform infrared (FTIR) spectrum (Fig. S14, ESI†), the C-NCM showed no characteristic peak for the covalent C-F bond at 1060 cm⁻¹ compared to P-NCM and S-NCM, and nor did it display peaks attributed to the residual alkali Li₂CO₃ at \sim 1423 and \sim 877 cm⁻¹.^{37,38} The SEM-ToF-SIMS spatial distribution of the F element (Fig. S15 and Videos S3, S4, ESI†) for the C-NCM cathode confirmed no obvious F element could be observed after the cleaning pretreatment. In addition, based on the EIS measurements of C-NCM and S-NCM (Fig. S16, ESI†), the contact resistance of C-NCM was decreased by three times that of the S-NCM. This further implied that the residual cathode impurities may act as a barrier that impede Li-ion transition. Furthermore, the morphological and structural characteristics of the recycled cathode were also investigated after the purifying treatment, as shown in Fig. 2c and Fig. S17 (ESI†). It was noted that the C-NCM cathode still maintained its morphology and integrity of the layered structure with limited monoclinic phase transition,28 as evidenced by the XRD patterns (Fig. S17 and S18, ESI†). Based on element analysis of the washing acid filtrate (Table S9, ESI†) and two-dimensional full-field transmission X-ray microscopy with X-ray absorption near-edge structure spectroscopy (2D TXM-XANES) (Fig. S19, ESI†) analyses for the cleaned cathodes particles, it was found that the acid washing treatment could, to a limited degree, dissolve the degraded surface and expose the bulk phase of the spent cathodes with a layered characteristic. 39 Although, it was previously accepted that the Ni-rich cathode is sensitive to humid and acid environments, we confirmed that the acid pretreatment developed here did not cause bulk damage to the cathode. As shown in Fig. S20, S21 and Table S10 (ESI†), we conducted additional cleaning experiments using a fresh Ni83 single-crystal cathode, which is known for its high sensitivity to the environment. Despite an increase in leaching concentrations up to 3 M, the chemical composition and micro-

morphology of the cathode remained unchanged, which may be related to the Li⁺/H⁺ exchange mechanism with the stabilizing lattice structure. 40,41 Moreover, as shown in Fig. 2b and Fig. S22 (ESI†), based on the charge/discharge efficiency, we further optimized the solution concentration as 1 M in the following investigations.

To reveal the effect of the residuals during the direct regeneration of the recycled cathode, in situ XRD characterizations were compared following the regeneration of S-NCM and C-NCM. During the heating, the unit cell lattice first nearly linearly expanded until there was a differentiation of the expansion ratio caused by the lithium insertion. As shown in Fig. 2d, the shift of the (003) peak of C-NCM was less pronounced than that of S-NCM when heating to 900 °C, indicating its unit cell lattice c was not expanded as much as for the S-NCM due to its more efficient lithium insertion. Therefore, more lithium insertion was observed for the C-NCM cathode. Correspondingly, the Li₂CO₃ in the mixture of S-NCM and C-NCM also performed differently, whereby the Li₂CO₃ in the

C-NCM cathode was consumed gradually until it disappeared at its melting point around 730 °C, while the Li₂CO₃ in the S-NCM cathode completely vanished at around only 600 °C, and this earlier consumption of the lithium source may be attributed to the reaction between Li₂CO₃ and the residual impurities (such as LiF, LiOH, and Li₃PO₄) by co-melting, vaporizing, and replenishing in S-NCM.42 Equivalently, the high angle reflection peak intensity spanning from (006) to (110), representing the layered structure, significantly increased starting from around 200 °C for the C-NCM cathode after the purifying treatment compared to there being no obvious enhancement for S-NCM, indicting the better repair of the layered structure during heating. To further unveil the underlying mechanism, Rietveld refinement of each XRD pattern was conducted, which can depict the continuous change of the unit cell parameters during regeneration. Generally, the unit cell parameter c decreases and a increases with the insertion of Li ions into a layered structure, similar to in the discharge process.²⁸ As shown in Fig. 2e, the lattice evolution of the S- and C-NCM

cathodes were compared. For C-NCM, the lattice c expansion slope became obviously flatter at 200 $^{\circ}$ C, denoting a lattice cshrinkage at this temperature induced by the Li-ion insertion and repairing. However, for the S-NCM without undergoing purifying treatment for the residuals, the lattice expanded still nearly linearly with no obvious lithium insertion until 600 °C. Concurrently, the lattice a expansion slope became steeper at 200 °C for C-NCM. Last but not least, Differential scanning calorimetry (DSC) characterization was also conducted during the regeneration process to confirm the lithium insertion pattern for the S- and C-NCM cathodes, which can trace the lithium replenishment associated with the exothermic reaction as reported by others. 43 As shown in Fig. 2f, the characteristic exothermic reaction at around 200 °C was only observed for C-NCM, confirmed the earlier lithium insertion after the purifying treatment. The earlier lithium insertion was also supported by the CO₂ gas release observed during Li₂CO₃ decomposition to supply the lithium source for the C-NCM cathode, as shown Fig. S23 (ESI†). Moreover, from the thermogravimetric results shown in Fig. 2f, the weight loss of C-NCM was 5.4%, which was significantly larger than that of S-NCM of 2.5%, indicating that more Li₂CO₃ was activated and decomposed to provide the lithium source for C-NCM. 43,44 To sum up, through multiple in situ and ex situ characterizations, we proved that, with a purifying pretreatment, the direct regeneration could be facilitated to start at a lower temperature of 200 °C from the spent cathode.

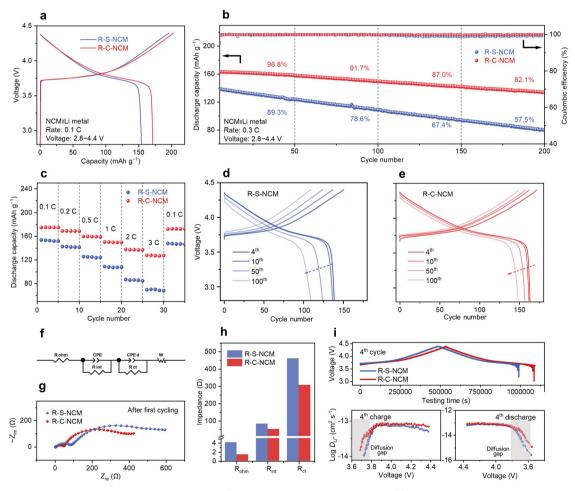
Fig. 4 Electrochemical deterioration for the regenerated NCM cathodes with impurity residue. (a) Initial galvanostatic charge-discharge curves of R-S-NCM and R-C-NCM at 0.1C (1C = 150 mA h g^{-1}) and (b) long cycling test and capacity retention in a half-cell. (c) Rate capabilities of R-S-NCM and R-C-NCM. Charge-discharge curves of (d) R-S-NCM, (e) R-C-NCM in the voltage range of 2.8-4.4 V (vs. Li/Li⁺) at different cycles. (f) Equivalent circuit applied in the EIS measurements. Nyquist plots of (g) R-S-NCM and R-C-NCM and (h) fitting results showing the Ohmic resistance (Rohm), interface resistance (R_{int}), and charge-transfer resistance (R_{Ct}). (i) GITT curves and the calculated Li⁺-diffusion rate of R-S-NCM and R-C-NCM for the 4th cycle number after activation in the same charge-discharge period. The shadow area indicates low Li⁺ diffusion in a certain voltage range.

As shown in Fig. 4a and Fig. S30 (ESI†), the initial discharge capacity increased from 154.1 mA h g⁻¹ for R-S-NCM to 171.4 mA h g^{-1} for R-C-NCM after the purifying treatment, although this was slightly lower than for P-NCM. In Fig. 4b and Fig. S31 (ESI†), the R-C-NCM cathode exhibit 91.7% and 82.1% capacity retention after 100 cycles and 200 cycles, respectively, compared with 91.6% and 78.3% for P-NCM, and 78.6% and

According to the above results (Fig. 1d, Fig. S6, S16 (ESI†), and Fig. 4h, i), the migration rate of lithium ions was significantly influenced by the residual impurities; therefore it was crucial to theoretically investigate their influence on capacity delivery in the reuse case and during direct regeneration. Considering the impurities were mostly concentrated at the surface before and after regeneration, and that F-rich residuals could be observed, as shown in Fig. S9 and S10 (ESI†) and Fig. 3c, we chose three representative inorganic components (LiF, Li2CO3, and LiOH) in the CEI layer⁴⁸ or residual alkali⁴⁹ to calculate the Li⁺ diffusion from a thermodynamic perspective, and their structures are shown in Fig. 5a. By maintaining a similar distance and concentration of mobile Li-ions, the diffusion energy barrier of lithium ions (ΔE_{Li^+}) during the cycling of spent cathodes within the different crystal structures (Fig. 5b) allowed valid comparisons. We found that the ΔE_{Li^+} of the LiF phase, as a common inorganic component from CEI, was about 2 and 3 times higher than that of the LiOH and Li₂CO₃ phases from
