# Nanoscale Advances

Zhenyu Zhang, Dongdong Liu, Xingqiao Deng *et al.*  
The damage mechanism in copper studied using *in situ* TEM  
nanoindentation

Copper (Cu) has a soft-plastic nature, which makes it susceptible to damages from scratching or abrasive machining, such as lapping and polishing. It is a challenge to control these damages as the damage mechanism is elusive. Nonetheless, controlling damages is essential, especially on the atomic surfaces of Cu. To interpret the damage mechanism, *in situ* transmission electron microscopy (TEM) nanoindentation was performed using a cube-corner indenter with a radius of 57 nm at a loading speed of 5 nm s<sup>-1</sup>. Experimental results showed that damages originate from dislocations, evolve to stack faults, and then form broken crystallites. When the indentation depth was 45 nm at a load of 20 μN, damages comprised dislocations and stacking faults. After increasing the depth to 67 nm and load to 30 μN, the formation of broken crystallites initiated; and the critical depth was 67 nm. To validate the damage mechanism, fixed-abrasive lapping, mechanical polishing, and chemical mechanical polishing (CMP) were conducted. Firstly, a no

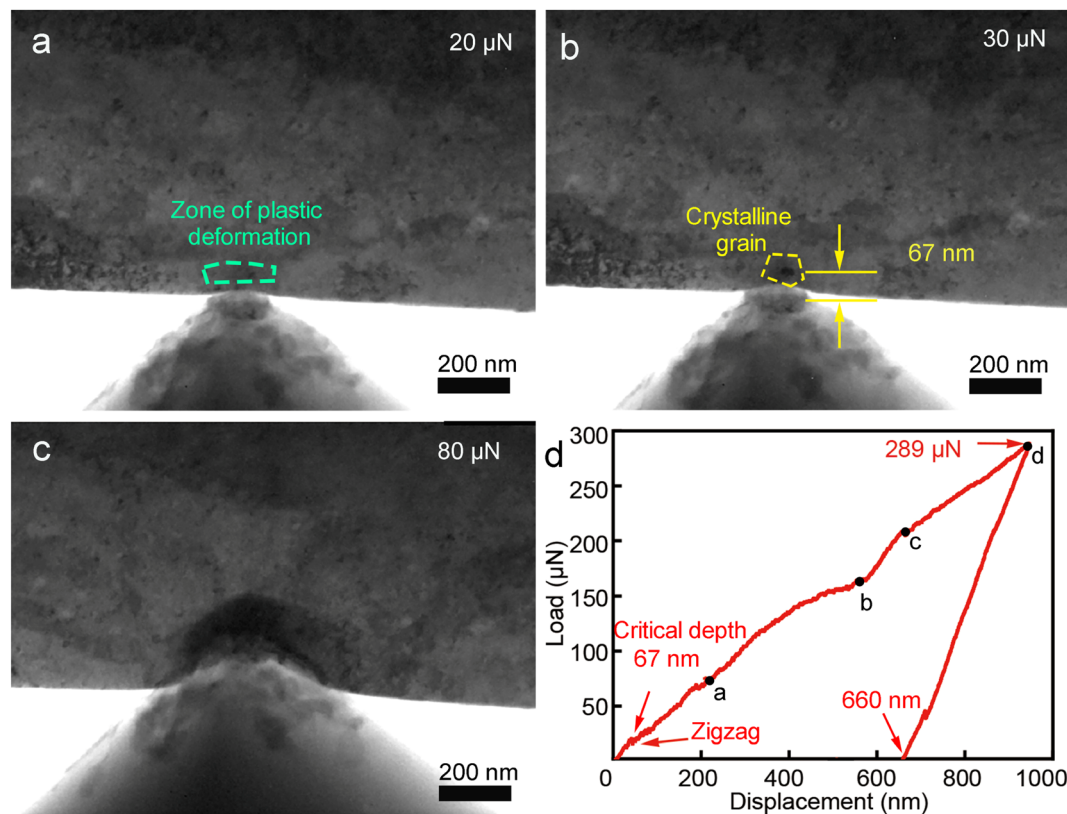
Fig. 1 Snapshots of TEM images of the nanoindentation area at sequential loads of (a) 20, (b) 30, and (c) 80  $\mu\text{N}$ ; (d) load–displacement curve of nanoindentation.

*In situ* TEM nanoindentation was performed to interpret the damage mechanism of the copper surface during machining. Fig. 1 shows a series of video snapshots during *in situ* nanoindentation of single-crystal copper nanoplates under a range of

applied loads. Prior to indentation, the sample surface remained flat. As depicted in Fig. 1(a), upon applying a load of 20 μN with a depth of 45 nm, slight irreversible plastic deformation occurred on the sample surface, along with the appearance of a minor zigzag in the load–displacement curve (Fig. 1(d)). These features are attributed to dislocation and stacking fault formation, sudden stress release, and instantaneous load drop.<sup>35</sup> TEM imaging confirmed that plastic deformation occurred in the indentation area without the formation of new grains at 20 μN, as shown in Fig. 1(a). Continuing to increase the load to 30 μN, Fig. 1(b) marks the onset of small grain formation within the single crystal, observed at the tip of the diamond indenter. A nano-sized grain is evident within the sample, indicated by the blue dashed line in Fig. 1(b), and a sudden load drop was observed in the load–displacement curve, indicating grain breakage in the single-crystal nanoplate at a depth of 67 nm under 30 μN. Further increasing the load to 80 μN, corresponding to a displacement of 219 nm, as shown in Fig. 1(c), the nanoplate experienced severe plastic deformation accompanied by the generation of new grains. Moreover, the serrated features observed on the load–displacement curve are a result of significant grain fragmentation. With further increases in the load, plastic deformation primarily occurred during the ‘ab’ stage, accompanied by grain fracture. In the ‘bc’ stage, due to excessive loading, the entire nanoplate sample undergoes overall elastic deformation, along with plastic deformation. The stiffness during the ‘bc’ stage is greater than that during the ‘ab’ stage. Finally, during the ‘cd’ stage, the plastic deformation of the sample further increases, and severe irreversible plastic deformation occurs in the indentation area. Loading was concluded when the displacement reached 900 nm.

As stress levels escalated, the damaged area witnessed an initial onset of dislocation motion and the emergence of stacking faults. Subsequently, grain fracture took place. Stress during the sample loading process was meticulously calculated. As illustrated in Fig. 1(d), grain fracture occurred in mono-crystalline nanoplate when the load reached 30 μN, corresponding to a displacement of 67 nm. In the realm of nanoindentation experiments, the equation employed to calculate the stress is as follows<sup>36</sup>

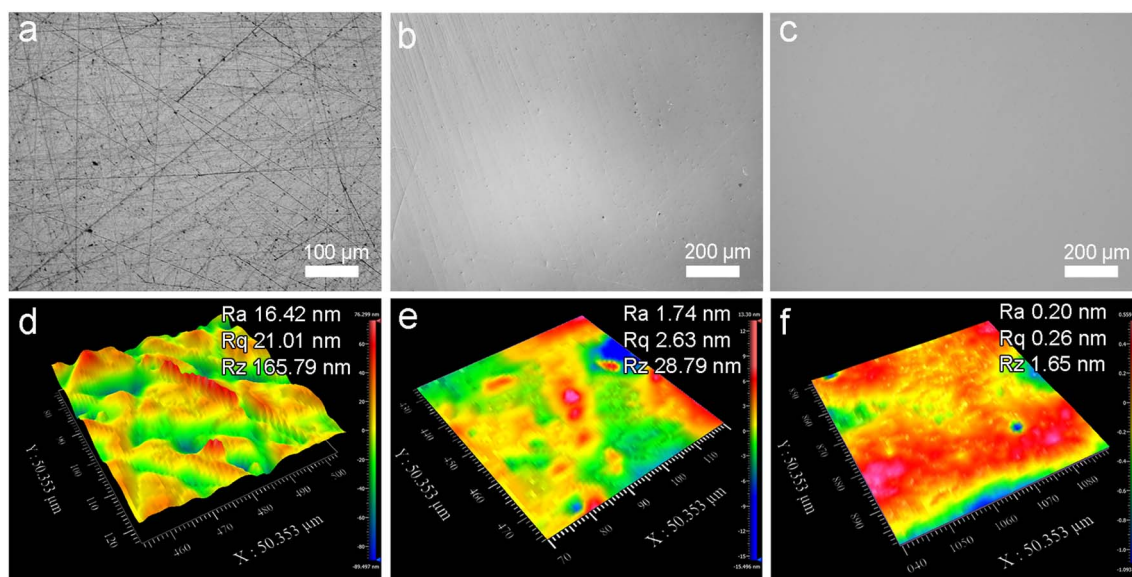
Fig. 3 Optical images of the copper wafer after (a) lapping with consolidated abrasive, (b) mechanical polishing with ceria slurry, and (c) polishing with a novel CMP slurry. Surface roughness and morphologies measured using a ZYGO profilometer after (d) lapping, (e) mechanical polishing, and (f) CMP.

To validate the machining damage mechanism, three typical processing techniques, lapping, mechanical polishing, and chemical mechanical polishing, were conducted. Fig. 3 illustrates the surface quality and topographical characteristics after consolidated abrasive lapping, mechanical polishing, and CMP processes. As depicted in Fig. 3(a), after lapping, numerous intersecting scratches were evident, characterized by a relatively significant depth. Surface roughness measurements were conducted using a 3D optical profilometer. The surface roughness parameters, namely  $R_a$  (arithmetic mean height),  $R_q$  (root mean square height), and  $R_z$  (maximum height) were determined to be 16.42 nm, 21.01 nm, and 165.79 nm, respectively. These measurements were obtained over a scan area of  $50\ \mu\text{m} \times 50\ \mu\text{m}$  (Fig. 3(d)). Upon completion of polishing with ceria slurry, a remarkable reduction in the number and intensity of scratches was observed (Fig. 3(b)). Additionally, an assessment of the surface quality was carried out, revealing surface roughness of  $R_a$ ,  $R_q$ , and  $R_z$  of 1.74 nm, 2.63 nm, and 28.79 nm, respectively. Afterward, utilizing an innovative polishing slurry, an exemplarily smooth copper surface was successfully

obtained without scratches. The treated surface displayed an immaculate mirror-like smoothness, devoid of any indications of scratch-induced harm or corrosion marks. The surface roughness parameters for the polished copper, specifically Ra,

Rq, and Rz, were measured to be 0.20 nm, 0.26 nm, and 1.65 nm, respectively, over a scanning area of  $50\ \mu\text{m} \times 50\ \mu\text{m}$ .

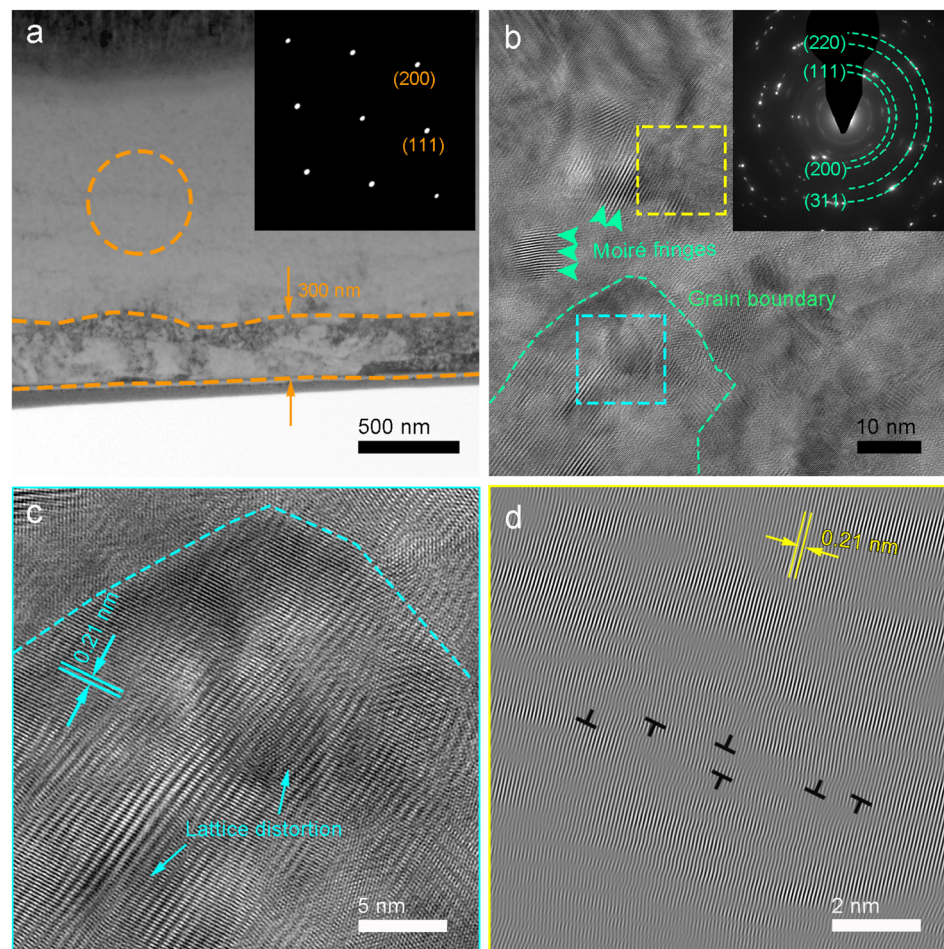
**Fig. 4** TEM characterization of copper subsurface after lapping. (a) A low magnification TEM image of subsurface damage, (b) an enlarged TEM image of the damaged area, (c and d) high-resolution TEM images obtained to visualize the damaged area, with distinct damage types corresponding to specific zones marked by cyan (c) and yellow (d) squares. The insets in (a) and (b) are their SAED patterns.

defects.<sup>41,42</sup> Fig. 4 presents the TEM results for lapping with consolidated abrasive. In Fig. 4(a), the TEM investigation unveiled that the thickness of the lapping-induced damaged layer was 300 nm. Before lapping, the copper sample demonstrated a remarkably monocrystalline state, as visually depicted in the inset of Fig. 4(a). Nevertheless, following the lapping procedure, a transition from a monocrystalline pattern to a polycrystalline state was observed in Fig. 4(b), which indicates grain breakage happening during lapping. The damaged area was further analyzed to gain deeper insights into the damage types that arose from the lapping process. In the lower leftmost region of the damage site, monocrystal structural breakage occurred due to the presence of high abrasive stress. This resulted in the emergence of conspicuous moiré fringes and grain boundaries, as indicated by the green arrows and dotted line in Fig. 4(b). These fringes originate from the overlapping and intersection of two crystalline grains.<sup>43</sup> Additionally, within the fractured crystal grains (Fig. 4(c)), regions of severe lattice distortion became apparent. Moving further into the interior of the damaged layer, as the abrasive stress diminishes, a distinct dislocation becomes discernible, clearly delineated by the

yellow square (Fig. 4(d)). The inverse fast Fourier transform (IFFT) image, focusing on the region indicated by the yellow square in Fig. 4(b), unveils the presence of edge dislocations within the inner zone of the damaged layer.

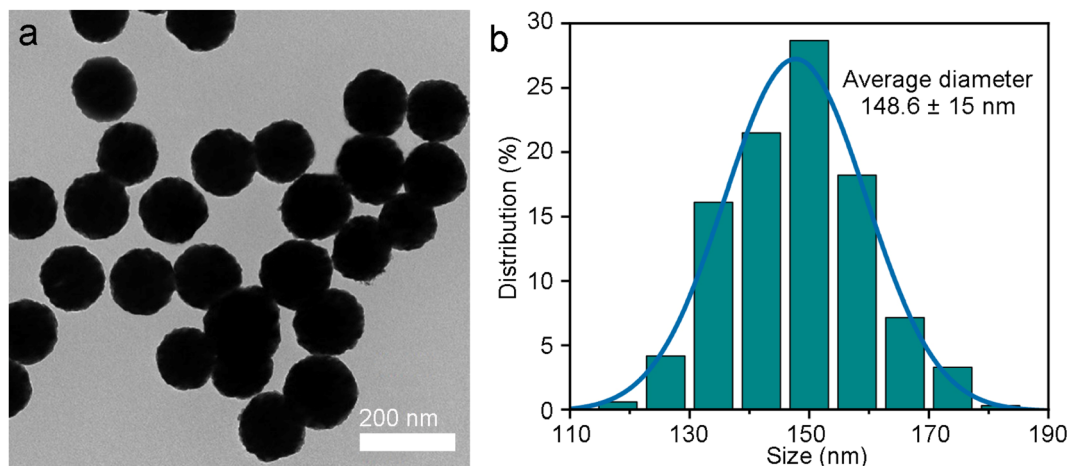
Fig. 5 (a) TEM image and (b) particle size distribution of CeO<sub>2</sub> abrasives.

Mechanical polishing is a precision polishing technology, that mainly relies on very fine polishing powder or polishing slurry lapping, rolling action, removing a layer of extremely thin material on the surface of the sample until the required smoothness is reached.<sup>44</sup> Fig. 5(a) shows the TEM image of ceria abrasive particles, indicating uniform dispersion of ceria. Particle size statistics revealed a normal distribution for ceria particles, with an average abrasive diameter of 148 nm (Fig. 5(b)).

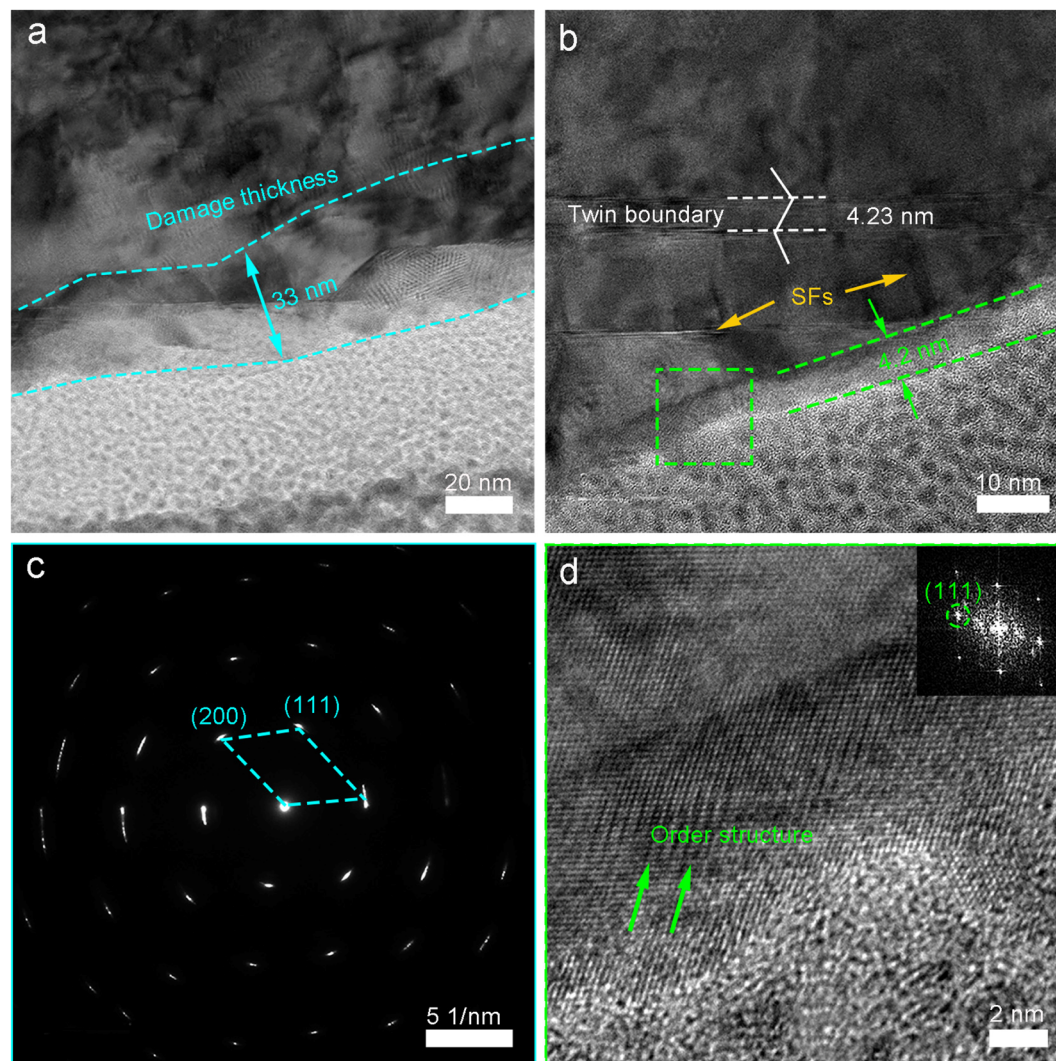
Fig. 6 (a) TEM characterization of the copper subsurface after mechanical polishing. (a) The low magnification TEM image of subsurface damage, (b) enlarged TEM image of the damaged area, (c) a SAED pattern of (a), and (d) HRTEM image of the green square in (b).

TEM. A low magnification TEM image presents a cross-sectional perspective of a mechanically polished surface, demonstrating a measured damage layer thickness of 33 nanometers (Fig. 6(a)). Additionally, the polished surface retained its monocrystalline structure (inset in Fig. 6(c)). Furthermore, the structure of the damage layer was observed. As depicted in Fig. 6(b), sporadic defects, including twin structures and stacking faults, were evident in the inner region. Notably, the width of these twin structures was measured at approximately 4.23 nm. The formation of an ordered periodic structure, as demonstrated in Fig. 6(d), was initiated through the alignment of the AB-type structure of two (111) planes within the superficial region, resulting from the vast stacking fault structure. In short, as the depth of the damage layer increases, the stress experienced by the sample gradually decreases, and the defect density also decreases accordingly.

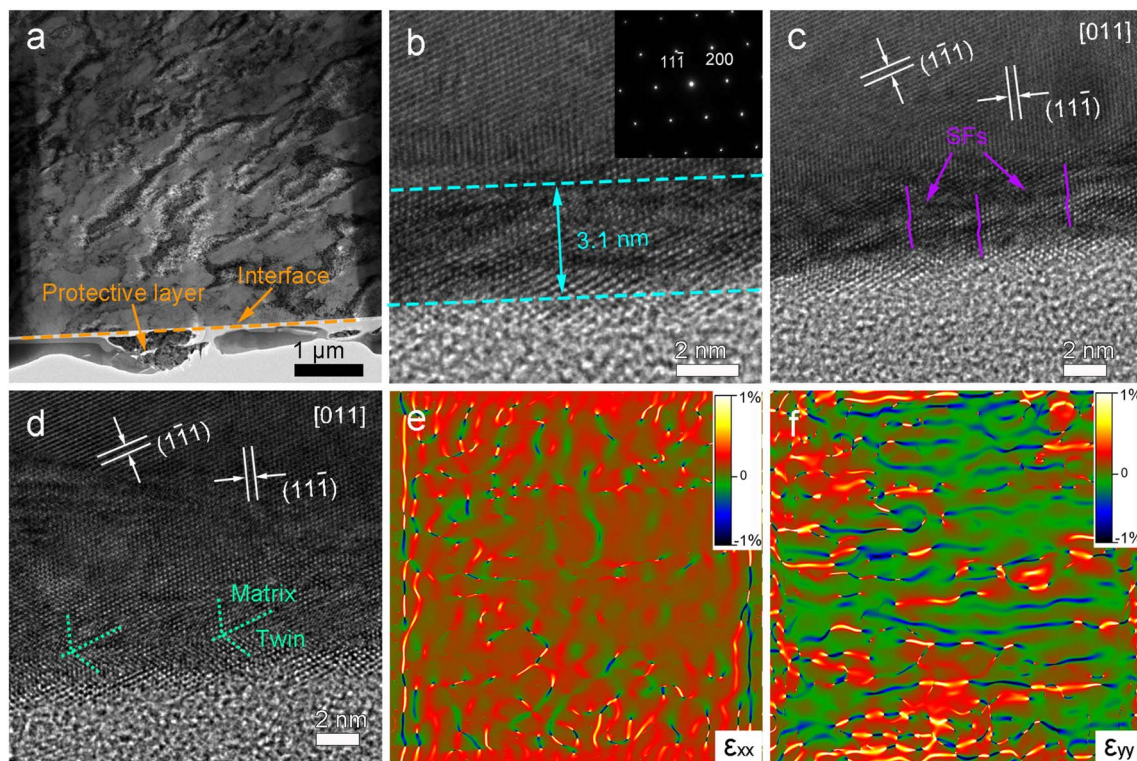
Fig. 7 TEM characterization of the copper subsurface after chemical mechanical polishing. (a) A low-magnification cross-sectional TEM image of subsurface and surface damage, (b) enlarged TEM image of the damaged area, (c) and (d) HRTEM images of different structure defects in different damaged regions, strains maps (e)  $\epsilon_{xx}$  and (f)  $\epsilon_{yy}$  obtained by GPA. The inset in (b) shows the SAED pattern of (b).

After conducting CMP, a TEM cross-section sample was meticulously prepared by employing FIB technology, enabling an in-depth analysis of the damage incurred during the polishing process. As illustrated in Fig. 7(a), a protective layer was strategically employed to shield the damaged layer from the potentially deleterious effects of the ion beam. Within the subsurface realm of the copper sample, a remarkable preservation of its single-crystal state was observed, as vividly presented in the inset of Fig. 7(b). Subsequently, upon scrutinizing the damaged area with precision, it was determined that the thickness of the damaged layer on the polished copper wafer was measured at a mere 3.1 nm, as depicted in Fig. 7(b). Furthermore, diverse damaged areas at distinct locations were meticulously characterized, revealing the presence of stacking faults composed of single-layer atoms, as impeccably exemplified in Fig. 7(c). Fig. 7(d) offers valuable insights into the core structure of twins, each measuring approximately 2 nm in length. To comprehensively assess the stress introduced by the polishing process, a microstrain analysis was conducted on the high-resolution TEM image employing geometric phase analysis (GPA) techniques, as elaborated in prior studies.<sup>45,46</sup> The strain maps meticulously charted the variations along [111] and

[200] directions (Fig. 7(b)). Within these strain maps, regions colored blue denoted compressive strain, whereas red and green regions signified tensile strain and an absence of strain, respectively. Notably, a conspicuous variation in strain was particularly pronounced along the [111] direction, whereas the [200] direction exhibited a notable lack of substantial stress distribution ( $\epsilon_{xx}$  in Fig. 7(e)). It is worth mentioning the presence of a considerable degree of compressive stress between the (111) planes ( $\epsilon_{yy}$  in Fig. 7(f)). The findings highlight that the CMP technology generates processing stress, notably manifesting in a direction parallel to the wafer's surface.

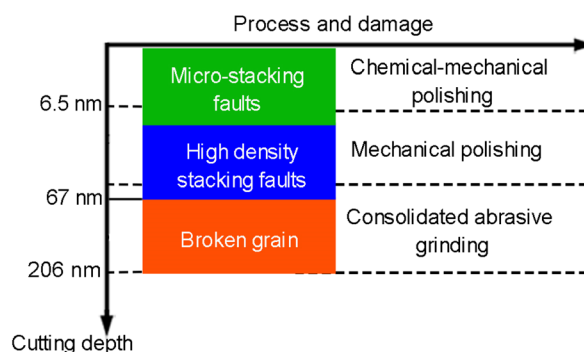
Fig. 8 Diagram of damage evolution under different process conditions.

Cutting depth is a crucial parameter that affects the quality of machining surfaces and the structure of the damage layer. According to the above experimental results, a relationship between the cutting depth and the damage generated during precision machining is established. The cutting depth for different processes was calculated, with specific details explained in the ESI.† The surface damage layer produced by the lapping process contains defects such as lattice distortions, broken grains, and edge dislocations. The surface of the sample was subjected to higher lapping stress, resulting in more severe damage, with a large number of broken grains in the damaged layer. The subsurface, on the other hand, experiences lower lapping stress, leading to relatively lower damage, characterized

by the presence of numerous crystal defects such as high-density stacking faults in the damaged layer (Fig. 8). During the mechanical polishing process, the stress on the copper surface exceeds the MPa level.<sup>19</sup> The damaged layer contains a significant amount of dislocation structures, and the density of dislocations decreases with increasing depth of the damaged layer. Moreover, in chemical mechanical polishing, copper atoms are collectively removed under mechanical and chemical action, forming micro-stacking faults composed of only a few atomic layers on the surface (Fig. 8). In high-precision machining, severe damage caused by broken grains significantly affects the surface quality and material mechanical
