The damage mechanism in copper studied using *in situ* TEM nanoindentation†

Dong Wang,^{ab} Zhenyu Zhang,^{ID} *^a Dongdong Liu,^{*a} Xingqiao Deng,^{*c} Chunjing Shi,^d Yang Gu,^e Xiuqing Liu,^e Xiaoyu Liu^e and Wei Wen^f

Copper (Cu) has a soft-plastic nature, which makes it susceptible to damages from scratching or abrasive machining, such as lapping and polishing. It is a challenge to control these damages as the damage mechanism is elusive. Nonetheless, controlling damages is essential, especially on the atomic surfaces of Cu. To interpret the damage mechanism, *in situ* transmission electron microscopy (TEM) nanoindentation was performed using a cube-corner indenter with a radius of 57 nm at a loading speed of 5 nm s⁻¹. Experimental results showed that damages originate from dislocations, evolve to stack faults, and then form broken crystallites. When the indentation depth was 45 nm at a load of 20 μN, damages comprised dislocations and stacking faults. After increasing the depth to 67 nm and load to 30 μN, the formation of broken crystallites initiated; and the critical depth was 67 nm. To validate the damage mechanism, fixed-abrasive lapping, mechanical polishing, and chem

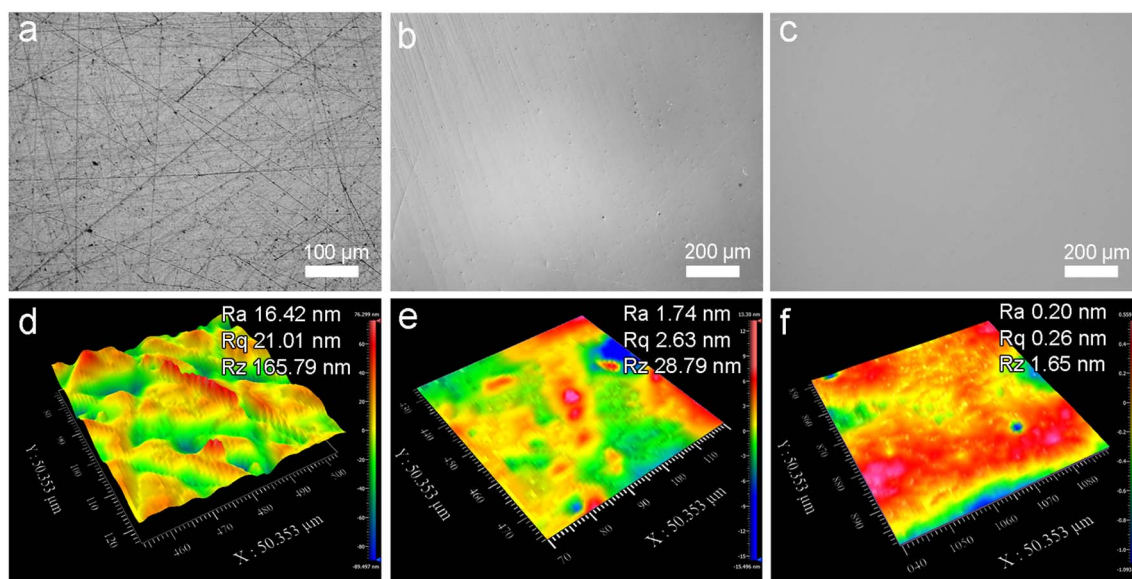
Fig. 3 Optical images of the copper wafer after (a) lapping with consolidated abrasive, (b) mechanical polishing with ceria slurry, and (c) polishing with a novel CMP slurry. Surface roughness and morphologies measured using a ZYGO profilometer after (d) lapping, (e) mechanical polishing, and (f) CMP.

To validate the machining damage mechanism, three typical processing techniques, lapping, mechanical polishing, and chemical mechanical polishing, were conducted. Fig. 3 illustrates the surface quality and topographical characteristics after consolidated abrasive lapping, mechanical polishing, and CMP processes. As depicted in Fig. 3(a), after lapping, numerous intersecting scratches were evident, characterized by a relatively significant depth. Surface roughness measurements were conducted using a 3D optical profilometer. The surface roughness parameters, namely Ra (arithmetic mean height), Rq (root mean square height), and Rz (maximum height) were determined to be 16.42 nm, 21.01 nm, and 165.79 nm, respectively. These measurements were obtained over a scan area of $50 \mu\text{m} \times 50 \mu\text{m}$ (Fig. 3(d)). Upon completion of polishing with ceria slurry, a remarkable reduction in the number and intensity of scratches was observed (Fig. 3(b)). Additionally, an assessment of the surface quality was carried out, revealing surface roughness of Ra, Rq, and Rz of 1.74 nm, 2.63 nm, and 28.79 nm, respectively. Afterward, utilizing an innovative polishing slurry, an exemplarily smooth copper surface was successfully

obtained without scratches. The treated surface displayed an immaculate mirror-like smoothness, devoid of any indications of scratch-induced harm or corrosion marks. The surface roughness parameters for the polished copper, specifically Ra,

Rq, and Rz, were measured to be 0.20 nm, 0.26 nm, and 1.65 nm, respectively, over a scanning area of $50\ \mu\text{m} \times 50\ \mu\text{m}$.
