Nanoscale Advances

The damage mechanism in copper studied using *in situ* TEM nanoindentation†

Copper (Cu) has a soft-plastic nature, which makes it susceptible to damages from scratching or abrasive machining, such as lapping and polishing. It is a challenge to control these damages as the damage mechanism is elusive. Nonetheless, controlling damages is essential, especially on the atomic surfaces of Cu. To interpret the damage mechanism, *in situ* transmission electron microscopy (TEM) nanoindentation was performed using a cube-corner indenter with a radius of 57 nm at a loading speed of 5 nm s⁻¹. Experimental results showed that damages originate from dislocations, evolve to stack faults, and then form broken crystallites. When the indentation depth was 45 nm at a load of 20 μN, damages comprised dislocations and stacking faults. After increasing the depth to 67 nm and load to 30 μN, the formation of broken crystallites initiated; and the critical depth was 67 nm. To validate the damage mechanism, fixed-abrasive lapping, mechanical polishing, and chemical mechanical polishing (CMP) were conducted. Firstly, a novel green CMP slurry containing silica, hydrogen peroxide, and aspa

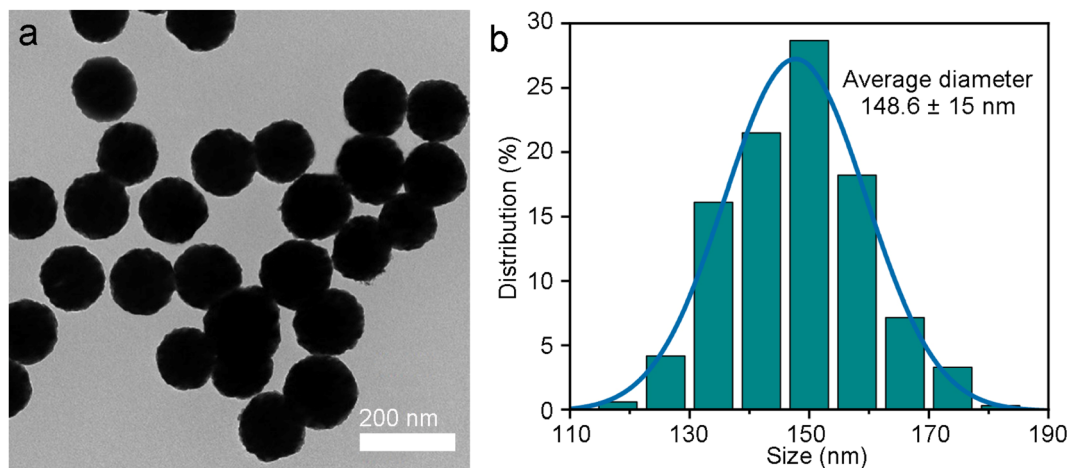
Fig. 5 (a) TEM image and (b) particle size distribution of CeO₂ abrasives.

Mechanical polishing is a precision polishing technology, that mainly relies on very fine polishing powder or polishing slurry lapping, rolling action, removing a layer of extremely thin material on the surface of the sample until the required smoothness is reached.⁴⁴ Fig. 5(a) shows the TEM image of ceria abrasive particles, indicating uniform dispersion of ceria. Particle size statistics revealed a normal distribution for ceria particles, with an average abrasive diameter of 148 nm (Fig. 5(b)).
