Probing the Molecular Structures of Plasma-damaged and Surface-repaired Low-k Dielectrics

Xiaoxian Zhang^a, John N. Myers^a, Qinghuang Lin^b, Jeffery D. Bielefeld^c, and Zhan Chen^{a*}*Received (in XXX, XXX) Xth XXXXXXXXX 20XX, Accepted Xth XXXXXXXXX 20XX*

Fully understanding the effect and the molecular mechanisms of plasma damage and silylation repair on low dielectric constant (low-k) materials is essential to the design of low-k dielectrics with defined properties and the integration of low-k dielectrics into advanced interconnects of modern electronics. Here, analytical techniques including sum frequency generation vibrational spectroscopy (SFG), Fourier transform infrared spectroscopy (FTIR), contact angle goniometry (CA) and X-ray photoelectron spectroscopy (XPS) have been employed to provide a comprehensive characterization of the surface and bulk structure changes of poly (methyl)silsesquioxane (PMSQ) low-k thin films before and after O₂ plasma treatment and silylation repair. O₂ plasma treatment altered drastically both the molecular structures and water structures at the surfaces of the PMSQ film while no bulk structural change was detected. For example, ~34 % Si-CH₃ g

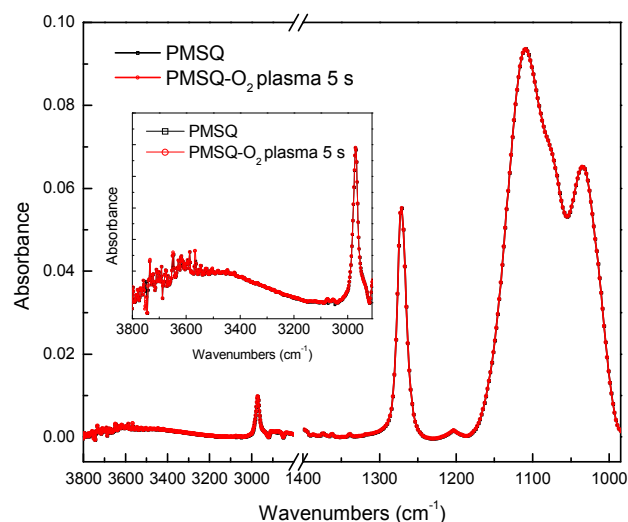
Fig. 2 FTIR spectra acquired from PMSQ thin films before and after oxygen plasma treatment for 5 s

In order to characterize the bulk structure change of low-k film after 5 s O₂ plasma treatment, transmission FTIR spectra were collected from untreated and plasma-damaged PMSQ thin films (Figure 2). The molecular structure of PMSQ is displayed in Figure 1a. A PMSQ molecule consists of two kinds of Si-O structures which are commonly called "cage" and "network" structures. In addition to Si-O bonds, Si-CH₃ groups are also part of the PMSQ structure. Figure 2 exhibits that the FTIR spectral features are almost unchanged before and after O₂ plasma treatment for 5 s, which also resembles most carbon-doped oxide

low-k films.^{5, 7, 8} In the C-H stretching frequency region, only a sharp CH₃ peak (~2971 cm⁻¹) and a broad water peak (~3400 cm⁻¹) were observed. This broad water peak has been assigned to weakly hydrogen bonded water inside the PMSQ bulk, indicating that most of water molecules in the bulk are physisorbed water.^{15, 41} In the fingerprint region, several pronounced peaks were detected, including a strong peak around 1272 cm⁻¹ (Si-CH₃ bending mode) and two strong overlapped peaks around 1109 and 1035 cm⁻¹, which were attributed to the caged and network Si-O bond structure, respectively.⁸ Undetectable changes in the FTIR spectra acquired from low-k film before and after plasma damage (Figure 2) indicate that almost no structure changes occurred in the PMSQ bulk after exposure to O₂ plasma for 5 s or that the structural changes in the PMSQ bulk were not substantial enough to be detected by FTIR.

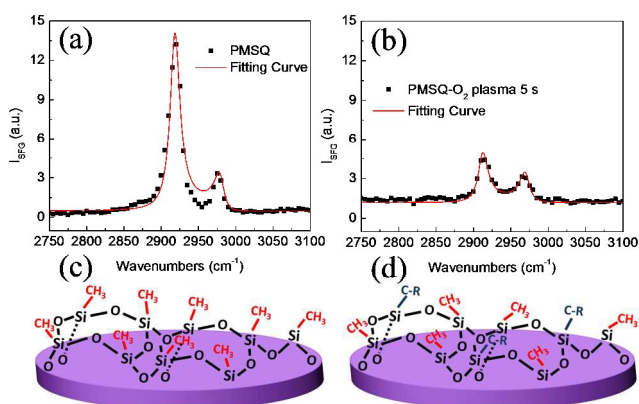
Fig. 3 ssp SFG spectra of a PMSQ thin film before (a) and after (b) oxygen plasma treatment, and the schematic illustrations of the corresponding surface structures of untreated (c) and plasma-damaged (d) PMSQ films

To investigate the effect of plasma on the PMSQ surface, SFG measurements were collected from untreated and plasma-damaged PMSQ thin films, respectively. Different from FTIR results, Figure 3 clearly shows that the SFG spectral features were drastically changed after oxygen plasma for 5 s. Similar to the case of untreated PMSQ shown in Figure 3a, the ssp SFG spectrum collected from the PMSQ thin film after 5 s plasma treatment was also dominated by two peaks located at 2915 and 2970 cm⁻¹, however, the ratios of two peaks are significantly different and the intensities became much weaker compared to the peaks in the SFG spectra collected from the untreated film. These results suggest that the surface of the plasma-damaged PMSQ thin film is still covered by Si-CH₃ groups, but the surface coverage and/or the possible orientation of Si-CH₃ groups were influenced even though the film was only exposed to O₂ plasma for 5 s. This clearly indicates that SFG is much more sensitive than transmission FTIR to surface structural changes.

surface coverage of Si-CH₃ groups after oxygen plasma exposure was deduced. The detailed calculation method can be found in ESI. SFG spectra fitting results were displayed in Figure 3a-b and the fitting parameters and the calculation results were included in Table 1. The average orientation of Si-CH₃ groups at the surface of untreated PMSQ thin film was ~37° (schematic illustration is shown in Figure 3c) which indicates that the Si-CH₃ groups tilt up at the PMSQ surface. Whereas, after exposure to O₂ plasma for only 5 s, the surface orientation of Si-CH₃ groups was ~48°, indicating that the Si-CH₃ groups lie down to the surface more compared to the untreated sample. The schematic illustration of a plasma-damaged PMSQ surface is shown in Figure 3d. After determining the possible orientation of methyl groups at the low-k/air interface before and after plasma treatment, the surface coverage change before and after O₂ plasma treatment was deduced using equation S8 (ESI). The coverage change (molecule number density after plasma treatment/molecule number density before plasma treatment) was determined to be ~66%, suggesting that 5 s oxygen plasma exposure removed ~34% methyl groups from the PMSQ surface.

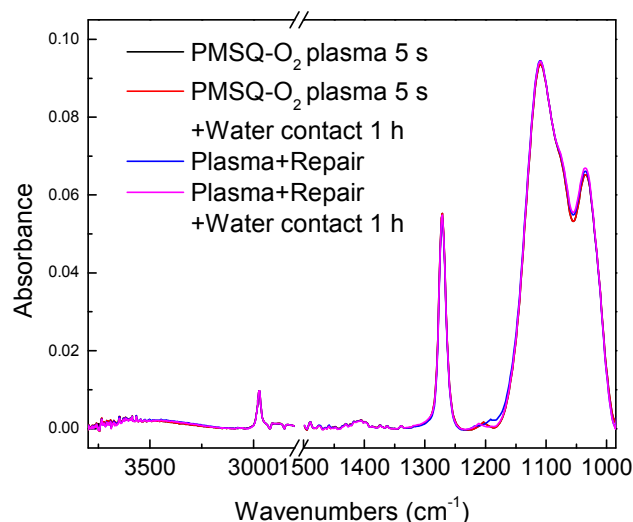
Fig. 5 FTIR spectra of the plasma-damaged PMSQ film before and after contacting with water for 1 hour, and the repaired PMSQ thin film before and after contacting with water for 1 hour

Subsequently, FTIR measurements were performed on the repaired PMSQ thin film to investigate the bulk structure change after silylation. Figure 5 indicates that no phenyl peaks were detected in the FTIR spectrum collected from the repaired film. Combined with the SFG spectrum collected from the repaired PMSQ thin film (Figure 4a), this suggested that only a small amount of PTMS molecules reacted with plasma-damaged PMSQ thin film.

film. First, water adsorption in the bulk of plasma-damaged and repaired PMSQ was compared by FTIR. The corresponding samples were immersed into water for 1 hour, and then FTIR tests were performed (shown in Figure 5). Almost no spectral features were altered after water immersion for both plasma-damaged and repaired PMSQ thin films, indicating that no more detectable water was present in the bulk of both plasma-damaged

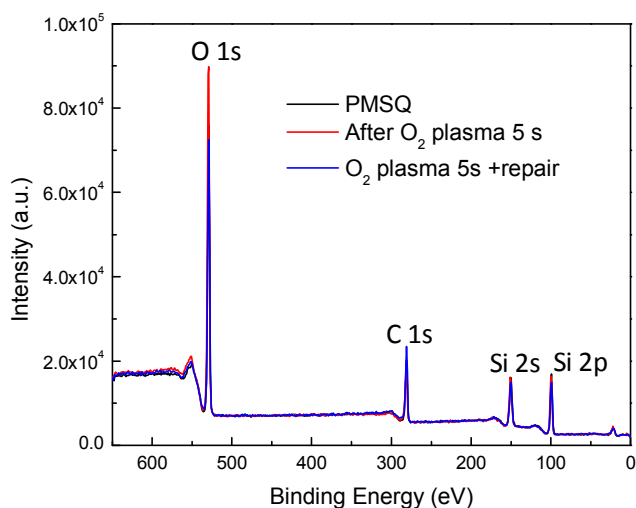
Fig. 7 XPS survey spectra of untreated, plasma-damaged and repaired PMSQ thin films

Next, XPS measurements were utilized to give more information about element compositions and chemical binding before and after O₂ plasma treatment and PTMS repair. First, XPS survey spectra were collected from the untreated, plasma-damaged, and repaired PMSQ thin films, respectively, to provide information about element composition changes. Figure 7 shows the XPS survey spectra collected from three samples in the energy range of 0 - 650 eV. Clearly, the intensity of the oxygen 1s peak at ~529 eV increased after oxygen plasma treatment for 5 s, while after PTMS silylation, this peak decreased again and became similarly strong as the untreated one. However, the changes of other peaks, such as C 1s, Si 2p, cannot be seen as clearly as O 1s peak in Figure 7. Therefore, in order to get more quantitative details, the XPS spectra shown in Figure 7 were fitted and the fitting results were displayed in Table 3. We can see from Table 3 that after 5 s oxygen plasma treatment, the atomic percentage of O 1s increased from 40.67 to 47.95 %, and then returned to 40.75 % after PTMS repair. Meanwhile, the C 1s content decreased from 34.22 to 29.10 %, and then increased to 37.80 % after repair. The XPS spectra shown here (Figure 7 and Table 3) imply that the oxygen content at PMSQ surface after 5 s plasma treatment increased and was recovered to the similar level as the untreated sample after repair by PTMS silylation. The carbon signal decreased after the oxygen plasma treatment and then increased again by PTMS silylation. These results are very consistent with our SFG and CA results, indicating that the damaged surface was effectively repaired by PTMS silylation.

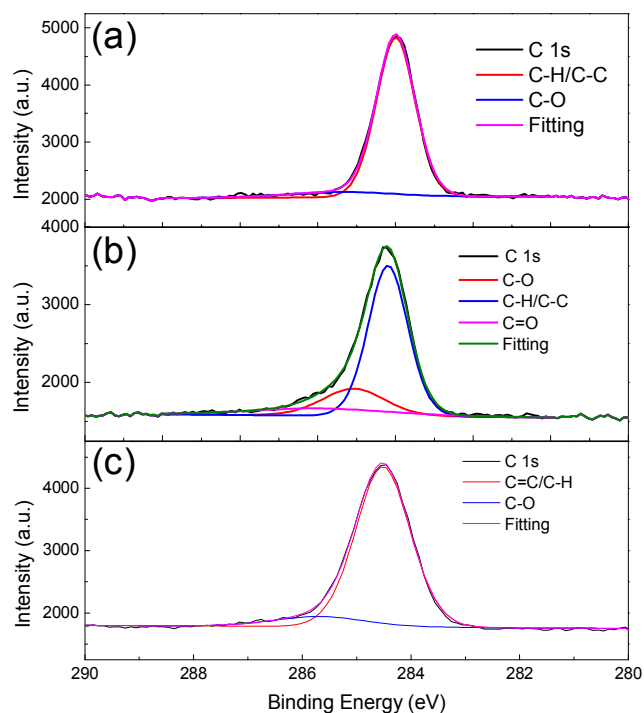
Fig. 8 C 1s high resolution XPS spectra collected from (a) the untreated, (b) plasma-damaged and (c) repaired PMSQ thin films

Furthermore, high-resolution XPS measurements were carried out on the untreated, plasma-damaged and repaired PMSQ thin films to obtain more information about the chemical state changes. That is, the local chemical binding energy changes of a specific element were examined to provide more information about O₂ plasma treatment and PTMS repair of PMSQ thin films. Here, a typical C 1s envelope provides local binding information about carbon. Additionally, all high-resolution XPS spectra were fitted to get more quantitative information about the PMSQ samples. The fitting results as well as the experimental spectra are exhibited in Figure 8 and all the fitting parameters are listed in Table 4. We can see from Figure 8 and Table 4 that for untreated PMSQ, the majority of the carbon near the surface is in the form of C-C/C-H bonds, only very small amounts of C-O (3.37%) were detected which may be due to slow natural oxidation in air. However, oxygen plasma treatment leads to an increase in the percentage of C-C/C-H bonds from 96.63 % to 69.04 %, meanwhile both C-O and C=O signals became higher, indicating breaking of the C-C/C-H bonds as well as the formation of new bonds such as C-O and/or C=O bonds after O₂ plasma exposure.

In addition, in the case of plasma-damaged PMSQ thin film after silylation repair by PTMS, the trend is opposite. That is, both C-O and C=O signals became lower while the C-C/C-H bonds increased from 69.04 % to 91.55 %, suggesting that the repaired surface is dominated by C-C/C-H bonds again. These results are very consistent with SFG, CA as well as XPS survey results.
