RSC Advances

Cite this: RSC Adv., 2019, 9, 17040

Potential of dynamic bacterial communities in the bio-corrosion process: a proof study with surface morphology of metal coupons[†]

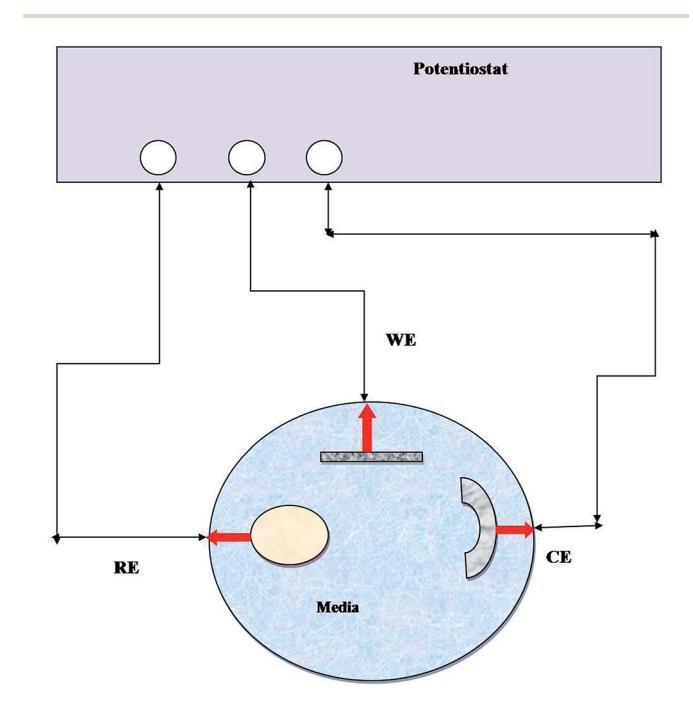
Fig. 1 Line diagram of the EIS experimental setup. RE: reference electrode, WE: working electrode, and CE: counter electrode and medium (abiotic and biotic) served as an electrolyte.

EIS has been widely used to measure the electrochemical properties of corroded surfaces. Experiments were conducted in an electrochemical cell containing a three-electrode system: platinum (counter), calomel (reference) and metal coupon (working electrode) (Fig. 1). The working electrodes (metal coupons) were tested in two ways: (i) abiotic (control) and (ii) biotic (treated) systems, where the medium Postgate B acted as the electrolyte. EIS studies were conducted, and data were recorded at 7 days intervals until 28 days of the incubation period. The impedance was represented by the Nyquist plot (imaginary component of impedance vs. real component), Bode (phase angle vs. frequency) spectra and Tafel plot. EIS was carried out with an AC voltage amplitude of 0.01 V in the frequency range from 0.01 Hz to 10 000 Hz. The data obtained were modelled using the NOVA software.

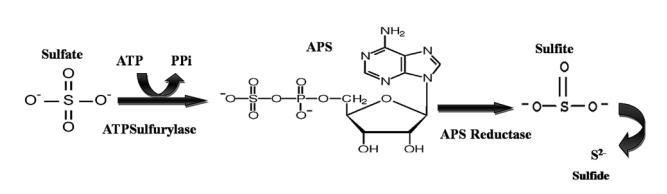
Fig. 2 The schematic of the reaction depicts the pathway for sulfate conversion into sulphide, where ATP: adenosine triphosphate, PPi: pyrophosphate and APS: adenosine-5'-phosphosulfate.

The detection of APS reductase (adenosine 5'-phosphosulfate) in the biotic system was performed using the Quickcheck[™] SRB kit (as per manufacturer's protocol). The Quickcheck[™] SRB Kit was also used for the detection and quantification of SRB. The kit was calibrated with microscopically counted cells of the SRB strain *Desulfovibriode sulfuricans*. APS reductase enzyme is commonly present in sulphate-utilizing organisms and helps in converting sulfates to sulfides, as shown in Fig. 2. The sulfides

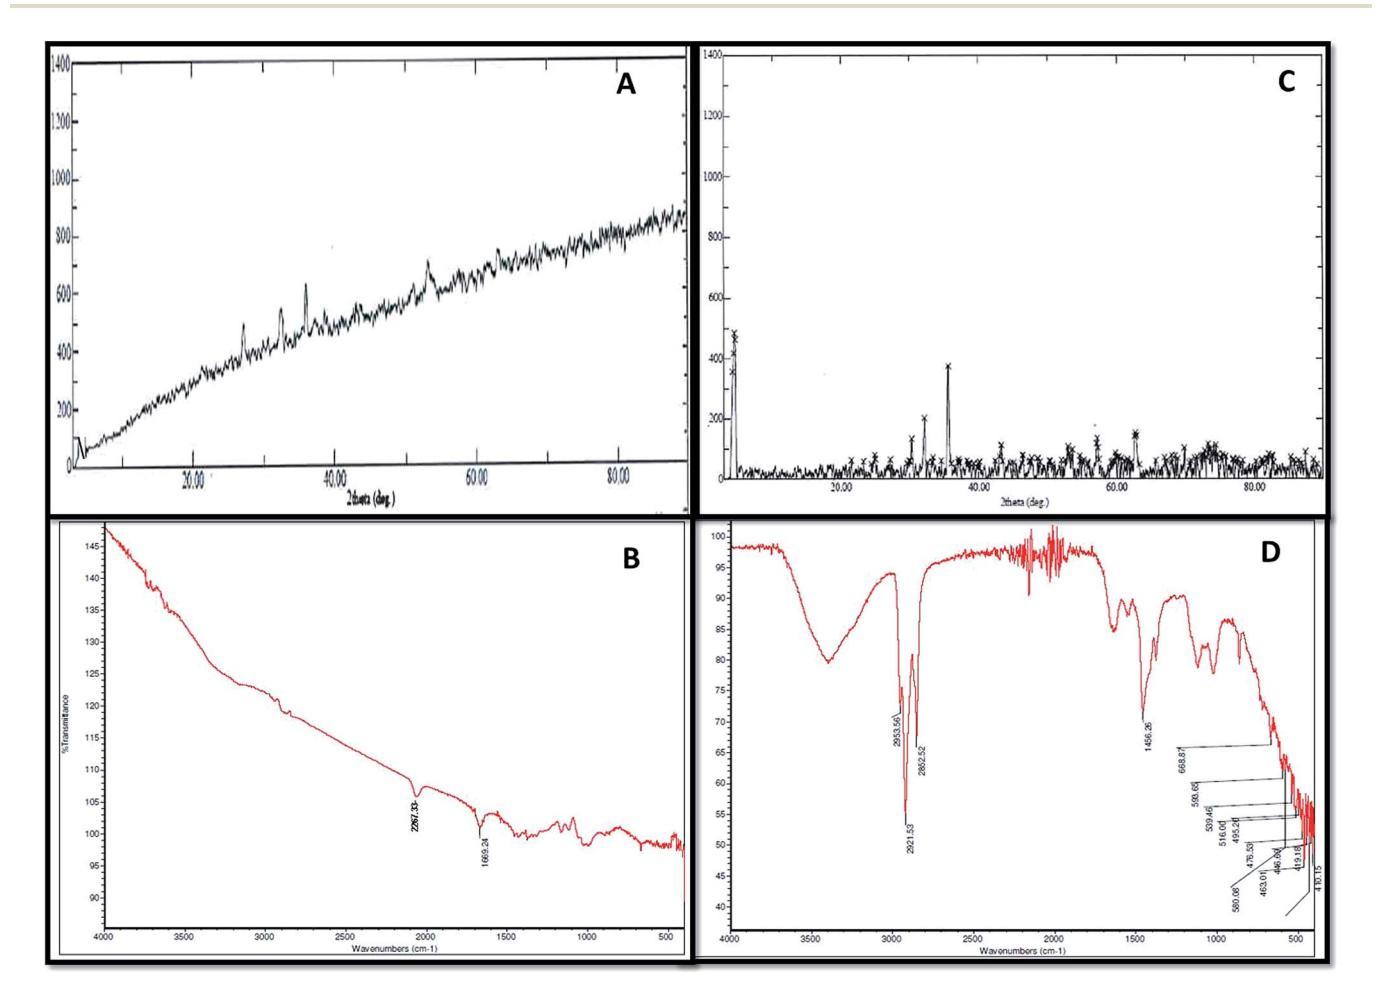
Fig. 3 The corrosive chemical composition produced in the abiotic and biotic systems illustrated by FT-IR and XRD spectra. (A and B) Represent the FT-IR and XRD results for the abiotic system, respectively. (C and D) Show the FT-IR and XRD results for the biotic system, respectively.

XRD and FTIR analyses provided information regarding the chemical composition and functional groups (oxides, sulphides and stretching of compounds) of the corrosive products deposited in the abiotic and biotic systems on the metal surface Fig. 3(A-D). The intensity of peaks in the abiotic system (control) was observed to be weak (Fig. 3A). The XRD spectra of the biotic system confirmed the presence of oxide and sulphide of iron (Fe₃O₄ and FeS) with high-intensity peaks; the pattern confirmed that the production of sulfide was biogenic in nature (Fig. 3C). Sulfate-reducing bacteria utilized the iron and sulfate (terminal electron acceptors) from the medium and finally altered them to iron sulfide (Fe_xS_v), which is considered as one of the most corrosive agents for pipelines.16,25 Similar spectra were reported by Parthipan et al.4 and AlAbbas et al.22 The XRD data revealed the role of bacteria in mineral deposition on the metal surface, which were responsible for coupon corrosion.

As such, no major peaks were observed in the FTIR spectra of the abiotic system (control) (Fig. 3B). Only minor peaks at 1667–2300 cm⁻¹, which corresponded to the -C=C conjugated

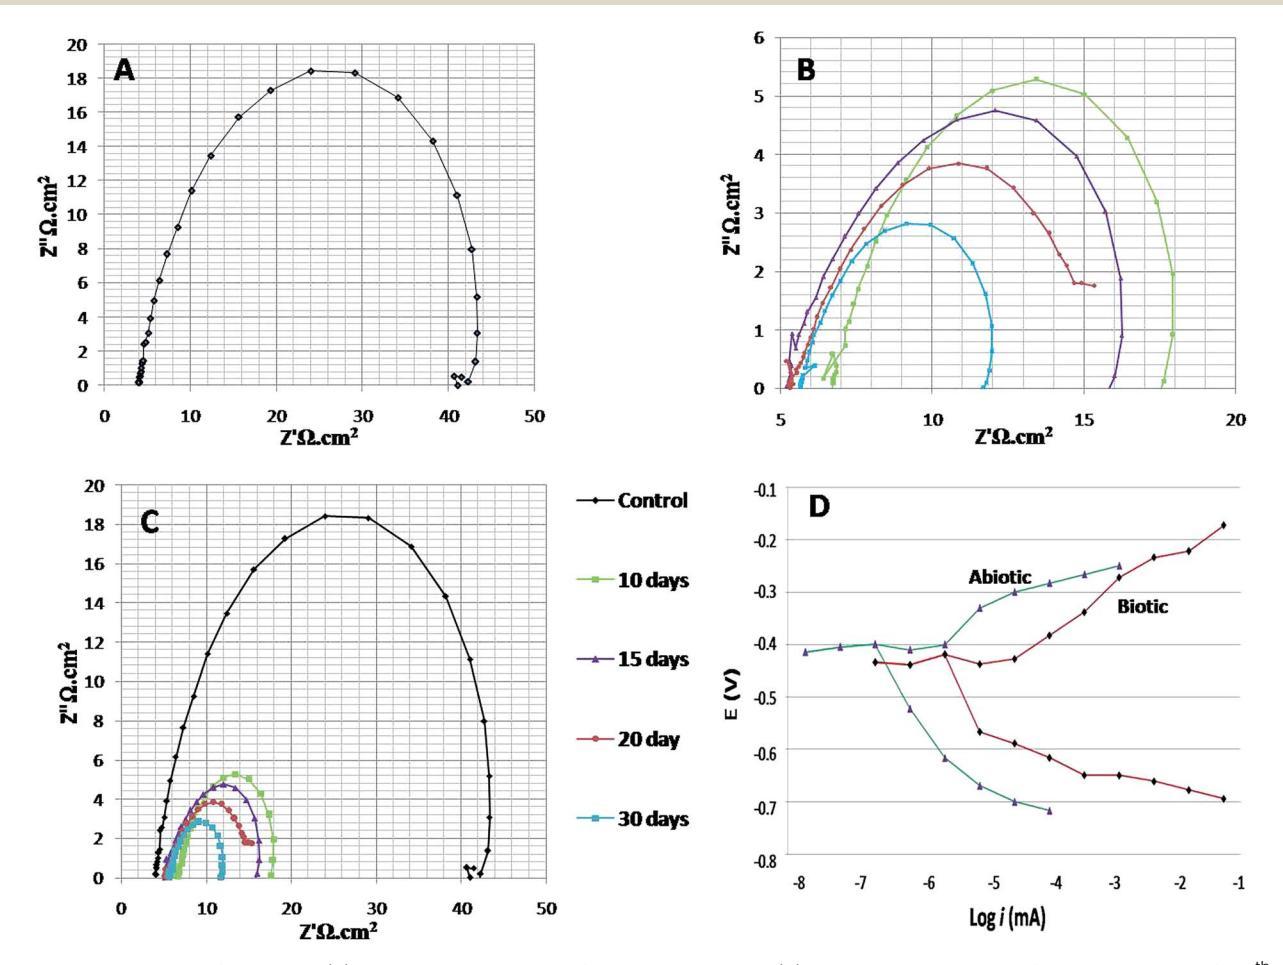
Fig. 4 The Nyquist and Tafel spectra. (A) Illustrates the spectra of the abiotic system, (B) illustrates the spectra of the biotic system for 7th, 14th, 21st and 28th days, (C) shows the combined spectra for both abiotic and biotic systems, and (D) elucidates the Tafel plots of the abiotic and biotic systems (on the 28th day).

EIS was recorded on every 7th day of the 28 days incubation period. The diameter of R_{ct} was observed to be maximum for control (Fig. 4A); as the environment was abiotic, there was no bacterial activity and the electron transfer was very low. Therefore, in the abiotic system, the chance of electro–biochemical reactions was negligible.

By studying the Nyquist loops of the biotic system, the corrosive nature of the sample can be justified. A significant difference was observed on comparing the diameters of the biotic and abiotic systems; a relatively reduced $R_{\rm ct}$ value was observed in the biotic system. The reduced diameter signified the role of bacterial activity in metal corrosion.³⁵ After exposing the coupons for different exposure times, it was observed that, as the incubation period increased, the corrosive behaviour caused by bacteria also increased. The diameter obtained on the

28th day was comparatively smaller than the diameter obtained on the 7th day of incubation (Fig. 4B and C). Fig. 4D illustrates the Tafel plots of the abiotic and biotic systems, corresponding to the occurrence of anodic and cathodic reactions, and the intersection in the graph gives the corrosion exchange current density. In the case of the biotic graph, the anodic and cathodic values are higher in comparison to the observations for the abiotic graph. This showed that the biotic system contained a corrosive environment. Study reported by Jia *et al.*,³⁶ similar Tafel plots were obtained; the abiotic system showed lesser corrosion values than the biotic system.

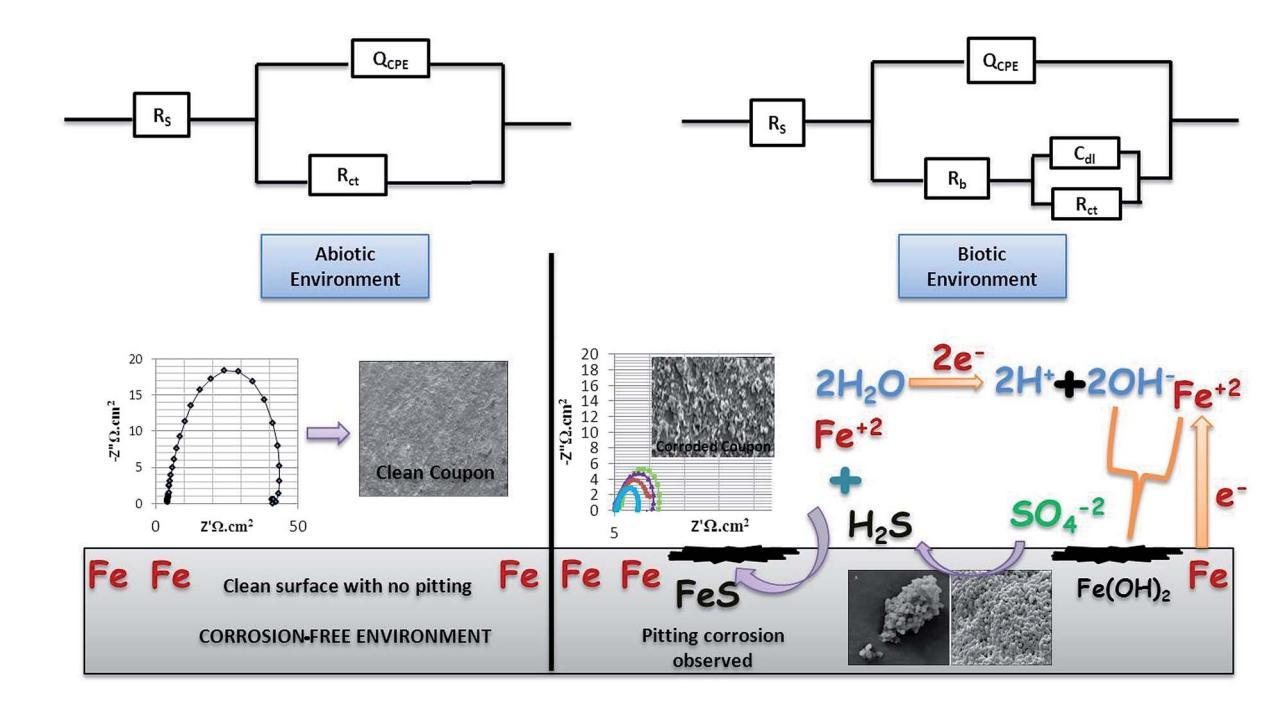
Fig. 5 The bio-electrochemical reactions of the abiotic and biotic systems. The biotic system is a potentially active system.

Fig. 5 shows the difference in the bio-electrochemistry of abiotic and biotic systems with the circuit model, where R_s denotes the resistance of the solution, $R_{\rm b}$ is the resistance created by the biofilm formed in the biotic system, and C_{dl} refers to the double layer capacitance. In the biotic system, the microorganisms accelerated the corrosion process by generating corrosive products on the metal coupons. The reciprocal of charge transfer resistance $(1/R_{ct})$ is known as the corrosion rate; the smaller the R_{ct} , the higher the rate of corrosion. It is evident that the diameter of the biotic semicircle decreases, which further reduces the polarization resistance. This suggests that the biotic system has a noticeable effect on corrosion growth by altering the surrounding environment; the metabolites produced (oxides of iron and sulfur) in the biotic system alter the electrochemical properties of the system, which further results in reduced polarization resistance.37

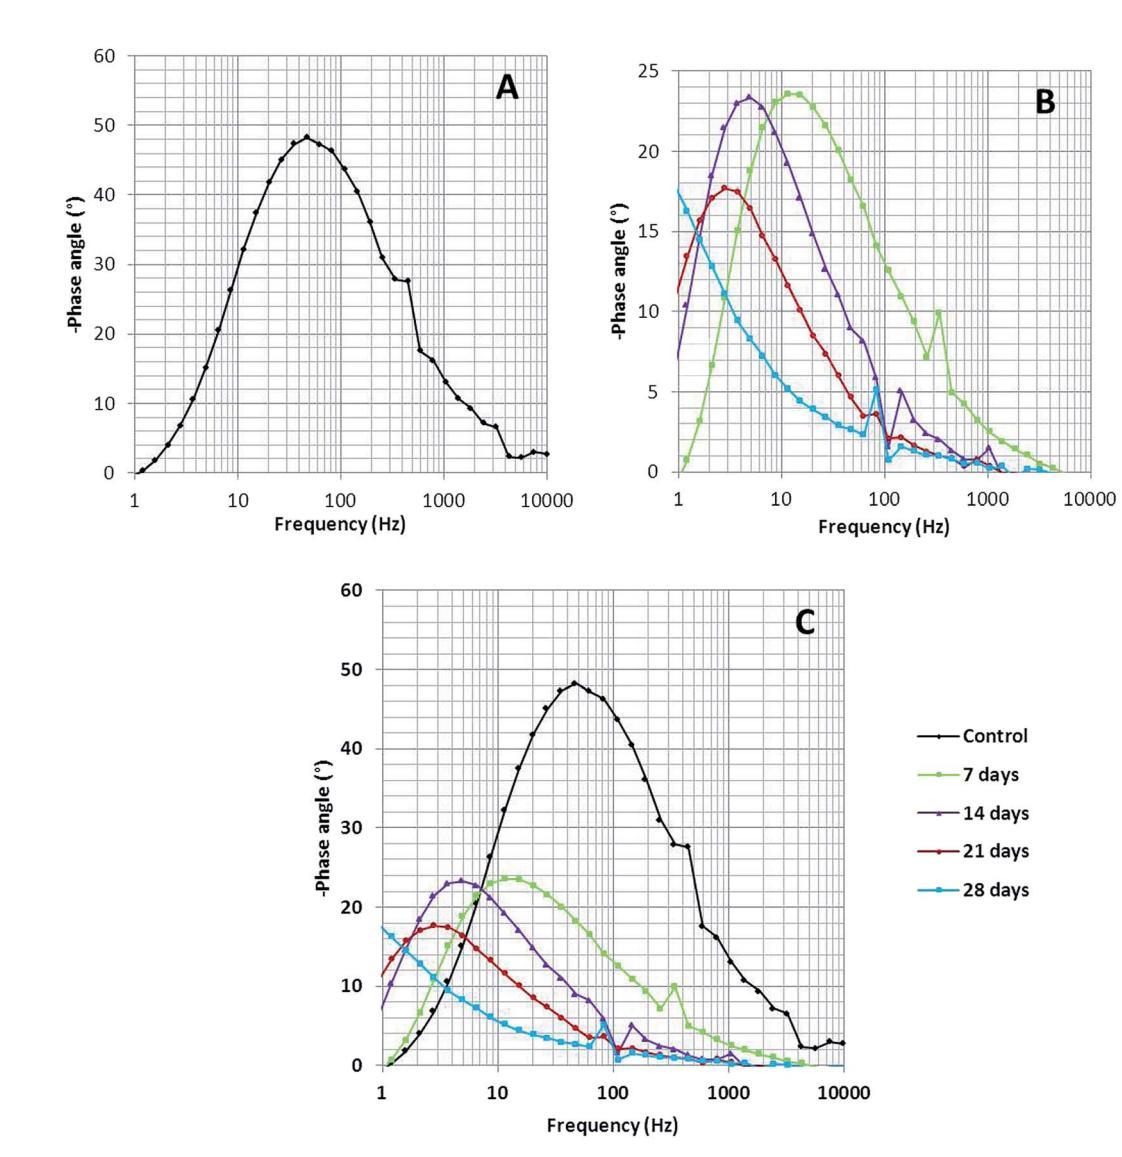
Fig. 6 The Bode phase spectra of (A) the abiotic system and (B) the biotic system on 7th, 14th, 21st and 28th days; (C) depicts the comparison of the abiotic and biotic systems.

Bode spectra (Fig. 6) are plotted in the orthogonal axis planes, in which the phase angle (degree) is on the ordinate axis and the logarithm of the frequency (Hertz) is on the abscissa axis. The phase angle spectrum of the biotic system is smaller than that of the abiotic system, which further represents that the conductivity of the solution sample is high as compared to that of the control.³⁸ The higher conductivity clarified the presence of more free ions in the system, due to which the bacterial electric pathways become active and this will speed up the process of corrosion.

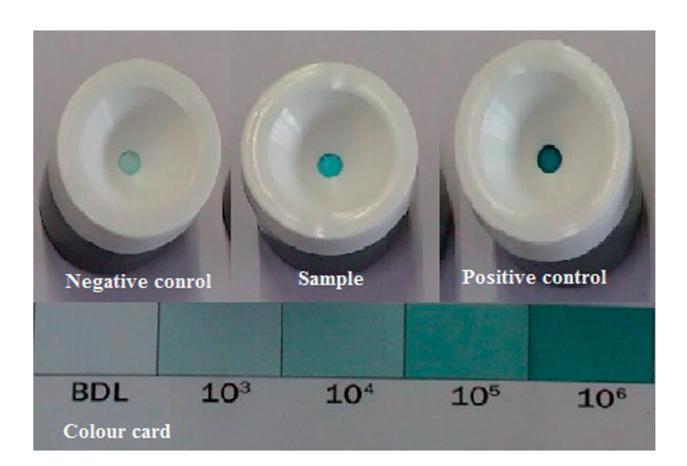
Fig. 7 APS Reductase test. The negative control falls in the BDL range (Below Detection Limit), whereas the positive control and the sample show positive responses towards the reaction. All the experiments were performed in triplicate. The data points are the average of the triplicate \pm standard deviation (less than 5% of average).

The biotic sample was subjected to the APS reductase assay, which involved a 15 minutes reaction. This assay indicated the presence of APS reductase enzyme in the sample. The kit contained an antibody against the enzyme adenosine-5'-phosphosulfate (APS) reductase, which is common to all strains of SRB. The detection of the enzyme can be examined by the appearance of blue colour on the membrane device after the addition of a chromogen (provided with the kit). Darker shades of blue signify the presence of a higher count of SRB in the sample, which can be inspected by matching the colour card (as per the manufacturer guidelines).18 For the present analysis, positive and negative controls were prepared. The negative control fell into BDL range (Below Detection Limit), whereas the sample showed a positive reponse towards the reaction with $10^5 \pm 1.5$ cell per mL and the positive control showed $10^6 \pm 1.5$ cell per mL bacterial count, as depicted in Fig. 7.

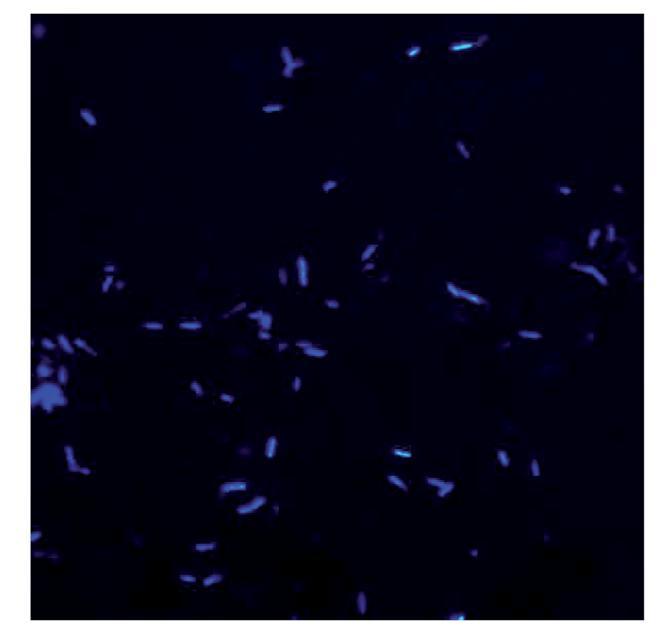
Fig. 10 Bacterial morphology under a DAPI filter, which appear to be bright blue rod-shaped with diplobacilli arrangement.

Morphology and surface analyses were performed by using DAPI and SEM (Fig. 10–13). Fluorescent dyes can be used to stain microorganisms from virtually any microbial habitat. Therefore, DAPI is a popular stain for this purpose as it targets the DNA of all bacterial cells, *i.e.*, live, dormant and dead. For the detection and monitoring of microorganisms in the pipeline industries, DAPI fluorescence is a fast and easy method.^{50,51} Fig. 10 illustrates the bacterial counts in the samples, which are in the range of $10^5-10^6 \pm 0.5$ cells per mL, with rod-shaped morphology. Although there is no well-defined reported threshold value of microbial count, increased levels of corrosive bacterial count might create a threat to the pipeline industries for bio-corrosion.

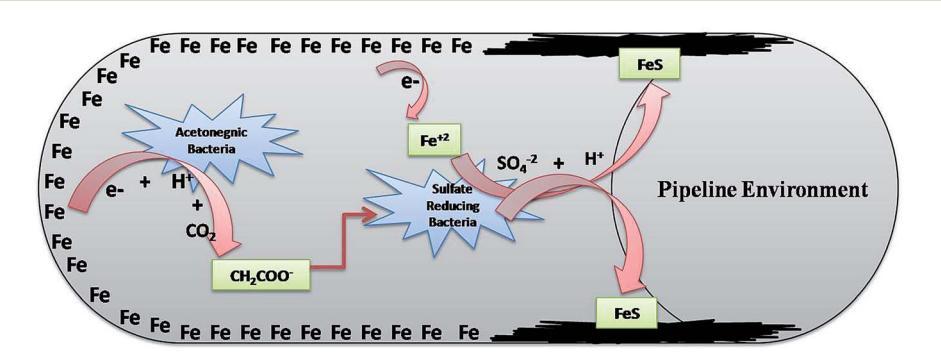
Fig. 9 The synergestic effect of the anaerobic bacterial community, where the by-product of one species acts as a carbon source for the other existing species.

show synergistic behaviour with other bacterial communities, where the by-products (small volatile fatty acids) of one species act as the carbon source for other species.^{5,13,48} As reported by Ilhan-Sungur *et al.*,⁴⁹ *Clostridium sp.* can show a corrosive effect with *Desulfovibro sp.* by providing the electron donor "hydrogen" to them. In this way, they support each other and accelerate the process of bio-corrosion. The data obtained from this analysis indicated that a mixed culture has a great potential towards bio-corrosion.

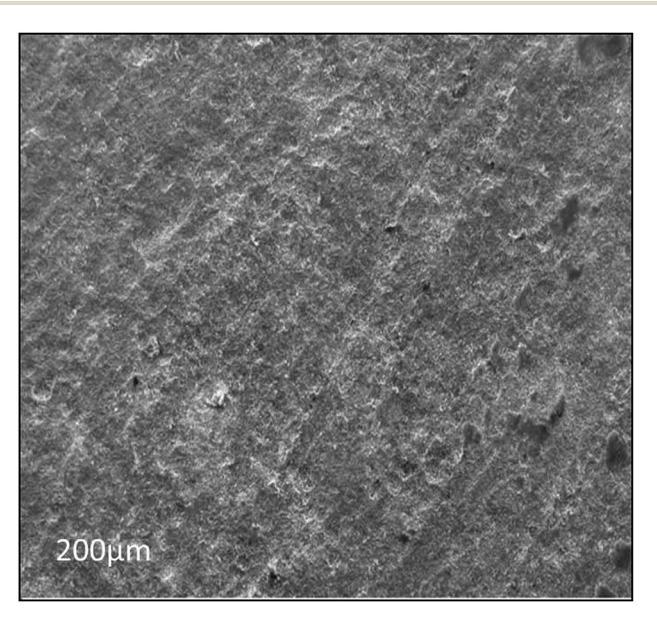
Fig. 11 The SEM image of the abiotic system, showing that the metal coupon surface is cleaned after the 28th day of incubation.

Furthermore, the level of the corrosive nature of samples was indicated by the scanning electron micrographs of the biotic coupons (Fig. 11–13). Fig. 11 represents the nature of the abiotic system (coupons in a sterile medium), whereas Fig. 12 and 13 illustrate the effect of the biotic system on the metal surface and the bacterial community responsible for corrosion. With respect to appearance, a significant difference was observed while comparing the coupons of the abiotic and biotic systems. The coupons in the abiotic system appeared clean and clear as compared to the coupons in the biotic system. In the biotic system, the bacterial community almost fully covered the coupon surface. While examining the images in Fig. 12(A–E), microscopic cracks and pits can be noticed, as indicated by the red arrows and boxes. Previous studies illustrated that corrosive bacterial species corroded the surfaces of the coupons by
