## Surface alloying of FeCoCrNiMn particles on Inconel-718 using plasma-transferred arc technique: microstructure and wear characteristics

Inconel-718 (IN-718) is a commonly used nickel-based superalloy in various fields, such as gas turbine and power generation applications. However, the lower wear and oxidation resistance hinder their wide usage. In this work, FeCoCrNiMn particles were mechanically ball-milled and preplaced on the IN-718 substrate. Then, the preplaced FeCoCrNiMn particles were scanned by heat source using plasma-transferred arc (PTA) technique. The effect of PTA alloying on the phase changes, microstructure, nanohardness and wear resistance has been investigated. The result showed that the PTA region contained different phases, such as FCC, BCC and intermetallic. No cracks were observed in the PTA alloyed region. Moreover, the porous free structure was viewed in the alloyed region, which revealed that the PTA alloying process was effectively used to perform the alloying process. More hard phases, such as NiFe, CoMn, Cr<sub>9</sub>Mn<sub>25</sub>Ni<sub>21</sub>, MnNi, FeCo, FeMn and MnCo, were formed on the PTA-alloyed region. The obtained wear rate of the substr

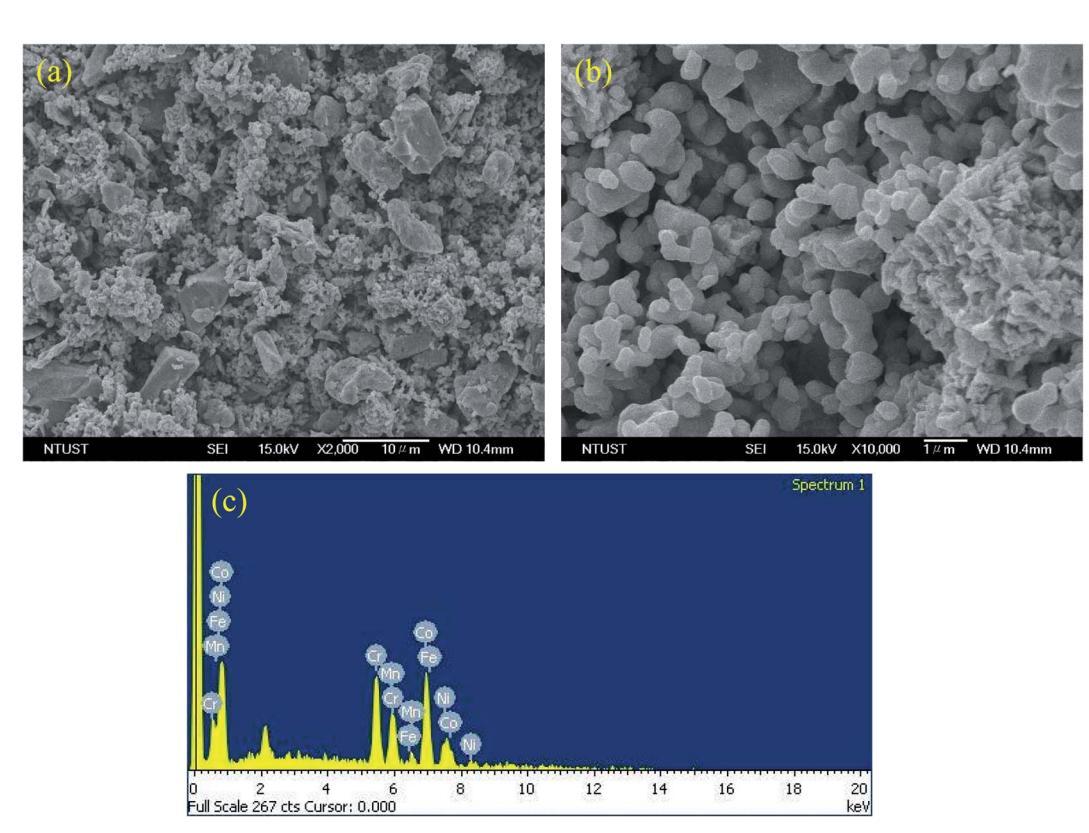
Fig. 1 (a) FESEM picture of mechanically ball-milled powder, (b) magnified view of (a), and their corresponding elemental analysis graph (c).

after 12 h is shown in Fig. 1. It mixes the different particle size powders through the mechanical alloying process. Each particle underwent multiple plastic deformations during the ball-milling process. The microstructure and morphology of the alloy particles were mixed thoroughly due to the leading role of friction and shear deformation. The results of the processing alloy powder in this ball mill process were reducing the particle size, as well as the blending of particles into new phases. Repeated processes, such as welding, fracturing and rewelding of powder particles, were involved during this blending process. Changes of the kinetic energy of the milling powder were inducted by the total amount of energy transferred to the alloy powder particles from balls during the milling process.

The reduction in the size of the particles depended on the ball size, rotational speed of the drum, alloying elements and duration of the milling time. In this study, the ball size, rotational speed of the drum and alloying elements were kept constant and the milling time was only considered up to the steady state level. The ball milling process was performed for up to 12 h. Even upon increasing the milling time beyond 12 h, there was no reduction in the size of the particles as the particles reduced the maximum exitances under this combination of the milling setups. If the ball size is reduced, then the particles size may be reduced. However, based on the availability of the facility, this milling process was restricted with this ball milling specification. Moreover, there was variation in the particles size due to variation in the hardness of the particles. The hardness of the Cr and Co elements were higher than that of the other alloying elements. The dispersal of Cr and Co powders did not exhibit any improvement with the increase of the milling time to 12 h because it was difficult to crush this element in these powders. Furthermore, we were unable to make them small due to their high hardness, causing heterogenization. As a result, the uneven distribution of the particles appeared in the FESEM image of the ball-milled powder (Fig. 1).

The EDS analysis shows that the ball-milled powders contain all essential chemical elements, such as Fe, Co, Cr, Ni and Mn. The cross-section of the PTA-alloyed region is shown in Fig. 5. Fig. 5(a) was taken by using an optical micrograph, whereas Fig. 5(b and c) were taken by using field emission-scanning electron microscopy. The cross-section of the PTA-treated sample contained the PTA-alloyed region, interface region and substrate region. The thickness of the alloyed region was measured along the line perpendicular to the direction of the movement of the PTA torch. The measured thickness of the alloyed region was 200  $\mu$ m, which is clearly visible in Fig. 5(a). Fig. 5(b) shows the interface region of the PTA-alloyed region and substrate material. Based on the EDS analysis, the dark gray color areas in Fig. 5(b) were rich in Co

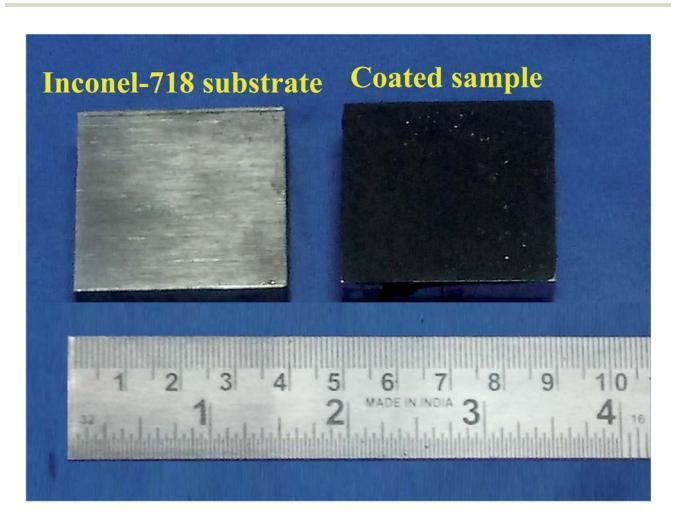
Fig. 2 Macropicture of Inconel-718 substrate and coated samples.

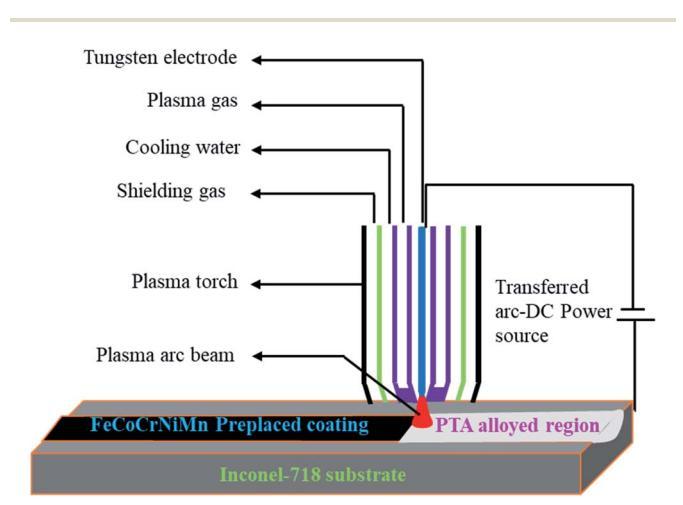
Fig. 3 Schematic representation of PTA alloying process.

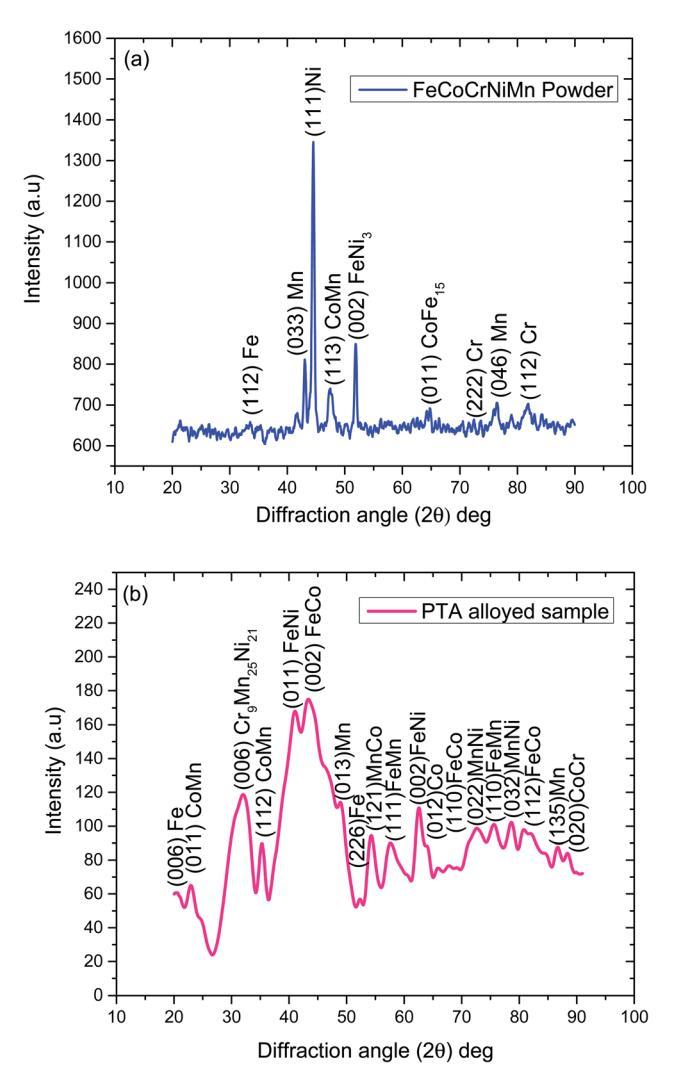
Fig. 4 XRD analysis of: (a) FeCoCrNiMn powder, (b) PTA alloyed sample.

XRD analysis was performed on the ball-milled FeCoCrNiMn particles, and their corresponding peak locations were studied. The ball-milled powders induced frictional collision between the elements in the alloy system. This frictional collision resulted in the formation of some secondary phase particles. Notably, a few broadened peaks were observed at about  $2\theta = 40^{\circ}$  to 55°. Moreover, it confirmed the presence of all alloying elements in the ball-milled powder. Some compound phases, such as CoMn, FeNi<sub>3</sub> and CoFe<sub>15</sub>, were also traced in this XRD analysis. Fig. 4(a) shows the XRD spectrum of the powder materials.

Fig. 4(b) shows the XRD analysis of the PTA alloyed surface. During the PTA alloving process, the preplaced FeCoCrNiMn coating and the top surface of the Inconel-718 substrate were molten simultaneously. The molten pool of the preplaced coating, along with the dilution of top surface of the Inconel-718 substrate, was formed rapidly. The alloying elements Fe, Co, Cr, Ni and Mn in the preplaced coating were very rapidly dissolved in the molten pool. The molten pool that contained the alloyed elements were solidified after the forward movement of the plasma arc. The XRD pattern revealed that the FeCoCrNiMn-alloyed PTA region contained different phases, such as FCC, BCC and intermetallic.19 Most of the alloying elements were formed in the compound phase, which shows that the high specific energy density of the plasma transferred arc results in sufficient dissolution of alloying elements in the Inconel-718 substrate. It was found that the alloyed region included CoMn, CoCr, Cr<sub>9</sub>Mn<sub>25</sub>Ni<sub>21</sub>, FeNi, MnNi, FeCo, FeMn and MnCo. Miller indices of (h,k,l) values were identified by X'Pert high score software. In the BCC phase, the reflection is allowed only when h + k + l is an even value.<sup>20</sup> In the FCC phase, reflection is allowed only when h, k and l are all odd or all even (unmixed). Based on these rules, (011) CoMn, (110) FeCo, (011) FeNi, (013) Mn, (112) CoMn, (121) MnCo, (110) FeMn, (112) FeCo, and FeCo were identified as the BCC phase. (111) FeMn and (135) Mn were identified as the FCC phase. (006) Fe, (022) MnNi,

(006) Cr<sub>9</sub>Mn<sub>25</sub>Ni<sub>21</sub>, (002) FeCo, (226) Fe, (002) FeNi, and (020) CoCr all obey both the rules. Hence, these phases are concluded as either BCC or FCC phases. (032) MnNi, (135) Mn and (012) Co are the phases that do not obey any of the above rules. Consequently, these phases are concluded as intermetallic phases.

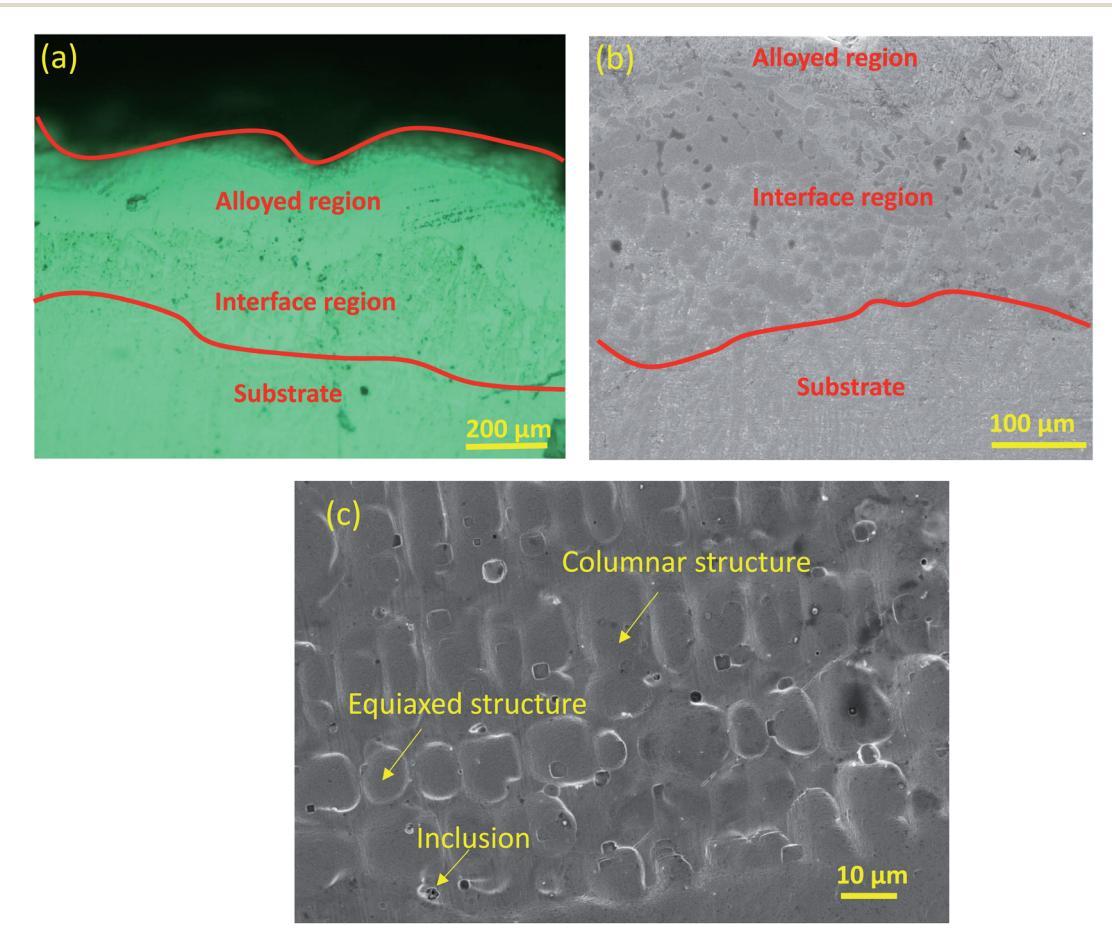
Fig. 5 (a) Cross-sectional view of PTA alloyed region with their thickness, (b) FESEM image of interface region, (c) alloyed center region with showing columnar and equiaxed structure.

and Mn elements that are dispersed non-uniformly with irregular shapes. The gray color areas are rich in Ni, Fe and Cr elements.

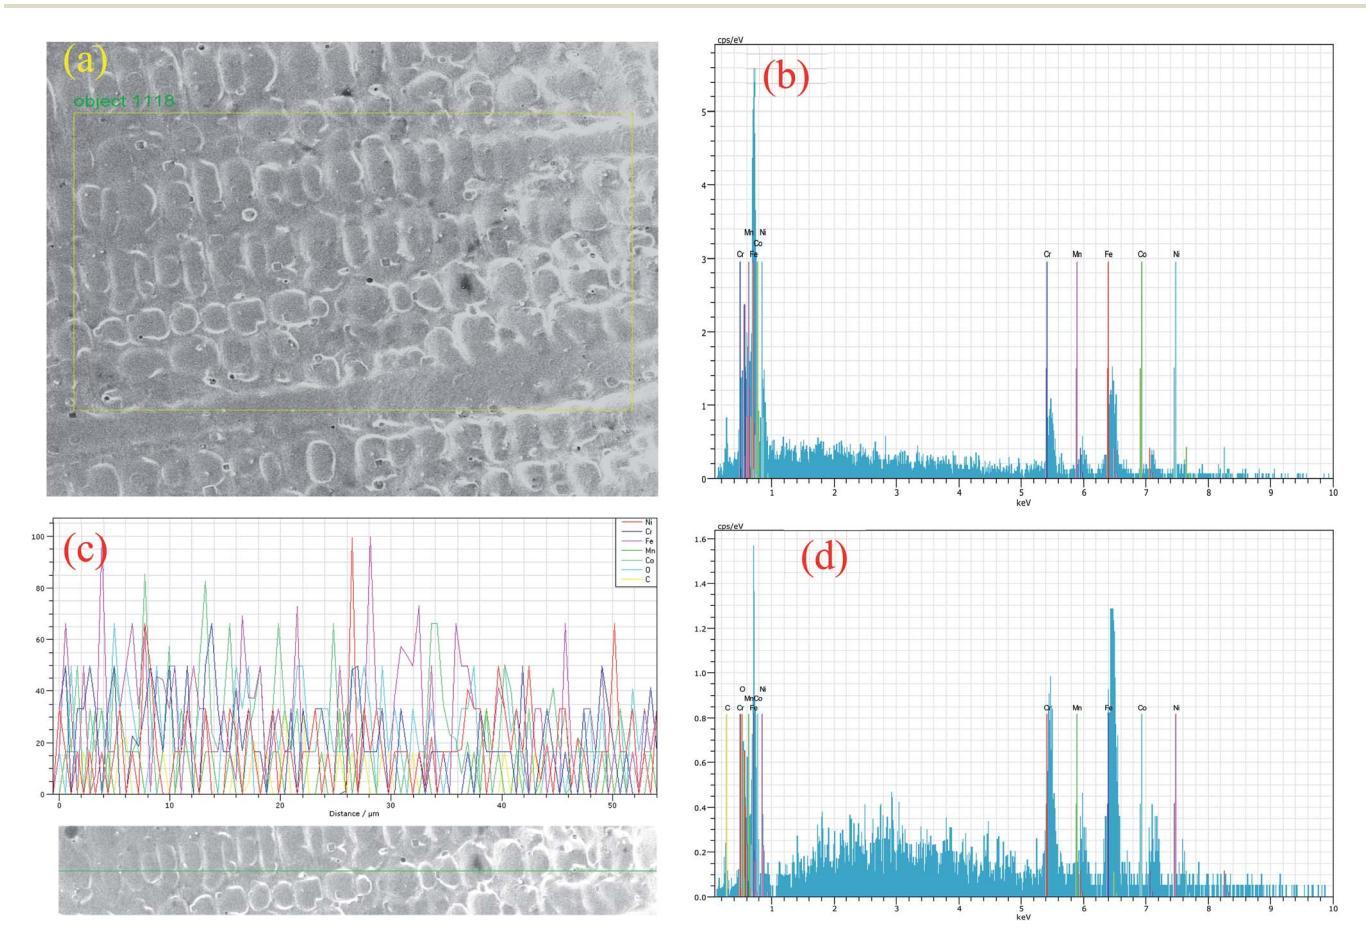
Fig. 6 (a) FESEM images of PTA alloyed region, corresponding EDS graph at: (b) area analysis, (c) line analysis and (d) point analysis.

Fig. 6(a-d) shows the EDS analysis of the PTA-alloyed region. The obtained EDS analysis indicates the presence of all alloying elements after the PTA process [Fig. 6(b)]. Table 3 lists the presence of elements obtained in the PTA-alloyed region. The elements Fe, Cr and Ni are observed as major elements with atomic wt% of 32.48, 25.59 and 16.48, respectively. The remaining positions are occupied by Mn and Co. Therefore, it is confirmed that the Fe element constitutes the matrix material for this PTA-alloyed system. The EDS analysis has proved that the diffusion of the elements of the substrate has never occurred in the central zone of the surface-alloyed region. The heat input by PTA has been majorly utilized for the melting of the alloying elements, and very meagerly utilized to melt the substrate for bonding. Therefore, the diffusion of the elements of the substrate was restricted. Fig. 6 (c and d) shows the EDS result of the interface region and substrate. This line and point scan indicate that the diffusion of major alloying elements, like Ni, Cr, Co, Fe and Mn, has occurred on either side; especially, diffusion mainly occurred on the substrate side. The EDS analysis clearly indicates that the surface treatment completely protects the Inconel-718 substrate, and no trace of the substrate chemical elements is found in the treated layer.

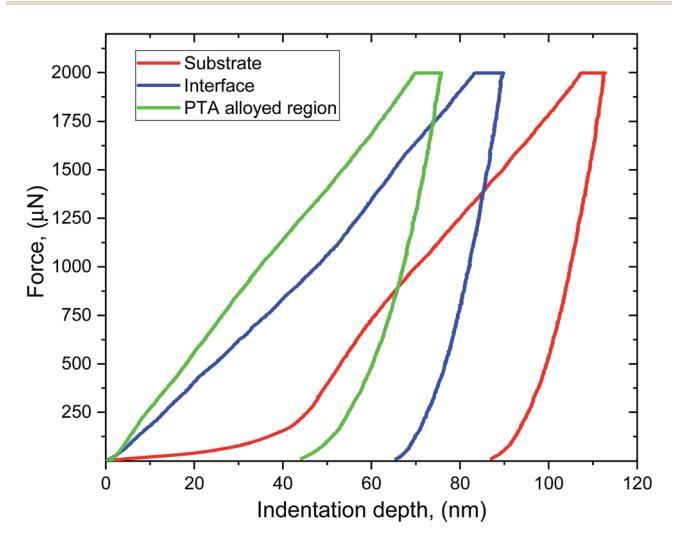
Fig. 7 Nanohardness profile of PTA alloyed, interface, substrate region.

Hardness is one of the important properties of the material performance, as it is closely associated with the wear resistance of the specimen. Fig. 7 shows the nanohardness profile of the substrate, interface and PTA-alloyed surface. The nanohardness of the substrate, interface and PTA-alloyed layer were 2.921 GPa,

4.051 GPa and 5.157 GPa, respectively. The main factors that affected the nanohardness of PTA alloying included the element contents and grain size of the alloyed region. The PTA treatment melted the alloy powders on the substrate surface, and rapid solidification occurred during the raster scanning of PTA. Owing to the rapid solidification process of the PTA alloyed region, the grains were refined as fine particles. This rapid solidification initiated the hard phase compounds in the matrix surface.22 During the measurement of nanohardness, an external force was applied on the grains that induced the plastic deformation of the grains. The PTA-alloyed region had fine grains that dispersed the plastic deformation to more grains instead of single grains. As a result, stress acting on each grain was reduced that led to an increase in the nanohardness of the alloyed region. Besides, the Co element increased the solubility of the Cr element in the Inconel-718 substrate. The Co element in the alloyed and interface regions improved the high temperature property. Consequently, the nanohardness of the alloying region increased. The nanohardness of the interface region decreased most notably owing to the lack of a hard phase and the alloying elements. Moreover, the solid solution strengthening of the Fe, Co, Cr, Ni and Mn alloying elements increased the hardness of the alloved region.

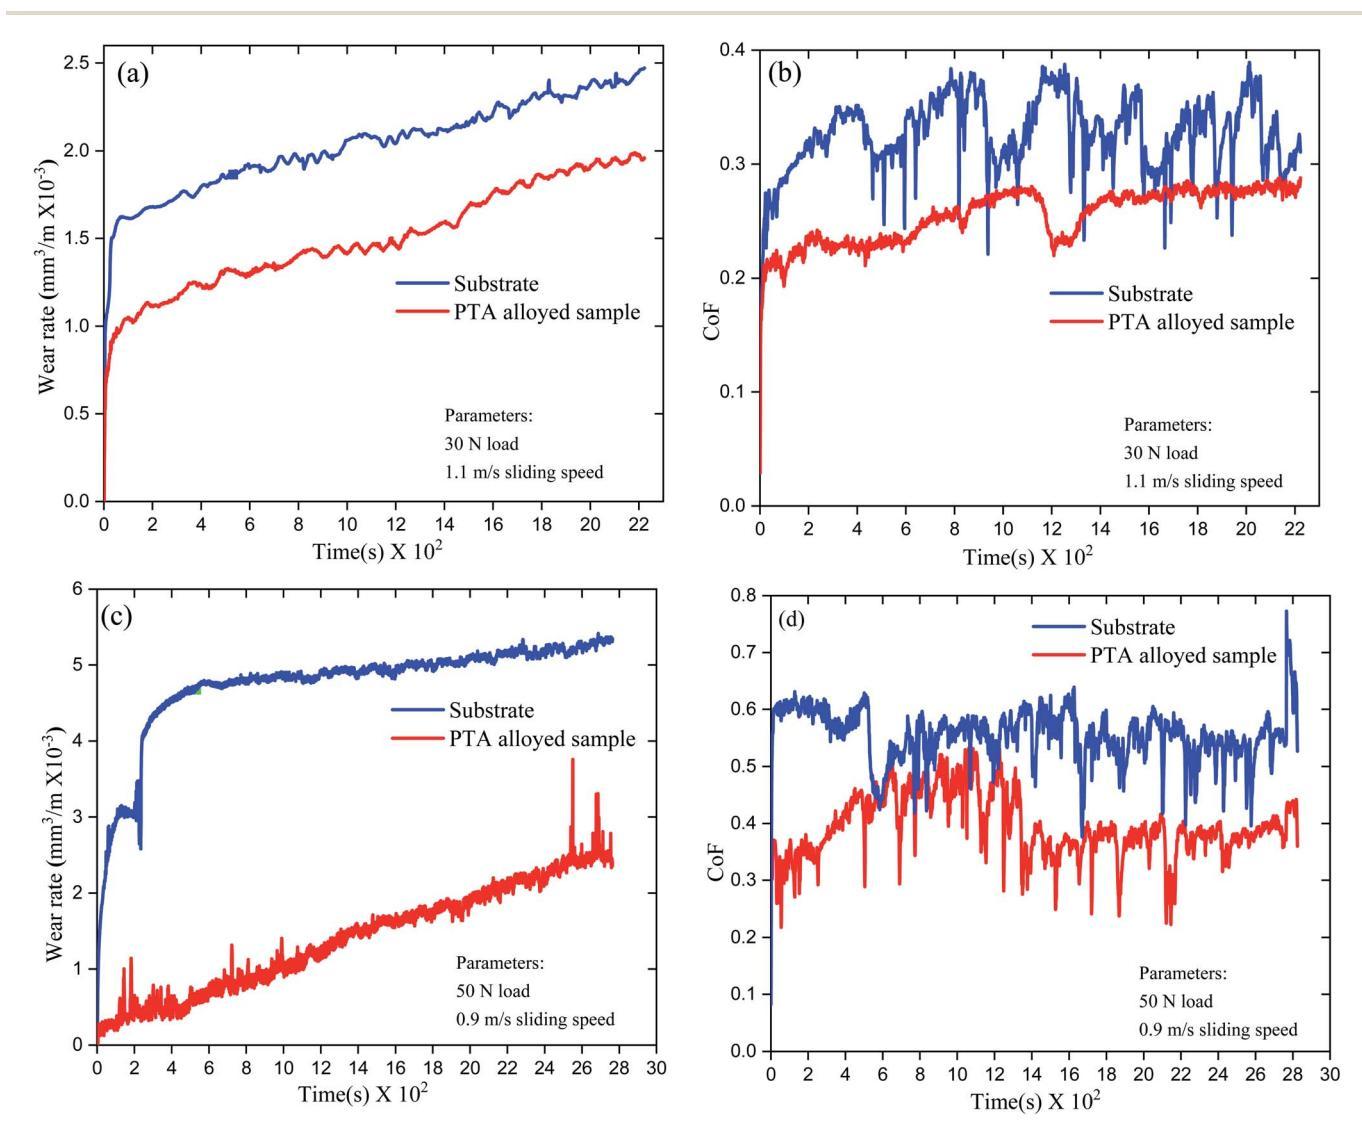
Fig. 8 (a and b) The obtained wear rate and co-efficient of friction graph at the applied load of 30 N, (c and d) wear rate and co-efficient of friction graph at the applied load of 50 N.

Fig. 8(a and c) show the wear rates of substrate and PTA alloyed samples at different input parameter conditions. The wear rate of the substrate specimen at 30 N applied load is  $2.45 \times 10^{-3}$  mm<sup>3</sup> m<sup>-1</sup> and for the PTA specimen, it is  $1.79 \times 10^{-3}$  mm<sup>3</sup> m<sup>-1</sup>. Similarly, the wear rate of the substrate specimen at 50 N is  $5.38 \times 10^{-3}$  mm<sup>3</sup> m<sup>-1</sup> and for the PTA sample, it is  $2.29 \times 10^{-3}$  mm<sup>3</sup> m<sup>-1</sup>. Comparison of the wear rates of the substrate and PTA specimen revealed that the PTA surfaces showed significantly improved wear resistance. Moreover, an increase in the applied load increased the wear rate in both substrate and PTA surfaces. The untreated surface tested at 50 N of applied load showed higher wear rate than the rest of the samples.

Fig. 8(b) shows the CoF of the untreated and treated samples tested at an applied load of 30 N. The CoF of the untreated sample shows an increasing trend from 0 to 0.4 at 400 s. Then, a sudden drop has occurred at 500 s, gradually increasing up to 1200 s. A similar drop in CoF is observed at 1200 s, 1400 s and 1700 s. The maximum drop of 0.25 CoF is observed at 1000 s. The initial steep increase in CoF resulted from the resistance of asperities for deformation. The frictional force minimizes when the asperities started deforming. However, the fractured asperities accumulated in the sliding path and acted as an obstacle for the forward sliding. Moreover, the fractured asperities cold-welded with the existing asperities, and formed a plasticized layer. The effect of accumulation of fractured asperities and formation of thin layer increased the frictional force to deform them. Then, the reduction of frictional force happened due to less resistance for deformation. This cycle continued until the completion of the wear test. The lower surface hardness and higher ductility are the cause for this variation of CoF in the untreated sample.

Fig. 8(b) also shows the CoF of the treated specimen tested at an applied load of 30 N. It can be observed that the CoF shows minimum fluctuations compared with the untreated sample. CoF increases up to 0.28 at 250 s. Then, a slight drop to 0.22 occurred after 250 s to 750 s. A steady increase in CoF up to 0.26 happened at 1250 s. A sharp drop in CoF occurred after 1200 s, and was retained up to 1500 s. After 1500 s, CoF has recovered and stabilized until the end of the test. Compared to the untreated sample, the fluctuations in the frictional forces are low in the treated sample. Initially, frictional forces were low during the test. However, when the test time increased, the frictional forces increased with time and attained a maximum around 1000 s to 1250 s. The PTA-alloyed surface improved the surface hardness significantly. Thus, a minimum deformation of the asperities occurred during the initial stages of the test. However, accumulation of the deformed asperities along the sliding path increased the frictional force for further deformation. The sudden decline of frictional forces was due to the bulk deformation of the accumulated thin layer of the deformed asperities. Then, the frictional forces have been regained and stabilized.

Fig. 8(d) shows the CoF of untreated samples tested at an applied load of 50 N. During the starting of the test, CoF of the untreated sample increased to 0.62 and was maintained with minor fluctuations up to 300 s. After 500 s, a sharp decline in the frictional force has been observed and major fluctuations happened over the testing. Absence of the cyclic variation in CoF was observed in 50 N loading condition compared with 30 N loading. The irregular high intensity asperities in the untreated surface have cold-welded with the counter material, and increased the frictional force at the initial stage. When the applied load exceeded the frictional resistance of the cold-welded asperities, a huge deformation occurred. Thus, it

Fig. 8(d) shows the CoF of the treated specimen at 50 N applied load. It can be observed that the treated specimen showed lower CoF than the untreated sample. In addition to that, wide fluctuations in the frictional forces are observed. The frictional forces are increasing over the testing time up to 0.45 at 500 s. A sharp decline in the frictional force occurred at 500 s. Then, it slightly increased to 0.50. This decline and recovery of CoF was observed throughout the test period. However, after 1500 s testing period, CoF reduced from its maximum range, and there were continuous fluctuations until the end. The surface-alloyed Inconel-718 improved the hardness through various particle elements. The minimum deformation of the surface asperities happened during the wear testing due to the increased hardness. The presence of intermetallic compounds and improved hardness prevented the crack propagation. The fluctuations in the CoF indicate the variations in the deformation behaviour of asperities. Decline of CoF after 1500 s of test time shows the stabilization of the surface with minimum deformation of the surface asperities. Even at increased applied load, due to increased surface hardness, the minimum deformation of asperities resulted with a reduction of the frictional forces.

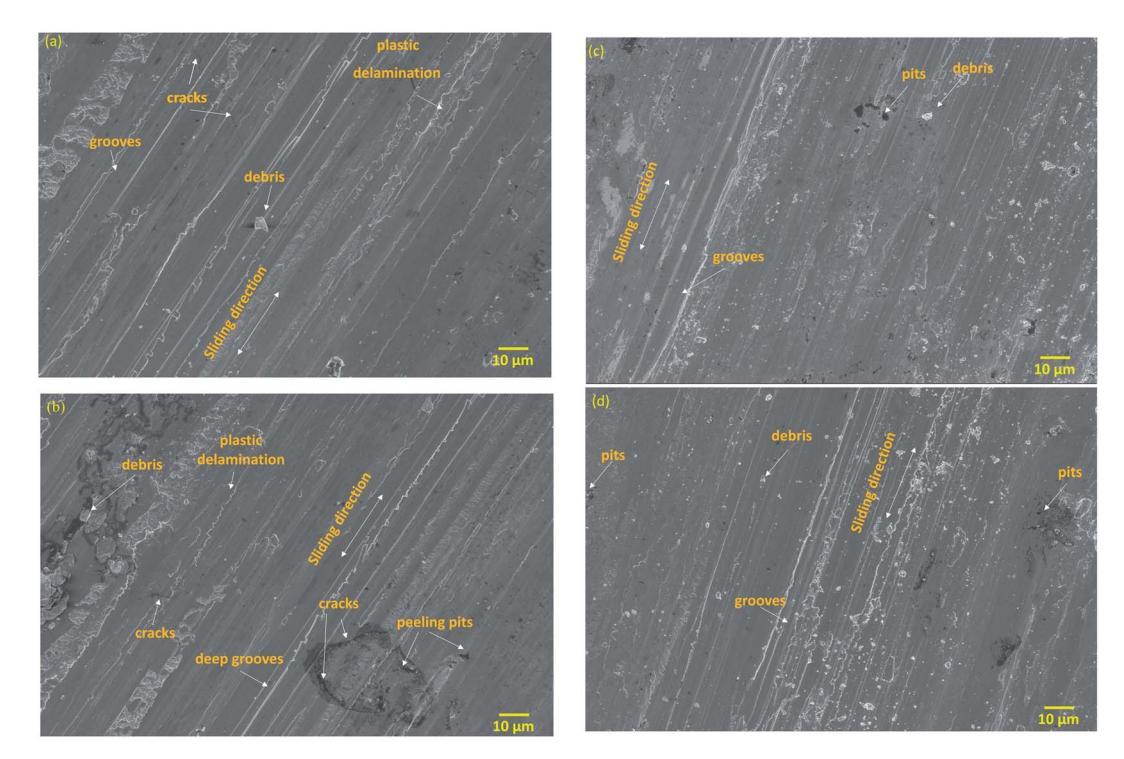
Fig. 9 Worn-out surfaces: (a and b) substrate at 30 N and 50 N load, respectively. (c and d) PTA alloyed specimen at 30 N and 50 N load, respectively.

Fig. 9(a) shows the worn-out surfaces of the substrate specimen at an applied load of 30 N. Fig. 9(a) shows the combination of adhesive and abrasive wear losses in the worn-out substrate surface. Lower hardness of the substrate accelerated the adhesive wear losses. Adhesive tendency in the substrate material varied with the nature of asperities in it. Furthermore, it is clear that a few areas in the substrate have experienced abrasive wear losses. The compressive stresses were induced in the substrate surface due to the applied load. Due to the lower surface hardness, this compressive stress initiated microcracks and plastic deformation. Fig. 9(b) shows the worn-out surface of the substrate at 50 N load condition. The worn-out surface indicates severe abrasive and adhesive wears. Along with the abrasive and adhesive wear, microcracks and plastic deformations are also observed. The adhesive wear dominated the worn-out surface of the substrate. Higher adhesive wear was attributed to the lower hardness of the substrate surface. Adhesive tendency of chemical elements like Al and Ni with the counter material during sliding increased the adhesive wear in the substrate material. Since adhesive wear was the dominant wear mechanism in the substrate, a few abrasive grooves were observed along with the adhesively worn-out areas. These abrasive losses occurred due to repetitive contact of the counter material with the adhesively bonded substrate on them.

Fig. 9(c) shows the worn-out surface of the treated surface at 30 N load condition. The worn-out surface revealed that wear losses were minimal and dominated by abrasive wear losses. A few narrow and shallow abrasive grooves were present in the worn-out surface. The absence of or a negligible amount of adhesive wear losses was observed. Improved hardness of the treated surface restricted the

adhesive wear losses and plastic deformation due to compressive stresses. Fig. 9(d) shows the worn-out surface of the PTA alloyed specimen at 50 N applied load. The worn-out surface shows the abrasive grooves. The wear type of the PTA alloyed specimen consisted of mild abrasion with oxidative wear. Different oxides were formed during the wear test and protected the PTA-alloyed surface. The results have shown that the heterogeneous oxidation film forms on the worn-out surface. The oxidation layer on the PTA-alloyed

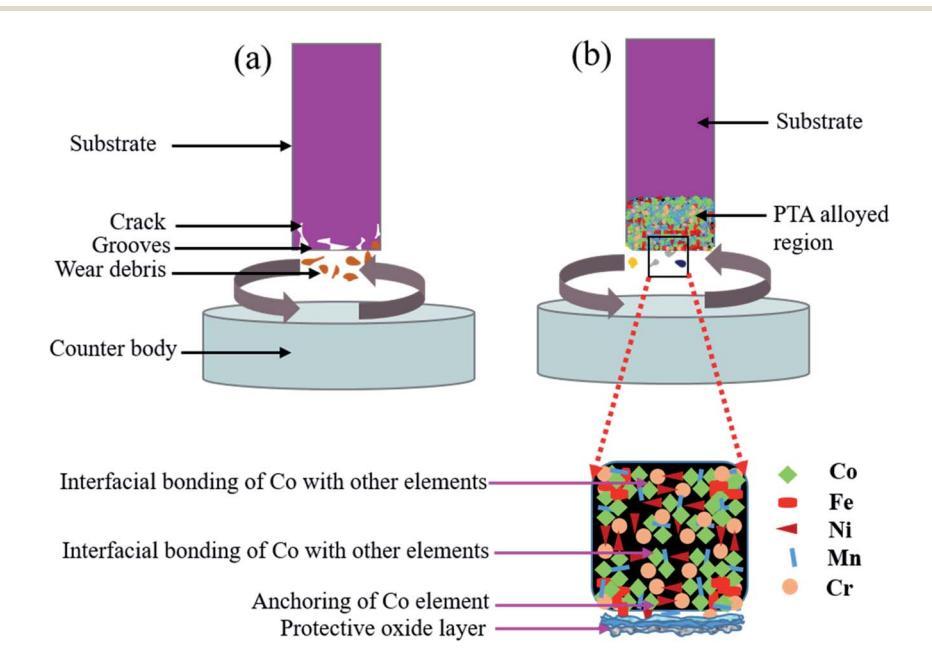
Fig. 10 Schematic representation of wear mechanism: (a) substrate showing with crack, deformation and deep grooves, (b) PTA alloyed specimen showing with mild and small grooves.

A schematic representation of the wear mechanism in the Inconel-718 substrate and the PTA alloyed specimen is shown in Fig. 10. During the wear test, the formation of thick oxide layers on the worn-out surface was followed by frictional heat generation. However, the bearing capacity of the Inconel-718

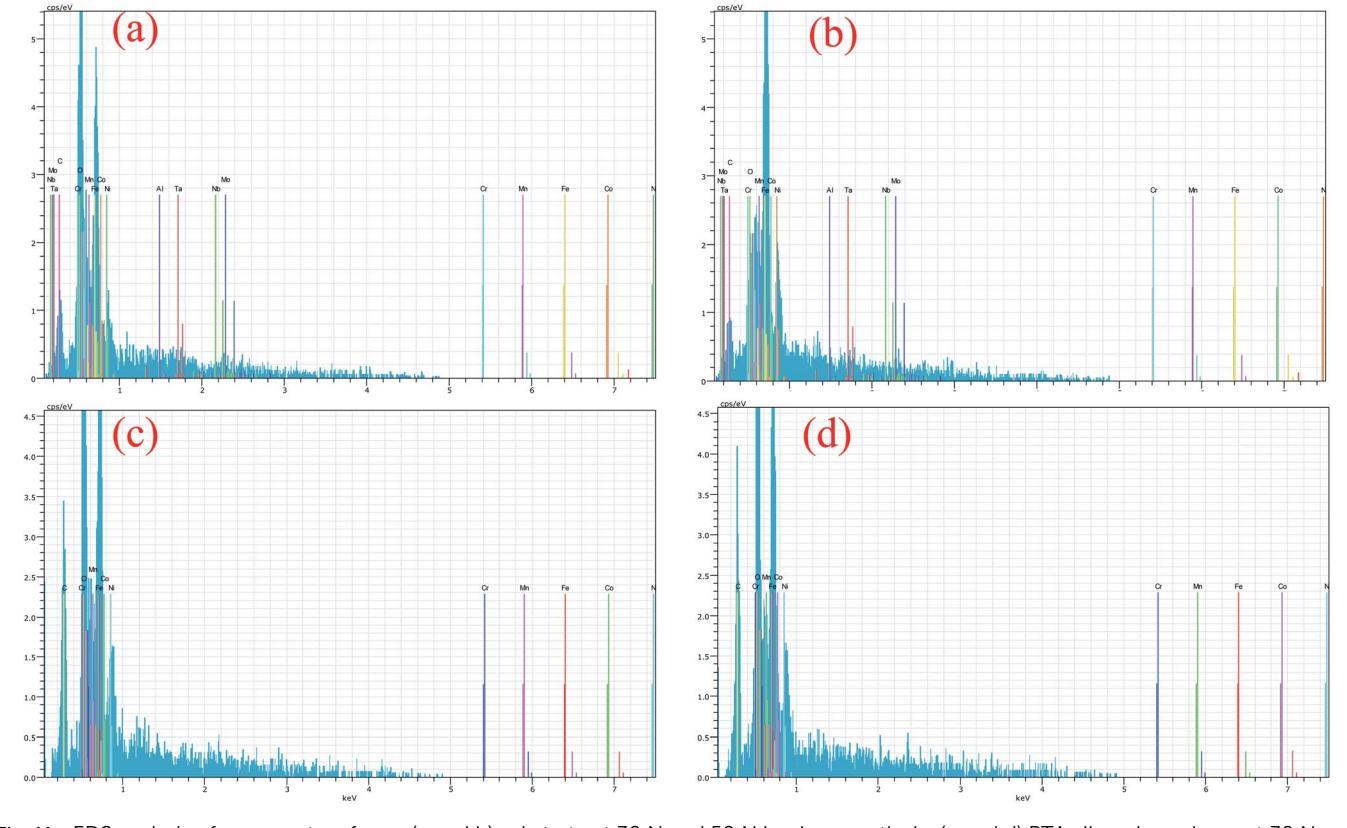
Fig. 11 EDS analysis of worn-out surfaces: (a and b) substrate at 30 N and 50 N load, respectively. (c and d) PTA alloyed specimen at 30 N and 50 N load, respectively.

The EDS results [Fig. 11(a and b)] of the worn-out surface indicate that the reduction of the Al and Ni elements in the

substrate is advocating the concept of adhesive wear loss due to those elements. Table 4 shows the detailed EDS results with their elemental percentages. While increasing the applied load, the adhesiveness of the substrate surface with the counter material increased and deformed drastically during sliding. The EDS [Fig. 11(c and d)] results proved that the worn-out surface contains the FeCoCrNiMn chemical elements with the absence of the substrate chemical elements. No traces of substrate chemical elements were found on the worn-out surfaces. Moreover, the presence of oxides in the worn-out surface acted as a barrier and protected the treated surface from an aggressive environment. This indicates that the PTA alloyed treatment significantly improved the surface protection.

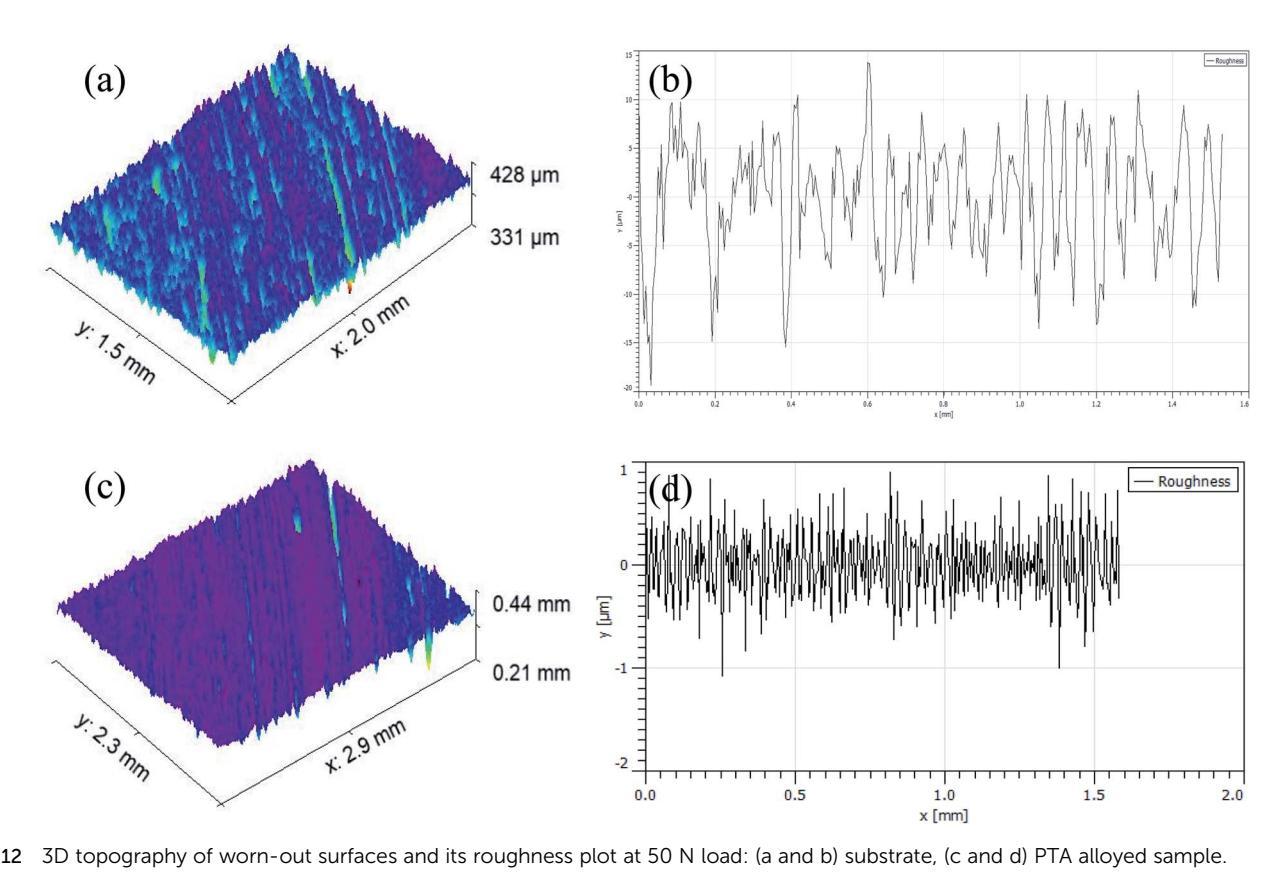
Fig. 12(a and b) shows the 3D topography, and the corresponding roughness profile of the worn-out untreated surface at 50 N load. The 3D topography shows numerous wear scar marks on the untreated surface, and these wear scar marks are deeper and wider. The 2D topography indicates that the surface undulations are very rough, and that deeper wear scars are present in regular intervals. The average surface roughness  $(R_a)$  of the worn-out untreated surface is measured as 6.31 µm. Fig. 12(c and d) shows the 3D topography, and the corresponding roughness profile of the worn-out PTA-alloyed surface at 50 N load. The 3D topography shows the minimum scar marks and losses. In addition to that, the absence of deep grooves is observed in the 3D topography. The 2D topography indicates that the wear scar depths are shallow and lower than the untreated surface. The PTA-alloyed surface with FeCoCrNiMn particles has significantly improved the hardness and minimized the wear losses.32 The average surface roughness of the PTA alloyed worn-out surface has been measured as 4.81 µm. This reduced roughness indicates the effect of the surface alloying on the Inconel-718.
