RSC Advances

Cite this: RSC Adv., 2021, 11, 29323

Understanding the effect of HF-based wet shallow etching on optical performance of reactive-ionetched fused silica optics[†]

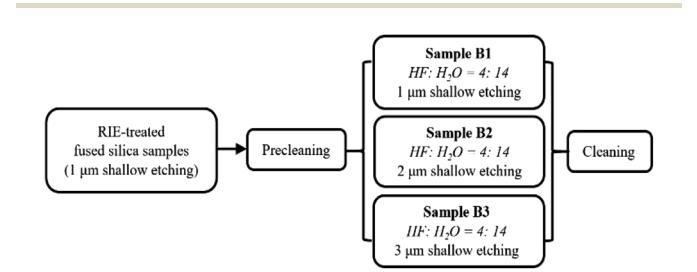
Fig. 1 Preparation of the samples for HF shallow etching with different depths.

Seven square polished fused silica samples (Corning 7980) were utilized for the etching experiments. All the samples (named A, B1, B2, B3, C1, C2, and C3) were typically 50 mm in side-length and 5 mm in thickness. The polishing of each sample was conducted *via* the same process utilizing $0.4 \,\mu\text{m CeO}_2$ abrasives. Sample A was not etched to be kept as a reference. For other samples, two types of wet etching processes were performed using HF or HF/NH₄F chemical solution.

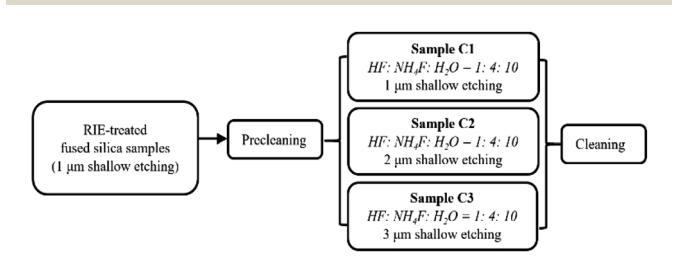
Fig. 2 Preparation of the samples for HF/NH_4F shallow etching with different depths.

The RIE-pretreated samples were then treated again using dynamic cleaning and an HF-based chemical etching technique (described as DCE in our previous study²²). Two sets of three samples were treated with different HF-based etching depths (1 μ m, 2 μ m, and 3 μ m, respectively), as summarized in Fig. 1 and 2. The first set (samples B1, B2, and B3) are the polished surfaces treated with RIE and HF etching, while the second set (samples C1, C2, and C3) are the polished surfaces that underwent RIE followed by HF/NH₄F etching. The HF/NH₄F etchant, which was more commonly used in our previous study, consists of HF (49 wt%), NH₄F (30 wt%), and H₂O (ultra-pure water) with a volume ratio of 1 : 4 : 10. We chose an HF-only (49 wt%) solution containing approximately 78 vol% H₂O because its etching rate (100 nm min⁻¹) was equal to that of the HF/NH₄F solution we typically used.

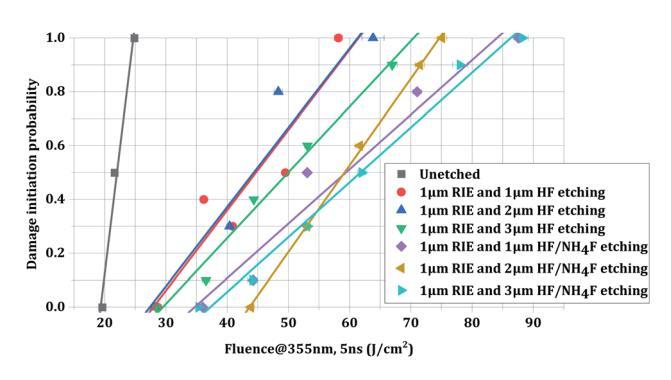
Fig. 3 Laser damage probability of various surfaces treated with different HF-based etching processes. The quality factor (peak energy/ average energy) of the laser beam spot was approximately 2.2. The energy density uncertainty of the testing system is 4.5%.

After RIE and HF-based etching, the treated samples and the aspolished sample were subjected to the LIDT test. Fig. 3 shows the relationship between the laser fluence and the 1-on-1 damage probability of the samples. Similarly to in our

previous work,^{23,25} the damage threshold of the combined etched surface was much higher than that of the unetched surface. This great improvement was attributed to the effective removal of the subsurface damage layer, which contains abrasive residues and other polishing-induced contaminants. It can also be noted from the figure that the second set of samples (those treated with RIE followed by HF/NH₄F etching) exhibited an increased LIDT compared to the first set of samples (those treated with RIE followed by HF etching). The results indicated that the addition of NH_4F to the HF solution was beneficial for improving the LIDT of fused silica.

As shown in Fig. 3 and Table 1, a significant improvement in the laser damage threshold was observed for all the samples treated with the combined etching process. The morphology of the damage sites shown in Fig. 4 also indicated that the combined etching can form a relatively pure fused silica optical surface with a homogeneous damage precursor type. This improvement has been largely attributed to the traceless removal of the fractured subsurface defects, which either absorb laser energy or cause field intensification.22 The etchants utilized in the wet etching play an important role in fully exploiting this technique. Combined treatment using 1 µm RIE and shallow HF etching can achieve at most a 1.60-fold enhancement in the 0% probability damage threshold (sample B3). A further increase in damage threshold (up to 2.3 times for sample C2) can be created by adding a certain amount of NH₄F to the HF solution. Based on the previous study by Suratwala,13 ammonium hexafluorosilicate $[(NH_4)_2SiF_6]$ precipitate can form when using HF/NH₄F as an etchant, and the solubility of SiF_6^{2-} scales inversely with the square of the ammonium fluoride concentration. The precipitation reaction and corresponding solubility of SiF_6^{2-} are given by

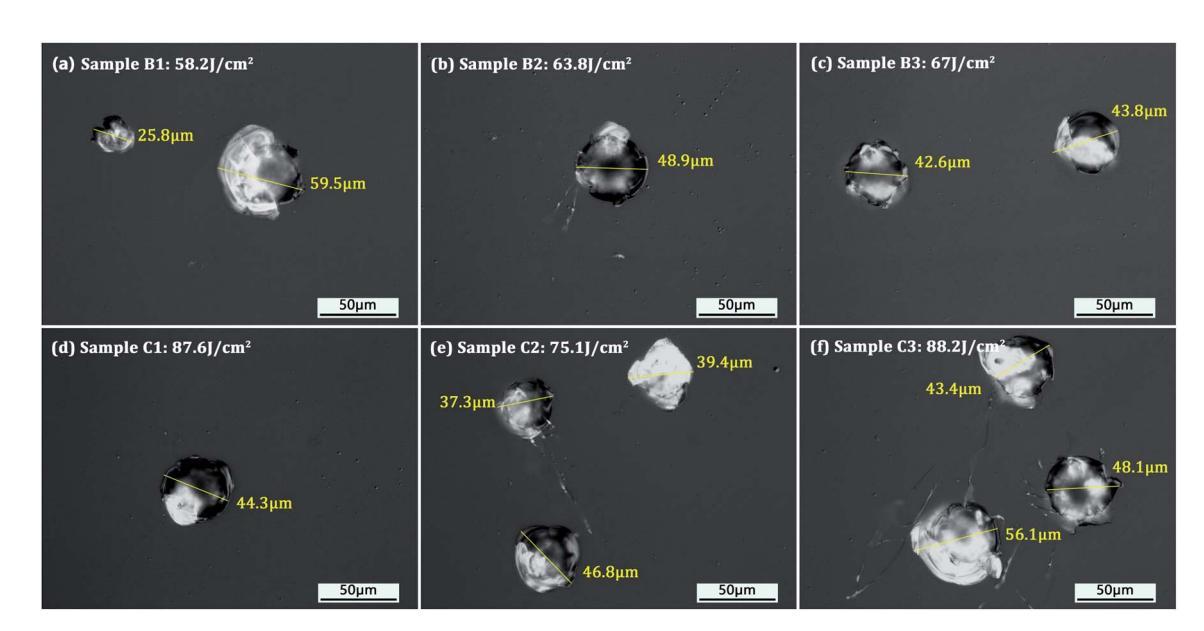
Fig. 4 Morphology of 100%-probability laser-damaged locations of the two sets of the combined etched samples. The first row of images (a-c) shows the damage sites on the HF-etched fused silica surfaces. The second row (d-f) shows the damage sites on the HF/NH₄F-etched fused silica surfaces. The laser fluence for each sample is noted. The yellow line across each damage crater indicates the approximate size (ranging from 25.8 μ m to 59.5 μ m) of the crater.

The surface morphologies of the 100%-probability laserdamaged locations for the two sets of the combined etched samples are illustrated in Fig. 4. No obvious differences in the damage morphologies of the samples were observed, regardless of which HF-based etchant or etching depth was chosen. The morphologies of the damage sites are generally smooth and disperse, and exhibit small microscale ablation craters (\sim 20 µm to \sim 60 µm wide), suggesting that the damage precursors were relatively homogeneous. The formation of these smooth craters might be attributed to the energy deposition and shockwave acceleration at high laser fluence.²⁶ In this case, the molten residues were substantially removed from the damaged craters. Additionally, slight amounts of ejected materials were observed near the edges of several craters (see Fig. 4(b), (e), and (f)), which was probably due to redeposition after fast ablation and vaporization of the materials. In Fig. 4(f), it can also be noticed that the damage produced plastic deformation near the craters.

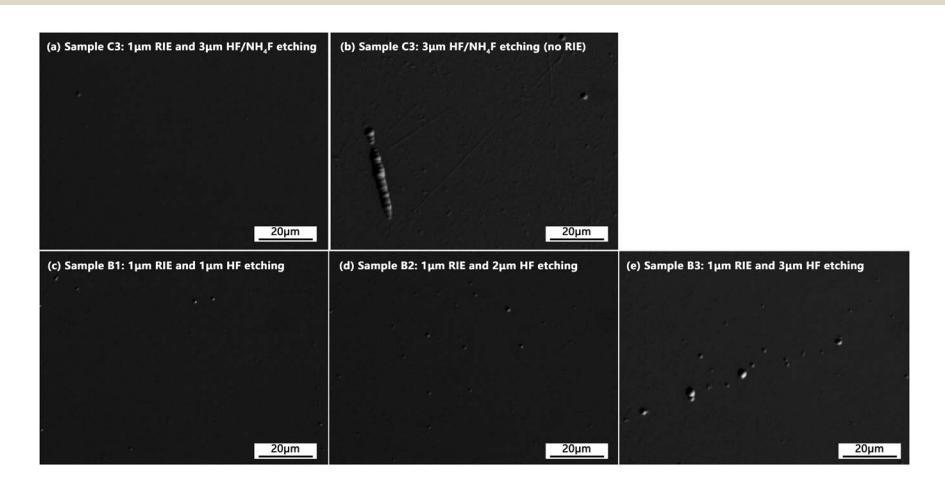
Fig. 5 Optical micrographs showing representative surface morphologies of the etched samples. (a) Sample C3 (exit surface): $1 \mu m$ RIE and $3 \mu m$ HF/NH₄F etching, (b) sample C3 (entrance surface): $3 \mu m$ HF/NH₄F etching, (c) sample B1: $1 \mu m$ RIE and $1 \mu m$ HF etching, (d) sample B2: $1 \mu m$ RIE and $3 \mu m$ HF etching, and (e) sample B3: $1 \mu m$ RIE and $3 \mu m$ HF etching.

Fig. 5 shows representative surface morphologies (undamaged locations) of the etched fused silica samples (samples C3, B1, B2, and B3). For sample C3, the morphologies of both the laser entrance (3 μ m HF/NH₄F etching) and exit surfaces

(combined etching) are given. The morphology results of samples C1 and C2 are not given because there were no obvious differences among the three HF/NH₄F-etched sample surfaces (at least for the observed results using $500 \times$ optical microscopy, see ESI[†]). It can be seen from the figure that the morphologies of the surfaces treated with the combined processes are very similar to each other. All the treated surfaces were very smooth without visible scratches or micro-cracks except for several lowdensity micro-pits. On the contrary, the entrance surface treated with only 3 µm HF/NH₄F etching presents a large number of scratches, which had been passivated by the HF/NH₄F solution, as shown in Fig. 5(b). The results suggested that the shallow combined etching process was very effective for tracelessly removing the fractured defects in the subsurface layer of the polished fused silica optics. However, the etched surfaces treated with RIE followed by HF etching exhibited slightly more micro-pits, which was indicative of the fact that this HF etching step might treat the subsurface fractured defects more isotropically. It is difficult to obtain the distribution of these isolated point defects; however, the SC imaging shown below can be used as an efficient tool for examining them.

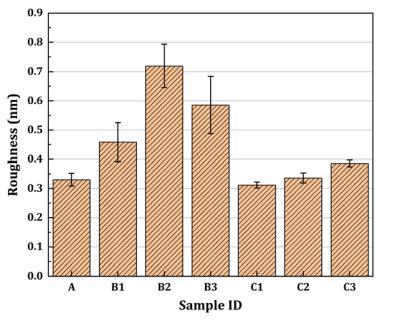
Fig. 6 Roughness R_q (at the sub-millimeter scale) of the as-polished surface and surfaces treated with RIE followed by HF or HF/NH₄F wet etching with different etching depths. The error bars indicate the standard deviation of the measured R_q values.

We then compared the surface roughness of the two sets of treated fused silica samples after RIE followed by HF-based etching, as well as that of the as-polished sample. In Fig. 6, each bar represents the mean R_q value of all the measured points on each sample surface. The unetched sample surface had a relatively low roughness (0.33 nm). The surface roughnesses of the samples treated with RIE followed by HF etching increased significantly (from 0.46 nm to 0.72 nm) as the etching depth was increased to 2 μ m, but decreased to 0.59 nm after 3 μ m etching. For the HF/NH₄F etched surfaces, the surface roughness increased slightly with the etching depth, and the variations in the R_q value were less than 0.1 nm. The maximum R_q value was only 0.39 nm (sample C3).

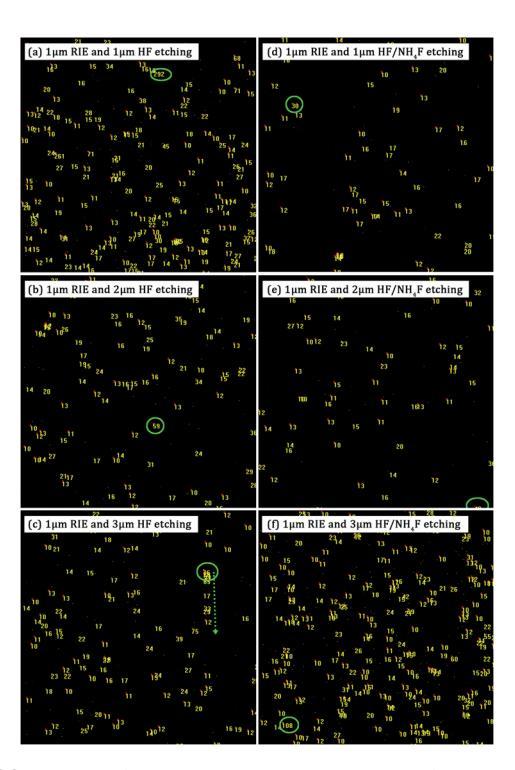
Fig. 7 SC images of the samples treated with RIE followed by HFbased etching. Left column (a–c): RIE and HF etching with removal amounts of 1 μ m, 2 μ m, and 3 μ m. Right column (d–f): RIE and HF/ NH₄F etching with removal amounts of 1 μ m, 2 μ m, and 3 μ m. Each image measures 3 mm per side. Yellow numbers on each image indicate the sizes (number of pixels) of the SC objects. Only objects with a size larger than 10 pixels were marked. The largest-sized SC object on each sample surface is also circled in green.

High-resolution SC imaging was used to observe microscopic features on the HF-based etched fused silica surfaces that were pretreated using RIE, as shown in Fig. 7. We used the software Image-Pro to obtain the size of each SC object by calculating the pixels it comprised. The left column represents the samples treated with the RIE and HF etching process, while the right column represents the samples treated with the RIE and HF/

NH₄F etching process. It was noted that many point features were visible on all the observed sample surfaces, regardless of which HF-based etching process or removal amount was chosen. The point defects were probably due to the presence of embedded particles in the subsurface layer and even the silica matrix. Because HF acid solution has a higher etching rate toward these particles than toward the silica matrix, the particles were first detached from the surface, leaving typical traces of pits. An interesting phenomenon observed from the SC images was that the densities of the point defects on the different treated sample surfaces were different. It was noted that, for the left column, the sample surfaces treated with RIE followed by 1 µm HF etching had the highest density of point defects. On the contrary, for the right column, the density of point defects on the surface treated with RIE followed by 3 µm HF/NH₄F etching was the highest. Except for samples B1 and C3, all others had a very similar density of point defects.

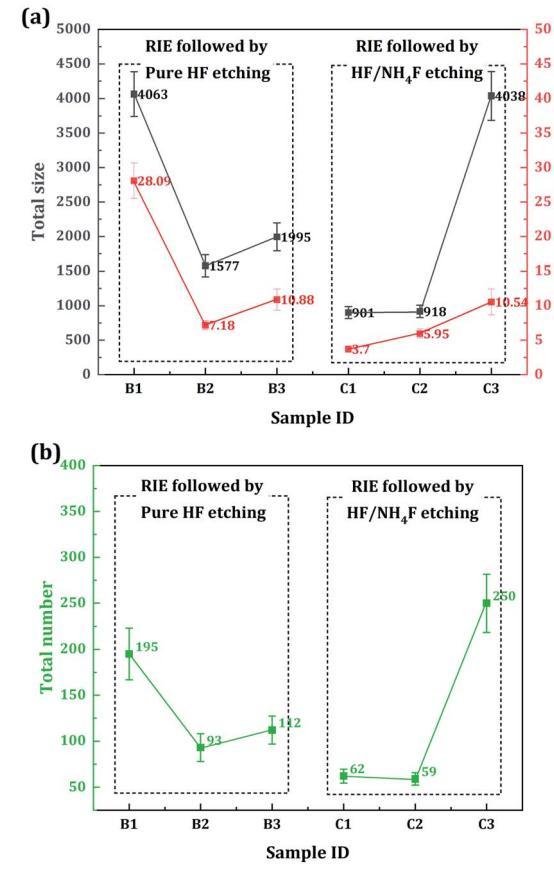
Fig. 8 Characteristics of the point defects on the etched sample surfaces. The gray, red, and green squares indicate the total size, standard deviation (std. dev.) of the size, and the total number of SC objects, respectively. The raw data and corresponding statistical data of the SC images can be seen in the ESI.†

To determine the characteristics of the point defects on the sample surfaces, we further extracted the total size, the standard deviation (std. dev.) of the size, and the total number of SC objects. As shown in Fig. 8, all the parameters presented similar trends for each of the HF-based etching processes. Additional information can be obtained through comparative analysis. First, samples B1 and C3 had the largest total sizes (nearly the same, ~4100 pixels) of point defects. Second, for the same

etching depth, the std. dev. of the sample surface treated with RIE followed by HF/NH_4F etching was lower than that of the surface treated with RIE followed by HF etching. Third, the total number of point defects on sample B1 was a little lower than that on sample C3. However, the other HF/NH_4F -etched samples (samples C1 and C2) had a relatively low total number of point defects compared to the other HF-etched samples (samples B2 and B3).

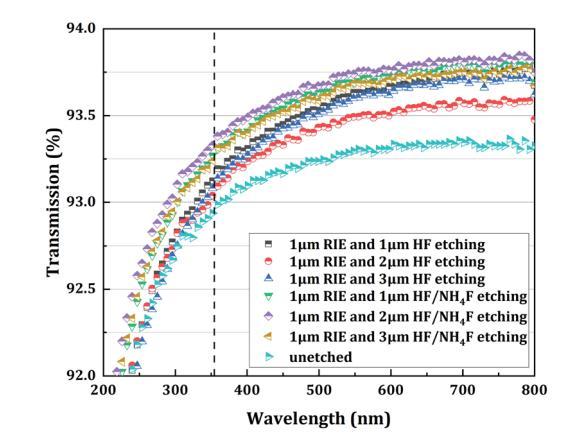
Fig. 9 Spectral transmission of the fused silica samples treated with RIE followed by HF-based etching. The spectral transmission of the unetched sample is used as a reference.

Fig. 9 shows the spectral transmission of the fused silica samples treated with RIE followed by HF-based etching. It was noted that all the combined-etched samples had a relatively high optical transmission compared to the unetched sample. It was also noted that the addition of NH_4F to the HF solution led to a slight increase in transmission, corresponding to a decrease in the absorption and scattering of the incident laser on the treated fused silica samples. This trend can be observed for all the samples treated with RIE followed by HF/NH₄F etching, but was most significant in the case of the 2 μ m HF/NH₄F etching depth (sample C2). In the UV wavelength range (*e.g.*, from the lowest measured wavelength, 190 nm, up to approximately 400 nm), this observed increase in transmission was more obvious. Additionally, it can also be noted that the

transmission of the sample treated with RIE followed by 2 μ m HF etching (sample B2) decreased strongly, especially in the visible range. The decrease in the transmission might be due to the plasma-induced and chemical-etching-driven formation of chemical structure defects,²⁷ such as the ODCs mentioned in the Introduction.

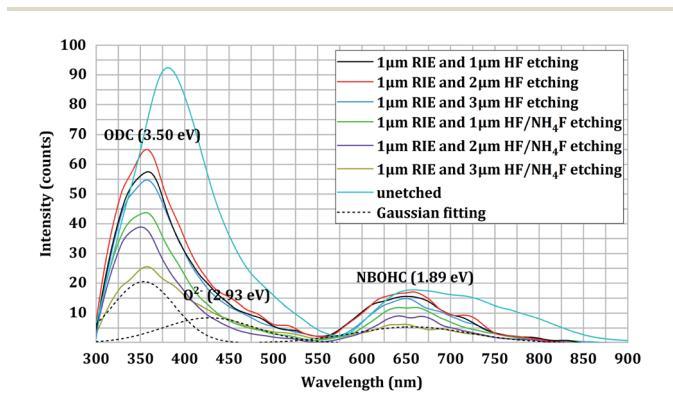
Fig. 10 Comparison of the FL spectra under 210 nm (5.9 eV) excitation for the combined-etched samples. The black dotted lines present the three Gaussian components of the spectrum deconvolution for the sample surfaces treated with 1 μ m RIE and 3 μ m HF/NH₄F etching. The FL spectrum of the unetched sample is used as a reference.

Finally, we performed FL spectra analysis for all the combined-etched samples as well as the unetched sample. It was noted that all the FL spectra had a very similar trend with the excitation wavelength. As expected, the unetched sample had the highest observed FL peak intensity. It can be also noted that the addition of NH₄F to the HF solution did not appear to cause a change in the FL defect type. Three main FL bands can be resolved from the measured emission spectra in the range of 300-800 nm. The 3.5 eV band is well known, and is attributed to ODC defects, while the 1.89 eV band is attributed to NBOHC defects. The other FL band centered at 2.93 eV is likely O^{2-} . Compared to the first set of samples (samples B1, B2, and B3), the second set of samples (samples C1, C2, and C3) had a much lower fluorescence intensity. For the first set of samples, the HF etching depth had a weak effect on the peak intensity of all the FL bands. For the second set of samples, however, we found that the FL peak intensity was highly dependent on the HF/NH4F etching depth. The intensities of the ODC and NBOHC defect peaks decreased with increasing HF/NH₄F etching depth. The results indicated that HF/NH₄F etching at a greater depth could cause a lower concentration of FL defects in the fused silica network.

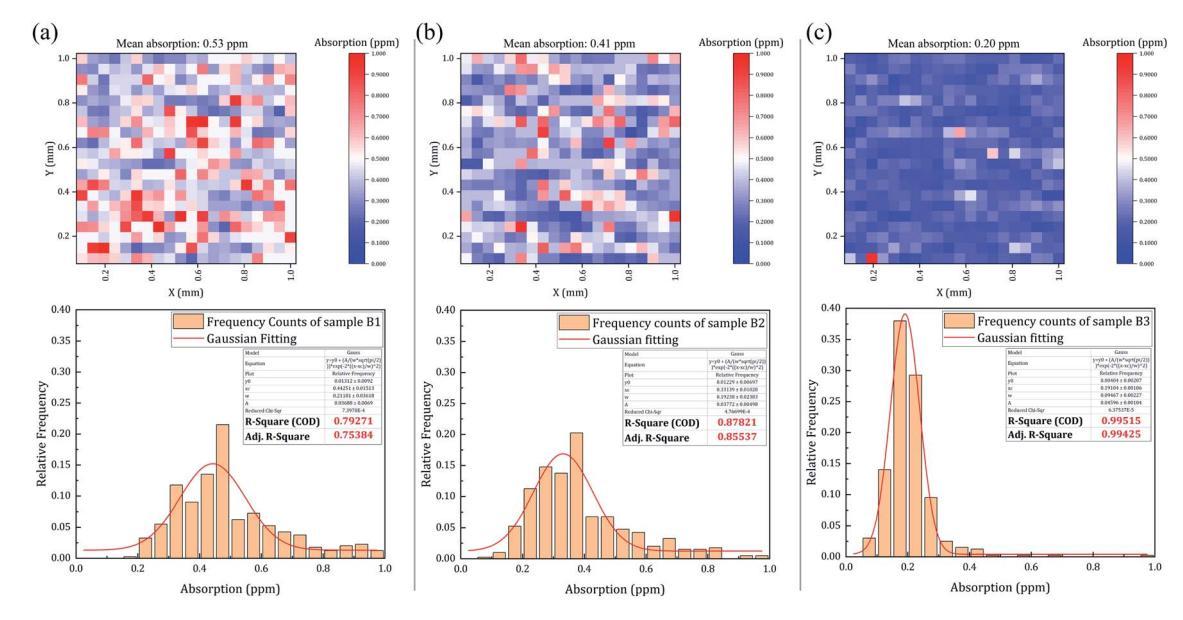
Fig. 11 Surface weak absorption mapping and corresponding statistical data (relative frequency) of the samples treated with RIE followed by HF etching (samples B1, B2, and B3). The measurements were conducted on 10 mm \times 10 mm scanning regions with a 0.05 mm step size for 400 testing points.

followed by NH₄F/HF etching. To further understand the effect of the HF etching depth on the optical performance of the combined-etched fused silica samples, we measured the weak absorption of the optical surfaces treated with RIE followed by HF etching (samples B1, B2, and B3), as shown in Fig. 11. The measurement was conducted using our self-developed photo-thermal deflection system based on a photo-thermal common-path interferometer. The pump beam was a 355 nm quasi-continuous laser with an output power of ~1.1 W. The beam spot was focused on the sample surface with a diameter (1/ e^2) of ~20 µm. The probe beam was a modulated He–Ne laser that overlapped with the pump laser on the tested sample surface. A detailed description of the system can be found elsewhere.²⁹ 400 sites in a 10 mm × 10 mm region on each sample surface were chosen for the measurement. It can be noted that the mean

absorption of the whole region trended to be a lower level when increasing the HF-etching depth. The relative frequencies of the absorption values were then analyzed and Gaussian-fitted. It was noted that the fitting relationship between the two variables became stronger as the HF-etching depth was increased (see the *R*-square coefficients). The results indicated that deep HF etching would make the fused silica surface more stable and uniform.

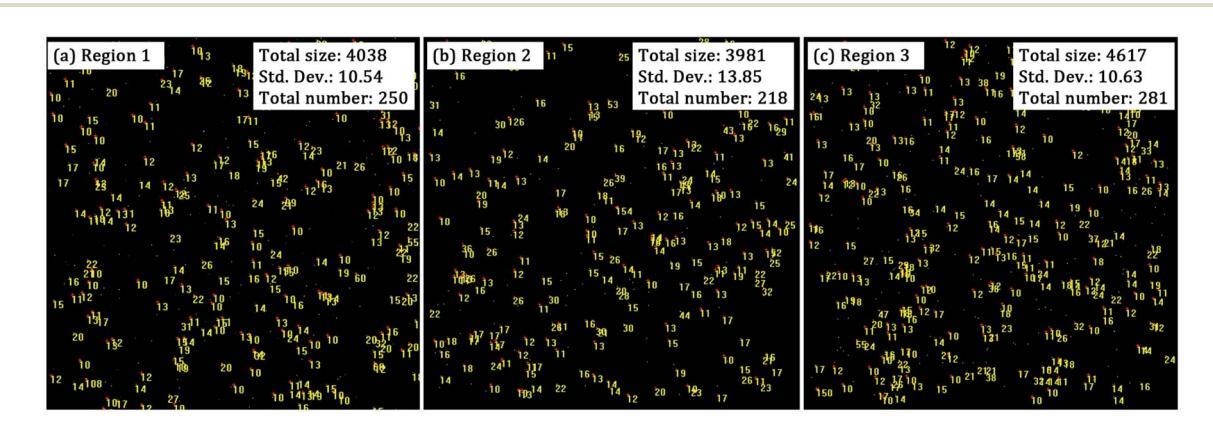
Fig. 12 SC images of three different regions of the sample treated with 1 μ m RIE followed by 3 μ m HF etching (sample C3). Yellow numbers on each image indicate the sizes (number of pixels) of the SC objects. Only objects with a size larger than 10 pixels were marked. The total size, the std. dev. of the sizes, and the total number of the SC objects for each region are also noted. Also, the raw data and the corresponding statistical data can be seen in the ESL[†]

One issue not yet addressed is whether the difference in the point defect density is due to the inhomogeneity of the material. We thus chose another two regions on the surface of sample C3 to compare the SC results (regions 2 and 3) with those we had obtained before (region 1). As shown in Fig. 12, similar SC features were observed for the three regions on the same sample surface, suggesting that the material on the fused silica surface was relatively homogeneous. We would not associate this variation with the HF-based etching depth, because the surface treated with 1 μ m RIE followed by 1 μ m HF etching (sample B1) also had a high point defect density. More evidence, such as the SC results of a series of samples treated with the same combined etching process, will be obtained in future work.
