Cite this: *Energy Environ. Sci.*, 2025, 18, 264

# Removal of residual contaminants by minute-level washing facilitates the direct regeneration of spent cathodes from retired EV Li-ion batteries†

DOI: 10.1039/d4ee03021d

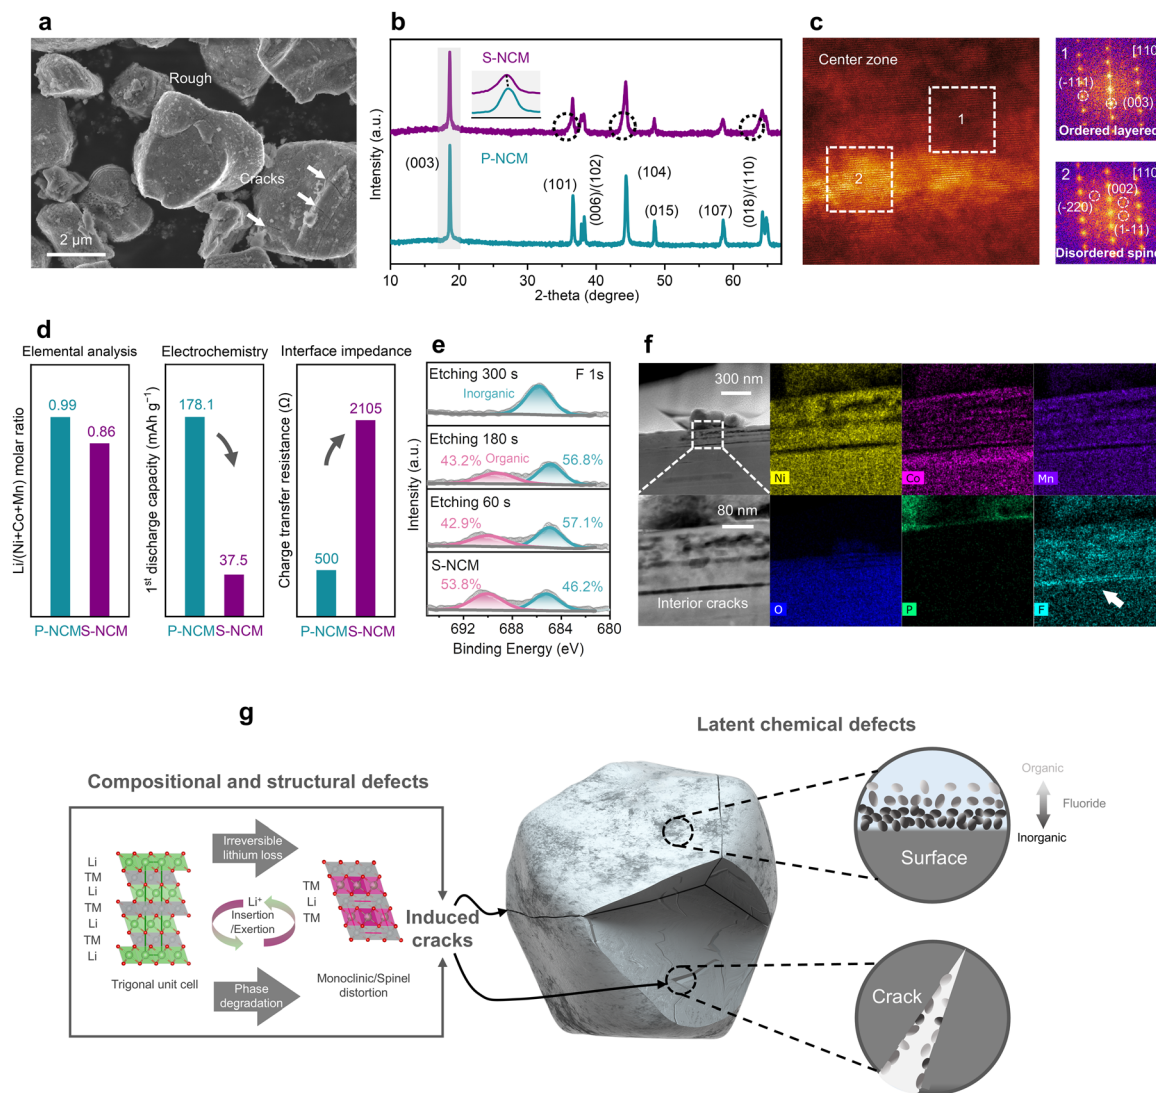
**Fig. 1** Neglected chemical residuals on the 250k-miles-serviced cathode. (a) SEM image and (b) XRD pattern of the degraded S-NCM. The black dotted circle accentuates the subtle peaks that do not belong to the layered structure; (c) high-resolution HAADF-STEM images on the central area of the S-NCM particle and the FFT patterns of the selected dark and bright regions; (d) comprehensive comparison of lithium loss in degraded powders measured by ICP-OES, electrochemical capacity, and charge-transfer resistance analyses in the half-cell using S-NCM and P-NCM powders as cathode active materials; (e) F 1s XPS patterns of S-NCM powders for different sputtering times using an ion-beam. Based on the calculated integral area, the proportional values of the organics and inorganics in fluoride are presented in the patterns; (f) HAADF-STEM images based on focused ion beam cutting and an enlarged view displaying the interior microcracks. Corresponding EDS mapping analysis indicates the presence of F elements along these microcracks pointed out by a white arrow. (g) Deficiencies of S-NCM addressed before direct regeneration, including the compositional and structural aspects (e.g., irreversible lithium-ionic loss, phase degradation, internal and external cracks) and latent chemical defects (e.g., surface and crack-edge impurities enriching the F element).

To understand the surface state of the spent cathode, energy-dispersive spectroscopy (EDS) element mapping and X-ray photoelectron spectroscopy (XPS) were conducted. As shown in Fig. S7–S9, and Tables S5, S6 (ESI<sup>†</sup>), the S-NCM cathode surface residuals consisted of C, O, F, and P elements, and displayed a surface-rich gradient distribution, as revealed

by XPS with etching. The F 1s XPS peaks with etching for S-NCM are shown in Fig. 1e, where two F 1s peaks could be observed before sputtering, with the major peak centered at 685.5 eV, which was attributed to inorganic fluorides and the minor F 1s peak centered at 690.4 eV, which could be assigned to organic fluorides, with the ratio of 53.8% for organic fluorides.<sup>29</sup> However, the organic-related F peak declined significantly after sputtering, and completely disappeared after 300 s Ar<sup>+</sup> sputtering. The surface-rich distribution of organic fluoride was consistent with the cathode electrolyte interphase (CEI) composition previously reported.<sup>29,30</sup>

To further reveal the microscopic distribution of those F-rich residuals, SEM combined with time-of-flight secondary ion mass spectrometry (SEM-ToF-SIMS) characterization was conducted for the cycled cathode. The results are shown in Fig. S10 and Videos S1, S2 (ESI†). Based on the spatial distribution of F<sup>−</sup> secondary ion fragments, it was confirmed that fluoride impurities were primarily deposited on the particle surface. Moreover, during the long-time battery service, it could be observed from the HAADF-STEM image and corresponding element mapping (see Fig. 1f) that, in the S-NCM cathode, the fluorides could spread into the interior of the cathode along the intragranular cracks. Coincidentally, from the selected FFT figure shown in Fig. S4 (ESI†), the existence of an amorphous ring was observed along the intragranular cracking, which may be related to the fluorides also observed in the bulk. To sum up, the collected S-NCM exhibited limited structural and compositional degradation, while preserving the fluoride-containing impurities aggregated on the surface and along the intragranular cracks, as illustrated in Fig. 1g.

Furthermore, it was previously widely accepted that the source of F-rich impurities in the spent cathode was due to decomposition of the PVDF binder during the heat delamination process at around 350 °C;<sup>11,23–25,31</sup> however, during the thermal decomposition of PVDF, most the fluoride-containing products were gas species (*i.e.*, HF) and fragments (−CF− and −CH−CF−),<sup>32–34</sup> which are subject to ejection instead of propagating along the cathode intragranular cracks. To confirm the source of those observed residual impurities, four kinds of cathodes with varying cycling conditions were collected and examined, namely cathode laminates with/without electrolyte filling, and laminates from 125k and 250k miles-serviced batteries, as listed in Table S7 (ESI†). The SEM images and electrochemical performance are shown in Fig. S11 and S12 (ESI†). Compared with the pristine one (sample A), the other spent cathodes from battery formation and cycling exhibited a rough surface and limited discharge capacity. Notably, the laminate from formation only but with no cycling (sample B), which it was believed would retain the full lithium inventory and show negligible structural degradation since it had not undergone charge/discharge cycling, showed a poor discharge capacity, which was the same as the other long-cycled ones. Moreover, the heat exfoliation used to pyrolyze the adhesive binders deteriorated the original CEI layer on the spent cathodes and generated more harmful byproducts (*e.g.*, Li<sub>2</sub>CO<sub>3</sub>, Li<sub>3</sub>PO<sub>4</sub>, LiF). This, combined with electrolyte decomposition during electrochemical cycling, exacerbates chemical degradation, resulting in a significant capacity decline. Therefore, the above comparison revealed that the cathode residual impurities should originate from the electrolyte components (such as LiPF<sub>6</sub>, DMC, ethylene carbonate (EC)) decomposition during battery formation, cycling, and common heat exfoliation, leading to severe capacity loss in spent cathodes (Fig. 1d).
