Cite this: *RSC Adv.*, 2018, 8, 30155

# Corrosion behaviour of welded low-carbon steel in the Arctic marine environment†

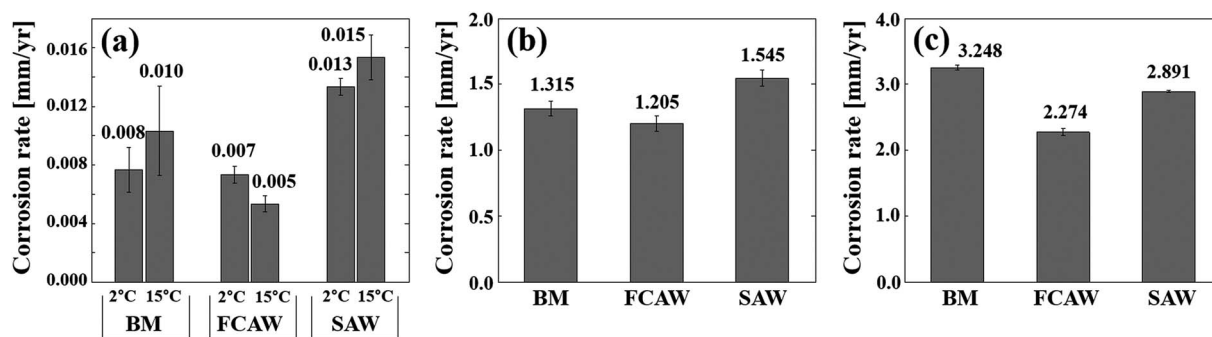
Fig. 1 Corrosion rates of experimental specimens obtained from various corrosion tests. (a) Immersion test, (b) salt-spray test, and (c) cyclic corrosion test.

Concerning the immersion test results (Fig. 1a), the corrosion rate of all specimens showed a satisfactory value of 0.005–0.015 mm y<sup>−1</sup>. The degree of corrosion was in the order of FCAW < BM < SAW, and the difference between BM and FCAW was very small. The BM specimen showed a slight higher corrosion rate than FCAW but lower than SAW, thus the degree of corrosion was in the order of FCAW < BM < SAW. As the seawater temperature decreased, no noticeable decrease in corrosion was observed. No pitting corrosion was found, and partial red-brown general corrosion was observed.

In the salt spray tests (Fig. 1b), the corrosion rate was 1.205–1.545 mm y<sup>−1</sup>, which is 70 times higher than that measured in the seawater immersion tests. This indicates that the base material is very weak in salt spray exposure conditions. The corrosion tendency was similar to the results of immersion test in the order of FCAW < BM < SAW. In general, SST is less relevant to reproduce practical corrosive conditions, but tests were conducted to compare corrosion differences between specimens under constant temperature conditions in saline conditions and for comparison with the CCT test results.

Fig. 1c, serious corrosion rate in the range of 2.274 to 3.248 mm y<sup>−1</sup> was confirmed. The degree of corrosion was in the order of FCAW < SAW < BM, and the formation of a significant rust layer was visually observed (ESI†). The corrosion level determined from the CCT was more than 130 times higher than the seawater immersion test, and it was confirmed that the corrosion change of the steel was caused by the repeated wetting and drying, as well as temperature changes. In particular, by comparing the results shown in Fig. 1a and b we confirmed the specific corrosion of the BM is slightly higher than FCAW but much lower than SAW. This is important information for base metals and weld joints in the design of the offshore materials; thus, we identified the causes.

As shown in Fig. 1, the corrosion trends for the BM and the WM under Arctic conditions were confirmed. In the submerged simulated condition test, rust was produced in the form of general corrosion, but it was difficult to visually distinguish the corrosive difference between the BM and the WM specimens because of the small amount of corrosion. However, when comparing the corrosion rates *via* measuring the weight loss, the values for the WM specimens were generally higher than those of the BM specimens. This indicates that the corrosion influence on FZ or HAZ is relatively higher than those of the PM.

On comparing the overall corrosion tendency, we found that the BM was less corroded in most experiments, but, from the CCT results, the BM specimens showed the most corrosion. This means that more corrosion can occur in the PM region than the FZ region in the splash zone. Therefore, it is necessary to find the cause of this phenomenon for the design of corrosion-resistant Arctic offshore structures. Thus, the influence of corrosion factors on the corrosion was investigated by analysing the microstructure, chemical composition, and CTEs.

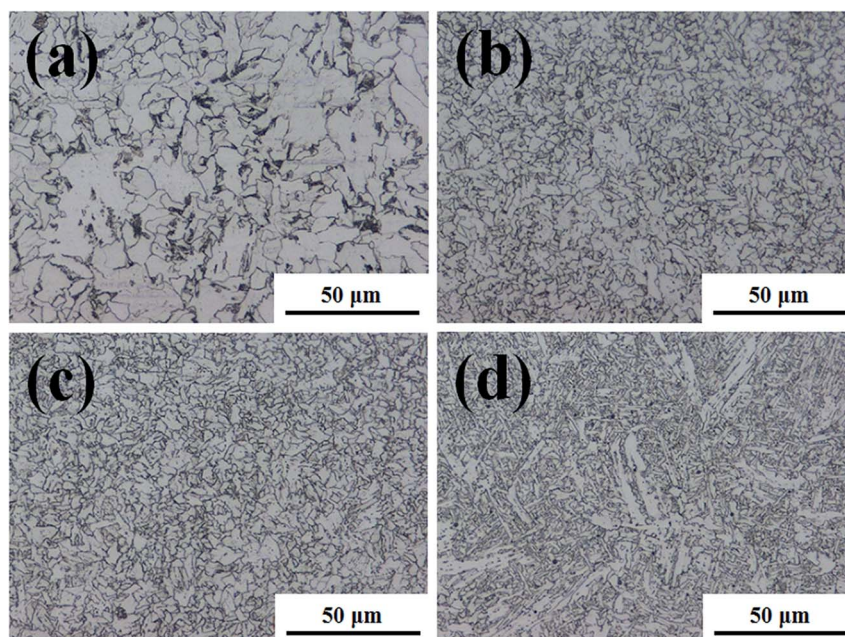
The microstructures were analysed to explain the corrosion of the BM. This is because local differences in microstructure, such as grain size and elemental microcomposition, can give rise to different corrosion properties. Therefore, the microstructure can be used to compare the corrosion difference between the FZ and PM in the specimen. Fig. 2 and 3 exhibit the microstructure morphology of FZ, coarse grain heat affected zone (CGHAZ), fine grain heat affected zone (FGHAZ), and PM in the FCAW and SAW test specimens. In the case of the FCAW test specimen, the PM phase was mainly quasi-polygonal ferrite + acicular ferrite + pearlite, FGHAZ was bainitic ferrite + granular bainite + acicular ferrite, CGHAZ was granular bainite +

martensite + acicular ferrite, and FZ was acicular ferrite + martensite. Ralston and Birbilis reported that a finer microstructure gives rise to a more reactive surface as a result of the smaller grains and more grain boundaries, making the surface more prone to corrosion.<sup>21–23</sup> In addition, bainite is nobler than ferrite; thus, a ferrite–bainite microstructure results in galvanic corrosion.<sup>24</sup> In practice, the coexistence of ferrite and bainite phases in the HAZ is expected to result in more corrosion than in the FZ (ferrite + martensite) and PM (ferrite + pearlite). Considering the grain size, HAZ was found to have smaller grains than the PM, and the WM was found to have a dense needle-like structure. Bhagavathi reported that a ferritic–martensitic microstructure shows decreased galvanic effects because of the similarity between BCC and BCT crystal structures.<sup>25</sup> However, it has been reported that the corrosion rate of ferrite–martensite is higher than that of the ferrite–pearlite phase;<sup>26</sup> thus, the corrosion of the FZ would be higher than that of the PM and lower than that of the HAZ. Therefore, considering the microstructure, it is expected that corrosion progresses in the order of PM < FZ < HAZ in the welding joint of FCAW. In the case of the SAW test specimen, the PM phase was mainly quasi-polygonal ferrite + acicular ferrite + pearlite, FGHAZ was quasi-polygonal ferrite + acicular ferrite + granular bainite, CGHAZ was quasi-polygonal ferrite + acicular ferrite + granular bainite, and FZ was granular bainite + quasi-polygonal ferrite + acicular ferrite. Based on observation, HAZ has the smallest grain size and shows a ferrite–bainite structure with a high ferrite ratio. Therefore, it is expected that the corrosion rate of HAZ and FZ will be higher than that of PM because of the galvanic couple corrosion of ferrite–bainite microstructure. Consequently, if we predict the corrosion tendency of the structures, the corrosion of the HAZ should be the worst, and

Fig. 2 Microstructural characterisation of the welded joint of FCAW specimen. (a) Parent metal (PM), (b) coarse grain heat affected zone (CGHAZ), (c) fine grain heat affected zone (FGHAZ), and (d) fusion zone (FZ).

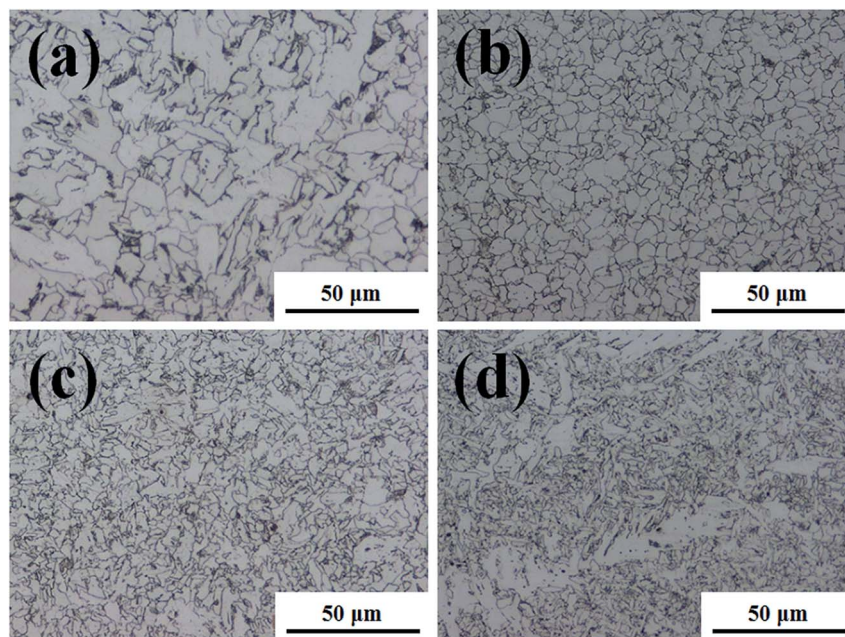
Fig. 3 Microstructural characterisation of the welded joint of SAW specimen. (a) Parent metal (PM), (b) coarse grain heat affected zone (CGHAZ), (c) fine grain heat affected zone (FGHAZ), and (d) fusion zone (FZ).

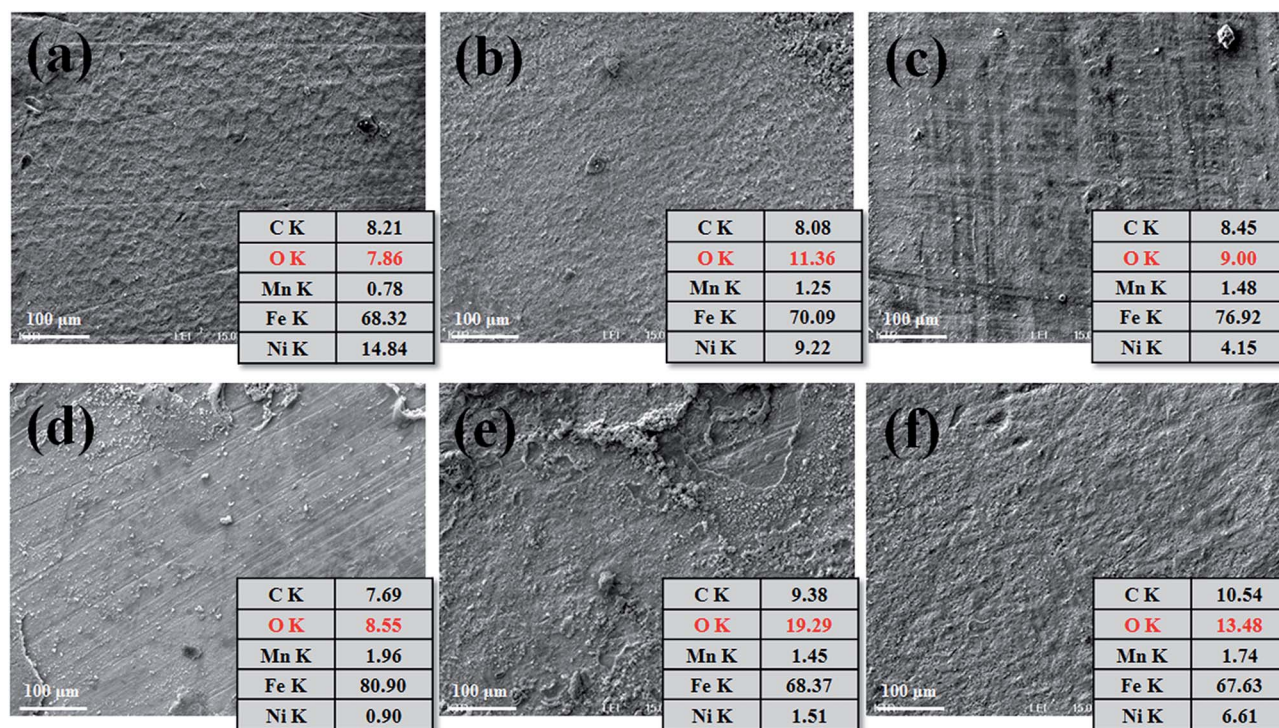
Fig. 4 SEM and EDS characterisation of the corroded surface of (a) FCAW-PM, (b) FCAW-HAZ, (c) FCAW-FZ, (d) SAW-PM, (e) SAW-HAZ and (f) SAW-FZ specimens after one cycle of CCT (wt%). The EDS data were obtained over the entire area shown in each SEM image.

Fig. 4 shows the surface morphology and EDS analysis results of FCAW and SAW specimens. In general, rust is comprised of various types of oxides: hydrated oxides, oxyhydroxides, and miscellaneous crystalline and amorphous substances, but all components are mainly composed of iron and oxide.<sup>29</sup> Therefore, measuring the oxygen ratio in the rust layer can provide information about the progression of corrosion under equal exposure conditions. Therefore, to understand the initial corrosion, the chemical composition of the rust layer was analysed at representative positions but excluding the severely corroded region after one cycle of CCT. As shown in Fig. 4, general corrosion occurred over the entire area. In both case of FCAW and SAW, corrosion progressed in the order of PM < FZ < HAZ. Therefore, we confirmed that the corrosion of the PM region progresses the least during the initial corrosion stage.

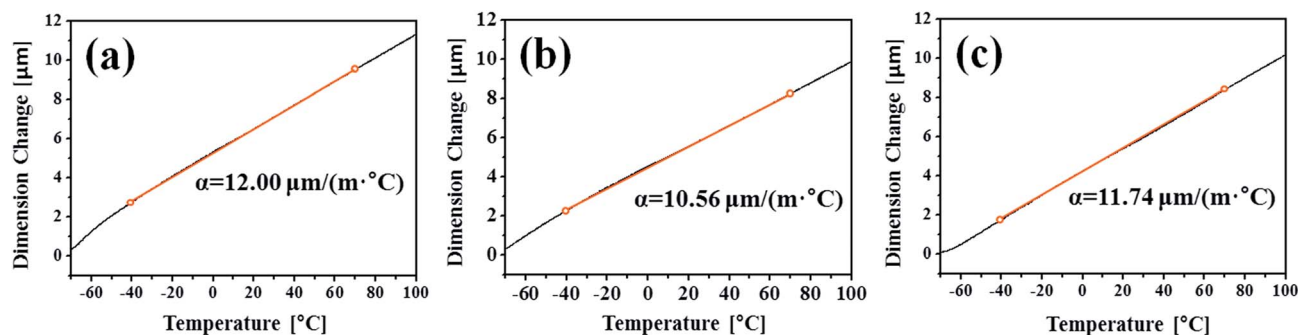
Fig. 5 TMA curves and the coefficient of thermal expansion (CTE) of samples of the (a) base metal (BM) and (b) fusion zone (FZ) of the FCAW specimen and the (c) FZ of the SAW specimen.

The CCT was characterised by adding a temperature change condition to the SST in consideration of the Arctic environment. In fact, comparing the corrosion in the splash and submerged zones, the splash zone condition is more severe considering the repeatability of the wetting/drying conditions arising from wave action and the daily temperature difference depending on the wind speed and seasonal differences. Therefore, thermal expansion measurements were conducted to confirm whether the temperature change affects the corrosion tendencies of the specimens. Fig. 5 shows the CTE measurement data from -50 to 100 °C, where the CTE is calculated based on the practical experiment range. As a result, the values for the BM, FCAW, and

SAW were 12.00, 10.56, and 11.74 μm (m °C)<sup>-1</sup>, respectively. Thus, the CTE of BM was highest. Because the CTEs of iron oxides are less than 8.5 μm (m °C)<sup>-1</sup> below 100 °C,<sup>30</sup> thermal stress occurs between the oxide and metallic layers. Therefore, it is expected that cracks will occur in the iron oxide layer at the locations where the stress is concentrated during corrosion. When the oxide layer on the surface is thick, the layer is damaged by the relatively high thermal deformation of the BM, and continuous corrosion will progress around the damaged locations. Fig. 6 illustrates the schematic corrosion progression pattern in the WM through the CCT. After the initial rust layer is formed, corrosion progresses in the order of PM < FZ < HAZ, depending on the corrosion potential. However, after a certain thickness of rust layer has developed, cracks with relatively high density occur in the PM, which ensures the most stress because of repeated temperature changes. These cracks provide paths for water, oxygen, and other corrosive substances to enter and cause additional corrosion. The protective density and adherence of the rust layer depend on the duration wetness;<sup>29</sup> thus, the existence of marine components (chloride) and long relatively long wet/dry cycles may produce unstable rust layers that possess many defects (holes and cracks). The defects inhibit the evaporation of trapped water; therefore, rapid oxidation occurs and reduces the compactness of the rust layer on carbon steel.<sup>31</sup> Thus, when corrosion progresses in the medium- and long-term, corrosion mostly occurs in the PM as a result of the influence of stress due to the differences in the CTE of each specimen. This means that the importance of impact on the corrosion rate is

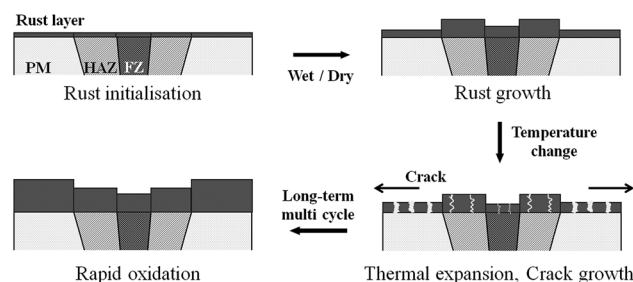
Fig. 6 Schematic of the rapid oxidation of the parent metal (PM), heat affected zone (HAZ), and fusion zone (FZ) under CCT conditions.

primarily affected by the compactness and adhesiveness of the rust layer than any other factors under severe corrosion conditions. Although many studies have dealt with the rust-expansion-induced cracking of steel bars in reinforced concrete structures,<sup>32,33</sup> no studies have shown the difference in rust cracking between the PM and FZ in weld joint regions.

Consequently, it can be seen that a difference in CTE is a critical factor for the corrosion behaviour under heavy corrosion conditions. It also shows the possibility of significant corrosion progression by repeated rust layer cracking. Therefore, this study suggests the severe influence of corrosion on PM in weld joints, and further related research will be needed in the future.
