Cite this: *RSC Adv.*, 2018, 8, 30155

Corrosion behaviour of welded low-carbon steel in the Arctic marine environment†

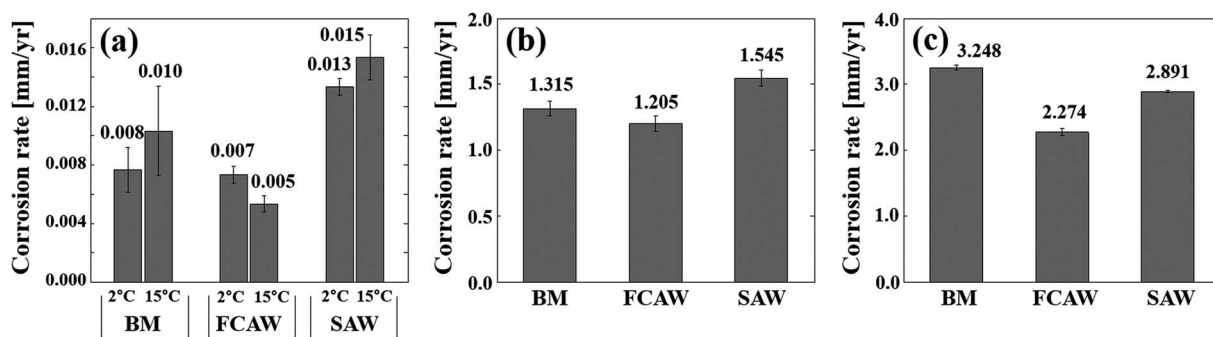
Fig. 1 Corrosion rates of experimental specimens obtained from various corrosion tests. (a) Immersion test, (b) salt-spray test, and (c) cyclic corrosion test.

Concerning the immersion test results (Fig. 1a), the corrosion rate of all specimens showed a satisfactory value of 0.005–0.015 mm y^{−1}. The degree of corrosion was in the order of FCAW < BM < SAW, and the difference between BM and FCAW was very small. The BM specimen showed a slight higher corrosion rate than FCAW but lower than SAW, thus the degree of corrosion was in the order of FCAW < BM < SAW. As the seawater temperature decreased, no noticeable decrease in corrosion was observed. No pitting corrosion was found, and partial red-brown general corrosion was observed.

In the salt spray tests (Fig. 1b), the corrosion rate was 1.205–1.545 mm y^{−1}, which is 70 times higher than that measured in the seawater immersion tests. This indicates that the base material is very weak in salt spray exposure conditions. The corrosion tendency was similar to the results of immersion test in the order of FCAW < BM < SAW. In general, SST is less relevant to reproduce practical corrosive conditions, but tests were conducted to compare corrosion differences between specimens under constant temperature conditions in saline conditions and for comparison with the CCT test results.

Fig. 1c, serious corrosion rate in the range of 2.274 to 3.248 mm y^{−1} was confirmed. The degree of corrosion was in the order of FCAW < SAW < BM, and the formation of a significant rust layer was visually observed (ESI†). The corrosion level determined from the CCT was more than 130 times higher than the seawater immersion test, and it was confirmed that the corrosion change of the steel was caused by the repeated wetting and drying, as well as temperature changes. In particular, by comparing the results shown in Fig. 1a and b we confirmed the specific corrosion of the BM is slightly higher than FCAW but much lower than SAW. This is important information for base metals and weld joints in the design of the offshore materials; thus, we identified the causes.

As shown in Fig. 1, the corrosion trends for the BM and the WM under Arctic conditions were confirmed. In the submerged simulated condition test, rust was produced in the form of general corrosion, but it was difficult to visually distinguish the corrosive difference between the BM and the WM specimens because of the small amount of corrosion. However, when comparing the corrosion rates *via* measuring the weight loss, the values for the WM specimens were generally higher than those of the BM specimens. This indicates that the corrosion influence on FZ or HAZ is relatively higher than those of the PM.

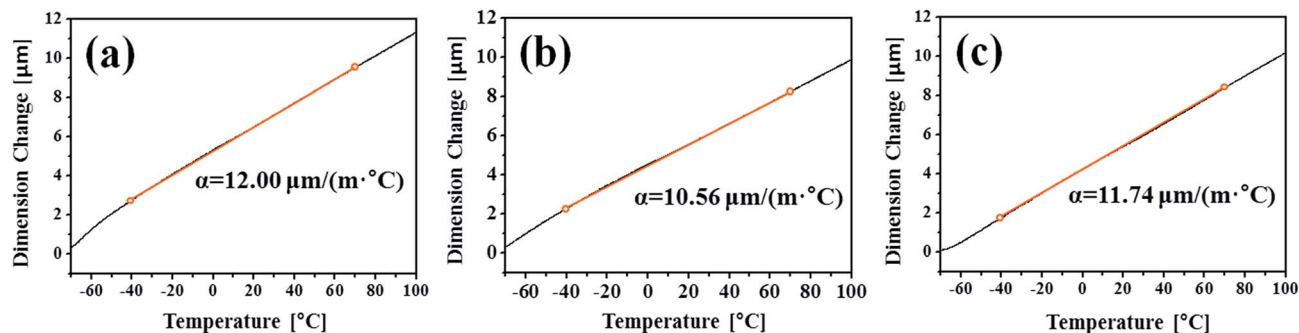
Fig. 5 TMA curves and the coefficient of thermal expansion (CTE) of samples of the (a) base metal (BM) and (b) fusion zone (FZ) of the FCAW specimen and the (c) FZ of the SAW specimen.

The CCT was characterised by adding a temperature change condition to the SST in consideration of the Arctic environment. In fact, comparing the corrosion in the splash and submerged zones, the splash zone condition is more severe considering the repeatability of the wetting/drying conditions arising from wave action and the daily temperature difference depending on the wind speed and seasonal differences. Therefore, thermal expansion measurements were conducted to confirm whether the temperature change affects the corrosion tendencies of the specimens. Fig. 5 shows the CTE measurement data from -50 to 100 °C, where the CTE is calculated based on the practical experiment range. As a result, the values for the BM, FCAW, and

SAW were 12.00, 10.56, and 11.74 μm (m °C)⁻¹, respectively. Thus, the CTE of BM was highest. Because the CTEs of iron oxides are less than 8.5 μm (m °C)⁻¹ below 100 °C,³⁰ thermal stress occurs between the oxide and metallic layers. Therefore, it is expected that cracks will occur in the iron oxide layer at the locations where the stress is concentrated during corrosion. When the oxide layer on the surface is thick, the layer is damaged by the relatively high thermal deformation of the BM, and continuous corrosion will progress around the damaged locations. Fig. 6 illustrates the schematic corrosion progression pattern in the WM through the CCT. After the initial rust layer is formed, corrosion progresses in the order of PM < FZ < HAZ, depending on the corrosion potential. However, after a certain thickness of rust layer has developed, cracks with relatively high density occur in the PM, which ensures the most stress because of repeated temperature changes. These cracks provide paths for water, oxygen, and other corrosive substances to enter and cause additional corrosion. The protective density and adherence of the rust layer depend on the duration wetness;²⁹ thus, the existence of marine components (chloride) and long relatively long wet/dry cycles may produce unstable rust layers that possess many defects (holes and cracks). The defects inhibit the evaporation of trapped water; therefore, rapid oxidation occurs and reduces the compactness of the rust layer on carbon steel.³¹ Thus, when corrosion progresses in the medium- and long-term, corrosion mostly occurs in the PM as a result of the influence of stress due to the differences in the CTE of each specimen. This means that the importance of impact on the corrosion rate is
