Surface alloying of FeCoCrNiMn particles on Inconel-718 using plasma-transferred arc technique: microstructure and wear characteristics

N. Jeyaprakash,^{ID}*^{ab} Che-Hua Yang,^{ab} G. Prabu^c and K. Ganesa Balamurugan^d

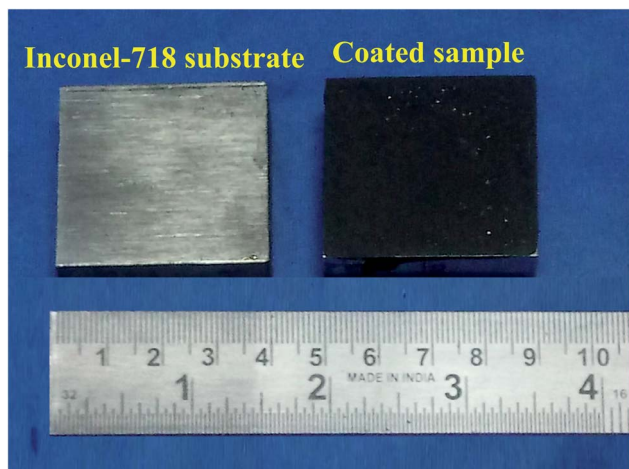
Fig. 2 Macropicture of Inconel-718 substrate and coated samples.

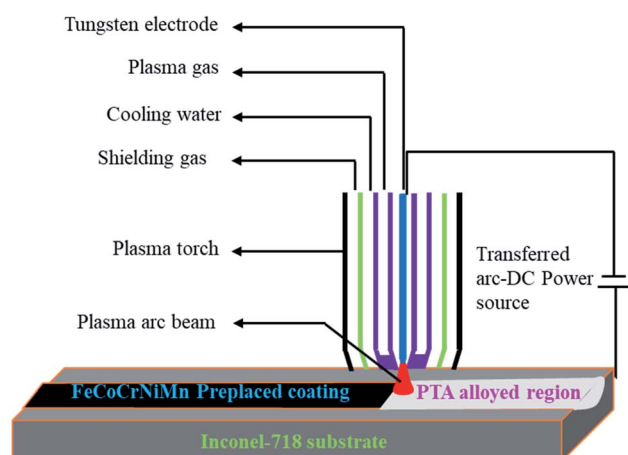
Fig. 3 Schematic representation of PTA alloying process.

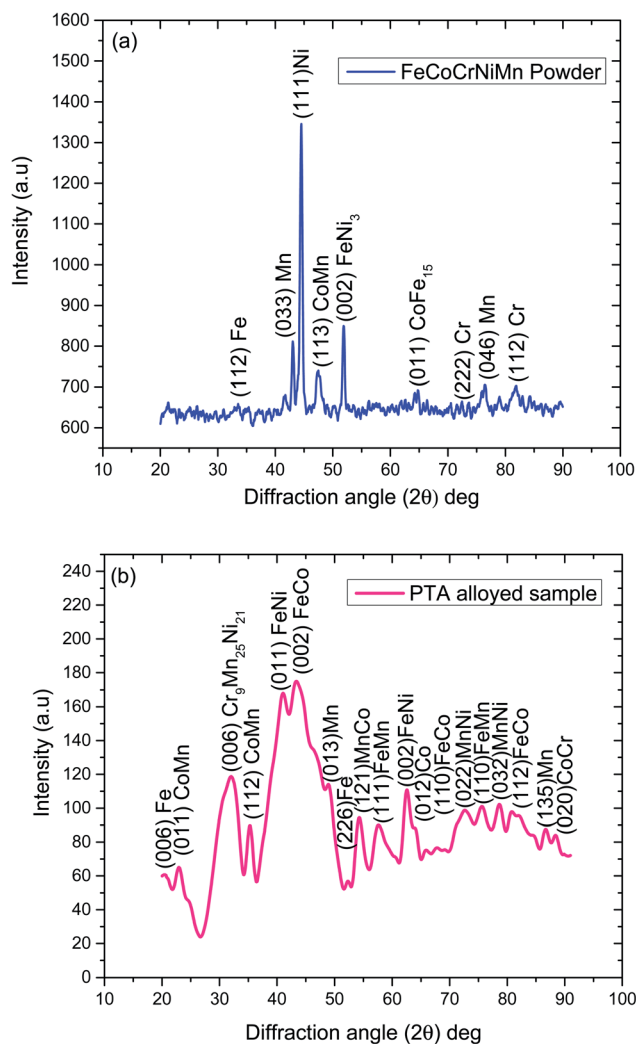
Fig. 4 XRD analysis of: (a) FeCoCrNiMn powder, (b) PTA alloyed sample.

XRD analysis was performed on the ball-milled FeCoCrNiMn particles, and their corresponding peak locations were studied. The ball-milled powders induced frictional collision between the elements in the alloy system. This frictional collision resulted in the formation of some secondary phase particles. Notably, a few broadened peaks were observed at about $2\theta = 40^\circ$ to 55° . Moreover, it confirmed the presence of all alloying elements in the ball-milled powder. Some compound phases, such as CoMn, FeNi₃ and CoFe₁₅, were also traced in this XRD analysis. Fig. 4(a) shows the XRD spectrum of the powder materials.

Fig. 4(b) shows the XRD analysis of the PTA alloyed surface. During the PTA alloying process, the preplaced FeCoCrNiMn coating and the top surface of the Inconel-718 substrate were molten simultaneously. The molten pool of the preplaced coating, along with the dilution of top surface of the Inconel-718 substrate, was formed rapidly. The alloying elements Fe, Co, Cr, Ni and Mn in the preplaced coating were very rapidly dissolved in the molten pool. The molten pool that contained the alloyed elements were solidified after the forward movement of the plasma arc. The XRD pattern revealed that the FeCoCrNiMn-alloyed PTA region contained different phases, such as FCC, BCC and intermetallic.¹⁹ Most of the alloying elements were formed in the compound phase, which shows that the high specific energy density of the plasma transferred arc results in sufficient dissolution of alloying elements in the Inconel-718 substrate. It was found that the alloyed region included CoMn, CoCr, Cr₉Mn₂₅Ni₂₁, FeNi, MnNi, FeCo, FeMn and MnCo. Miller indices of (h,k,l) values were identified by X'Pert high score software. In the BCC phase, the reflection is allowed only when $h + k + l$ is an even value.²⁰ In the FCC phase, reflection is allowed only when h , k and l are all odd or all even (unmixed). Based on these rules, (011) CoMn, (110) FeCo, (011) FeNi, (013) Mn, (112) CoMn, (121) MnCo, (110) FeMn, (112) FeCo, and FeCo were identified as the BCC phase. (111) FeMn and (135) Mn were identified as the FCC phase. (006) Fe, (022) MnNi,

(006) Cr₉Mn₂₅Ni₂₁, (002) FeCo, (226) Fe, (002) FeNi, and (020) CoCr all obey both the rules. Hence, these phases are concluded as either BCC or FCC phases. (032) MnNi, (135) Mn and (012) Co are the phases that do not obey any of the above rules. Consequently, these phases are concluded as intermetallic phases.

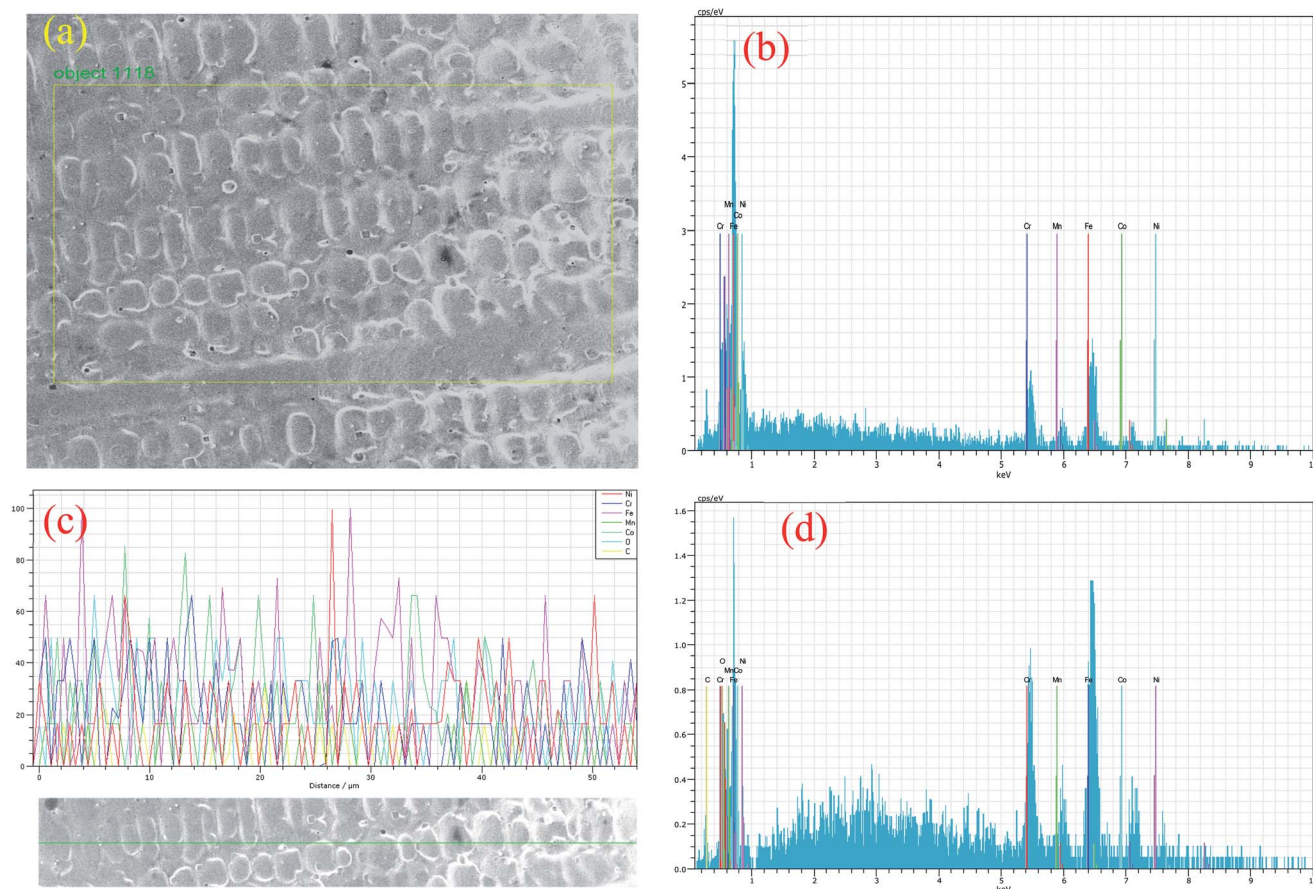
Fig. 6 (a) FESEM images of PTA alloyed region, corresponding EDS graph at: (b) area analysis, (c) line analysis and (d) point analysis.

Fig. 6(a–d) shows the EDS analysis of the PTA-alloyed region. The obtained EDS analysis indicates the presence of all alloying elements after the PTA process [Fig. 6(b)]. Table 3 lists the presence of elements obtained in the PTA-alloyed region. The elements Fe, Cr and Ni are observed as major elements with atomic wt% of 32.48, 25.59 and 16.48, respectively. The remaining positions are occupied by Mn and Co. Therefore, it is confirmed that the Fe element constitutes the matrix material for this PTA-alloyed system. The EDS analysis has proved that the diffusion of the elements of the substrate has never occurred in the central zone of the surface-alloyed region. The heat input by PTA has been majorly utilized for the melting of the alloying elements, and very meagerly utilized to melt the substrate for bonding. Therefore, the diffusion of the elements of the substrate was restricted. Fig. 6 (c and d) shows the EDS result of the interface region and substrate. This line and point scan indicate that the diffusion of major alloying elements, like Ni, Cr, Co, Fe and Mn, has occurred on either side; especially, diffusion mainly occurred on the substrate side. The EDS analysis clearly indicates that the surface treatment completely protects the Inconel-718 substrate, and no trace of the substrate chemical elements is found in the treated layer.

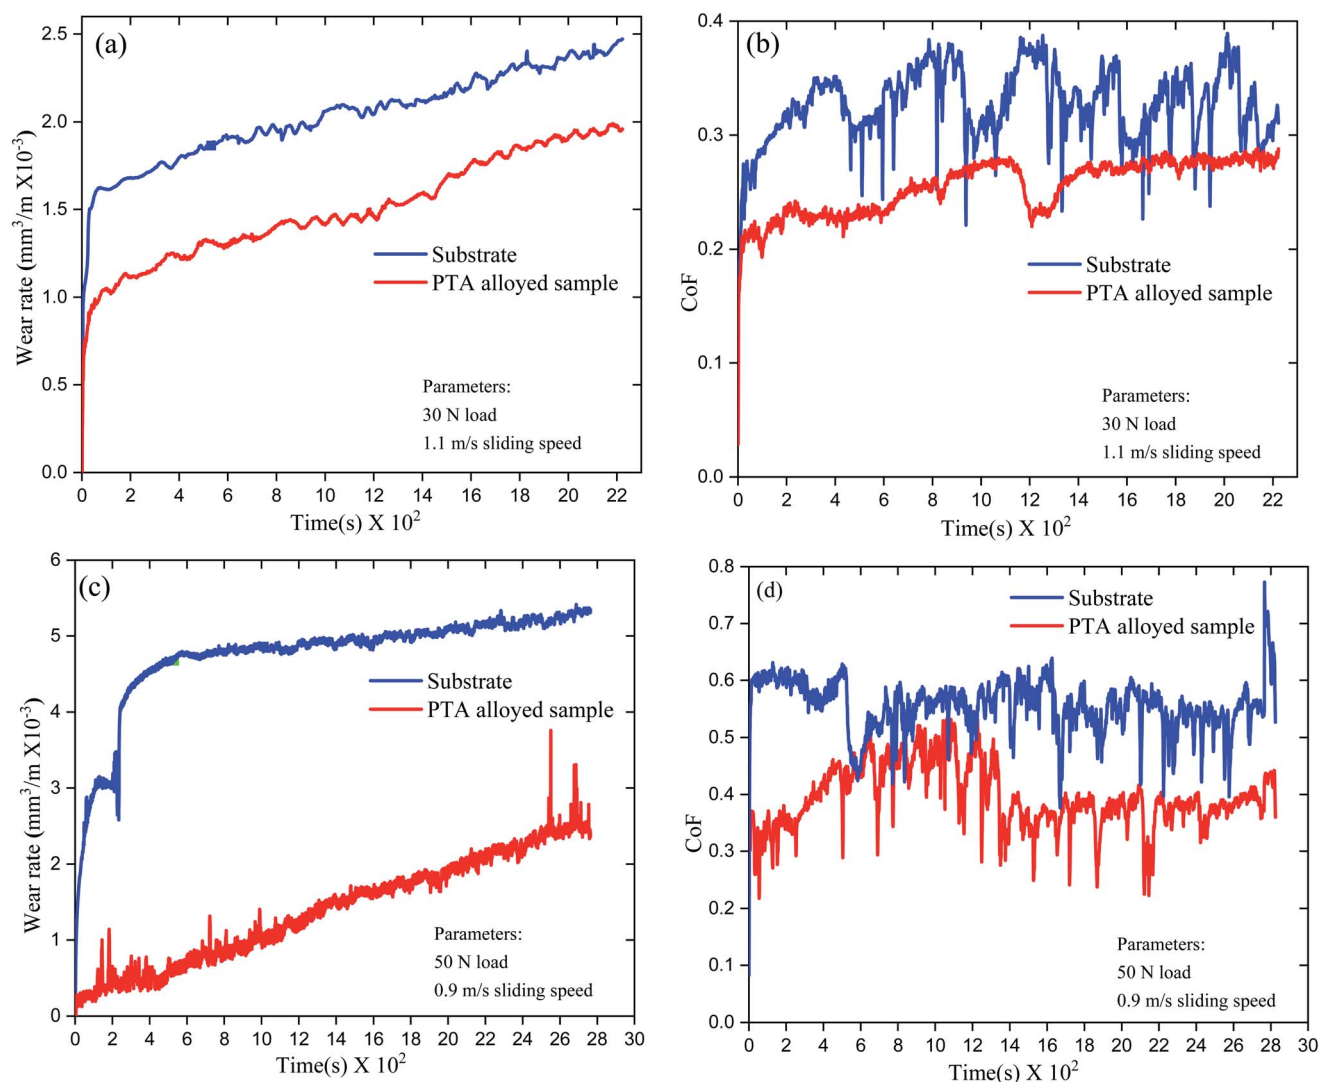
Fig. 8 (a and b) The obtained wear rate and co-efficient of friction graph at the applied load of 30 N, (c and d) wear rate and co-efficient of friction graph at the applied load of 50 N.

Fig. 8(a and c) show the wear rates of substrate and PTA alloyed samples at different input parameter conditions. The wear rate of the substrate specimen at 30 N applied load is $2.45 \times 10^{-3} \text{ mm}^3 \text{ m}^{-1}$ and for the PTA specimen, it is $1.79 \times 10^{-3} \text{ mm}^3 \text{ m}^{-1}$. Similarly, the wear rate of the substrate specimen at 50 N is $5.38 \times 10^{-3} \text{ mm}^3 \text{ m}^{-1}$ and for the PTA sample, it is $2.29 \times 10^{-3} \text{ mm}^3 \text{ m}^{-1}$. Comparison of the wear rates of the substrate and PTA specimen revealed that the PTA surfaces showed significantly improved wear resistance. Moreover, an increase in the applied load increased the wear rate in both substrate and PTA surfaces. The untreated surface tested at 50 N of applied load showed higher wear rate than the rest of the samples.

Fig. 8(b) shows the CoF of the untreated and treated samples tested at an applied load of 30 N. The CoF of the untreated sample shows an increasing trend from 0 to 0.4 at 400 s. Then, a sudden drop has occurred at 500 s, gradually increasing up to 1200 s. A similar drop in CoF is observed at 1200 s, 1400 s and 1700 s. The maximum drop of 0.25 CoF is observed at 1000 s. The initial steep increase in CoF resulted from the resistance of asperities for deformation. The frictional force minimizes when the asperities started deforming. However, the fractured asperities accumulated in the sliding path and acted as an obstacle for the forward sliding. Moreover, the fractured asperities cold-welded with the existing asperities, and formed a plasticized layer. The effect of accumulation of fractured asperities and formation of thin layer increased the frictional force to deform them. Then, the reduction of frictional force happened due to less resistance for deformation. This cycle continued until the completion of the wear test. The lower surface hardness and higher ductility are the cause for this variation of CoF in the untreated sample.

Fig. 8(b) also shows the CoF of the treated specimen tested at an applied load of 30 N. It can be observed that the CoF shows minimum fluctuations compared with the untreated sample. CoF increases up to 0.28 at 250 s. Then, a slight drop to 0.22 occurred after 250 s to 750 s. A steady increase in CoF up to 0.26 happened at 1250 s. A sharp drop in CoF occurred after 1200 s, and was retained up to 1500 s. After 1500 s, CoF has recovered and stabilized until the end of the test. Compared to the untreated sample, the fluctuations in the frictional forces are low in the treated sample. Initially, frictional forces were low during the test. However, when the test time increased, the frictional forces increased with time and attained a maximum around 1000 s to 1250 s. The PTA-alloyed surface improved the surface hardness significantly. Thus, a minimum deformation of the asperities occurred during the initial stages of the test. However, accumulation of the deformed asperities along the sliding path increased the frictional force for further deformation. The sudden decline of frictional forces was due to the bulk deformation of the accumulated thin layer of the deformed asperities. Then, the frictional forces have been regained and stabilized.

Fig. 8(d) shows the CoF of untreated samples tested at an applied load of 50 N. During the starting of the test, CoF of the untreated sample increased to 0.62 and was maintained with minor fluctuations up to 300 s. After 500 s, a sharp decline in the frictional force has been observed and major fluctuations happened over the testing. Absence of the cyclic variation in CoF was observed in 50 N loading condition compared with 30 N loading. The irregular high intensity asperities in the untreated surface have cold-welded with the counter material, and increased the frictional force at the initial stage. When the applied load exceeded the frictional resistance of the cold-welded asperities, a huge deformation occurred. Thus, it

Fig. 8(d) shows the CoF of the treated specimen at 50 N applied load. It can be observed that the treated specimen showed lower CoF than the untreated sample. In addition to that, wide fluctuations in the frictional forces are observed. The frictional forces are increasing over the testing time up to 0.45 at 500 s. A sharp decline in the frictional force occurred at 500 s. Then, it slightly increased to 0.50. This decline and recovery of CoF was observed throughout the test period. However, after 1500 s testing period, CoF reduced from its maximum range, and there were continuous fluctuations until the end. The surface-alloyed Inconel-718 improved the hardness through various particle elements. The minimum deformation of the surface asperities happened during the wear testing due to the increased hardness. The presence of intermetallic compounds and improved hardness prevented the crack propagation. The fluctuations in the CoF indicate the variations in the deformation behaviour of asperities. Decline of CoF after 1500 s of test time shows the stabilization of the surface with minimum deformation of the surface asperities. Even at increased applied load, due to increased surface hardness, the minimum deformation of asperities resulted with a reduction of the frictional forces.

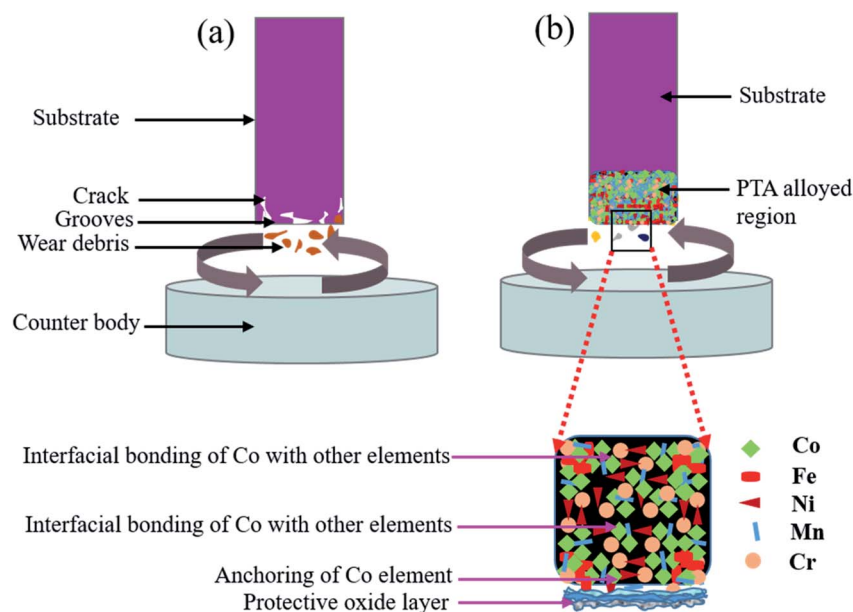
Fig. 10 Schematic representation of wear mechanism: (a) substrate showing with crack, deformation and deep grooves, (b) PTA alloyed specimen showing with mild and small grooves.

A schematic representation of the wear mechanism in the Inconel-718 substrate and the PTA alloyed specimen is shown in Fig. 10. During the wear test, the formation of thick oxide layers on the worn-out surface was followed by frictional heat generation. However, the bearing capacity of the Inconel-718

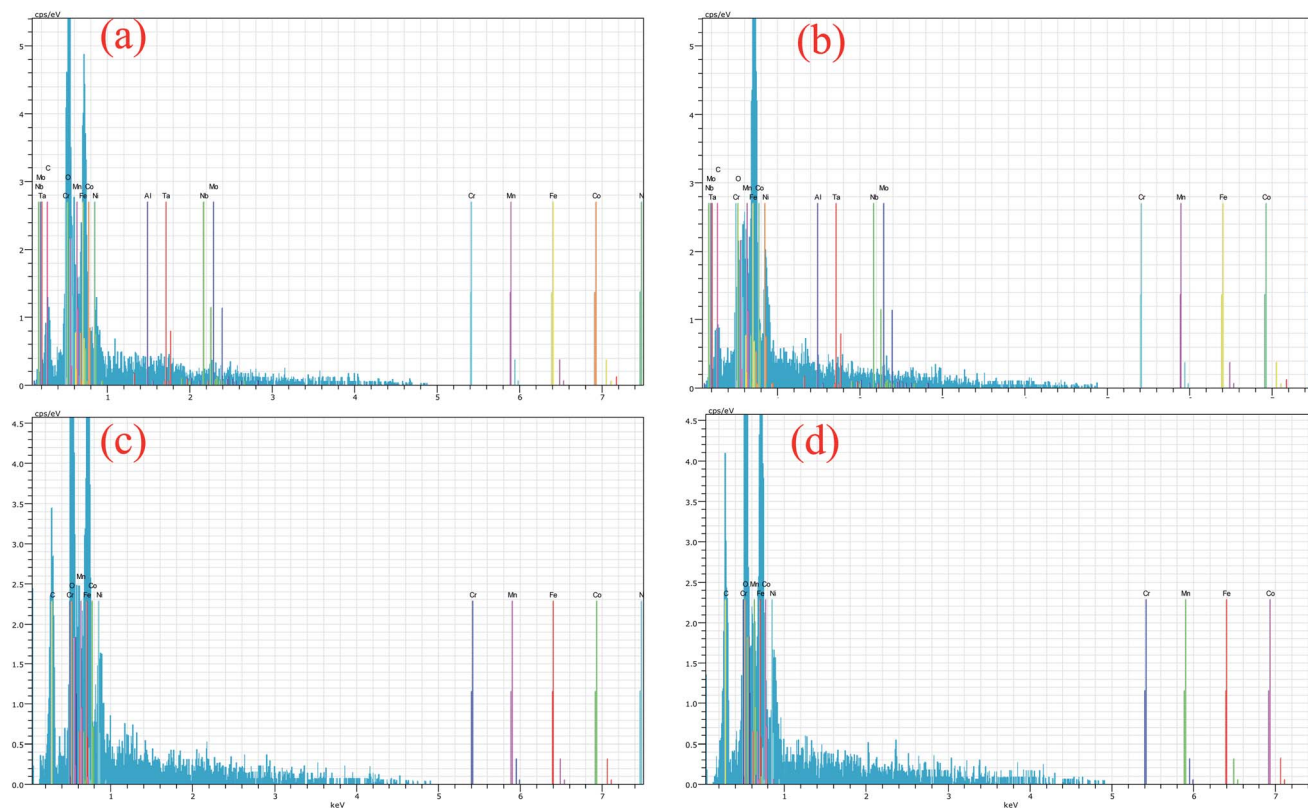
Fig. 11 EDS analysis of worn-out surfaces: (a and b) substrate at 30 N and 50 N load, respectively. (c and d) PTA alloyed specimen at 30 N and 50 N load, respectively.

The EDS results [Fig. 11(a and b)] of the worn-out surface indicate that the reduction of the Al and Ni elements in the

substrate is advocating the concept of adhesive wear loss due to those elements. Table 4 shows the detailed EDS results with their elemental percentages. While increasing the applied load, the adhesiveness of the substrate surface with the counter material increased and deformed drastically during sliding. The EDS [Fig. 11(c and d)] results proved that the worn-out surface contains the FeCoCrNiMn chemical elements with the absence of the substrate chemical elements. No traces of substrate chemical elements were found on the worn-out surfaces. Moreover, the presence of oxides in the worn-out surface acted as a barrier and protected the treated surface from an aggressive environment. This indicates that the PTA alloyed treatment significantly improved the surface protection.

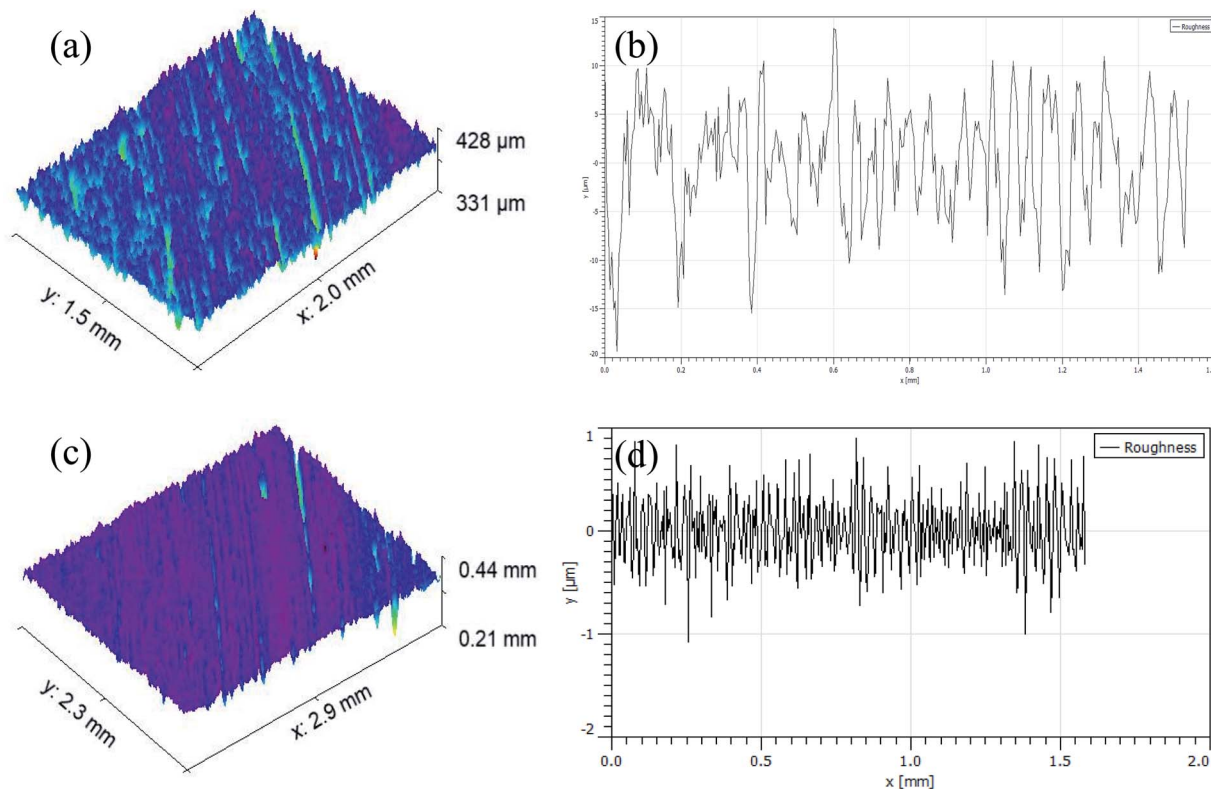
Fig. 12 3D topography of worn-out surfaces and its roughness plot at 50 N load: (a and b) substrate, (c and d) PTA alloyed sample.

Fig. 12(a and b) shows the 3D topography, and the corresponding roughness profile of the worn-out untreated surface at 50 N load. The 3D topography shows numerous wear scar marks on the untreated surface, and these wear scar marks are deeper and wider. The 2D topography indicates that the surface undulations are very rough, and that deeper wear scars are present in regular intervals. The average surface roughness (R_a) of the worn-out untreated surface is measured as $6.31 \mu\text{m}$. Fig. 12(c and d) shows the 3D topography, and the corresponding roughness profile of the worn-out PTA-alloyed surface at 50 N load. The 3D topography shows the minimum scar marks and losses. In addition to that, the absence of deep grooves is observed in the 3D topography. The 2D topography indicates that the wear scar depths are shallow and lower than the untreated surface. The PTA-alloyed surface with FeCoCrNiMn particles has significantly improved the hardness and minimized the wear losses.³² The average surface roughness of the PTA alloyed worn-out surface has been measured as $4.81 \mu\text{m}$. This reduced roughness indicates the effect of the surface alloying on the Inconel-718.
