## Removal of residual contaminants by minute-level washing facilitates the direct regeneration of spent cathodes from retired EV Li-ion batteries†

The direct regeneration of spent cathodes stands out as an environmentally and economically benign strategy within the battery ecosystem, eclipsing the cumbersome metallurgical approaches. Before addressing the lithium loss and structural degradation, it is crucial to focus on the residual contaminants within the spent cathode collected from retired Li-ion batteries after industrial exfoliation processes. Here, comprehensive characterizations and calculations show that in contrast to metal scraps, the electrolyte decomposition after battery operation and heating exfoliation uniformly coat the particle surfaces of cathodes, severely impeding the reuse and rejuvenation of  $\text{LiNi}_x\text{Co}_y\text{Mn}_z\text{O}_2$  (NCM) cathodes with limited degradation by obstructing lithium diffusion. Considering the high costs and environmental risks of organic systems, we further propose a minute-level water-based pretreatment to purify the spent cathode and selectively eliminate these stubborn impurities that can deteriorate the interfacial c

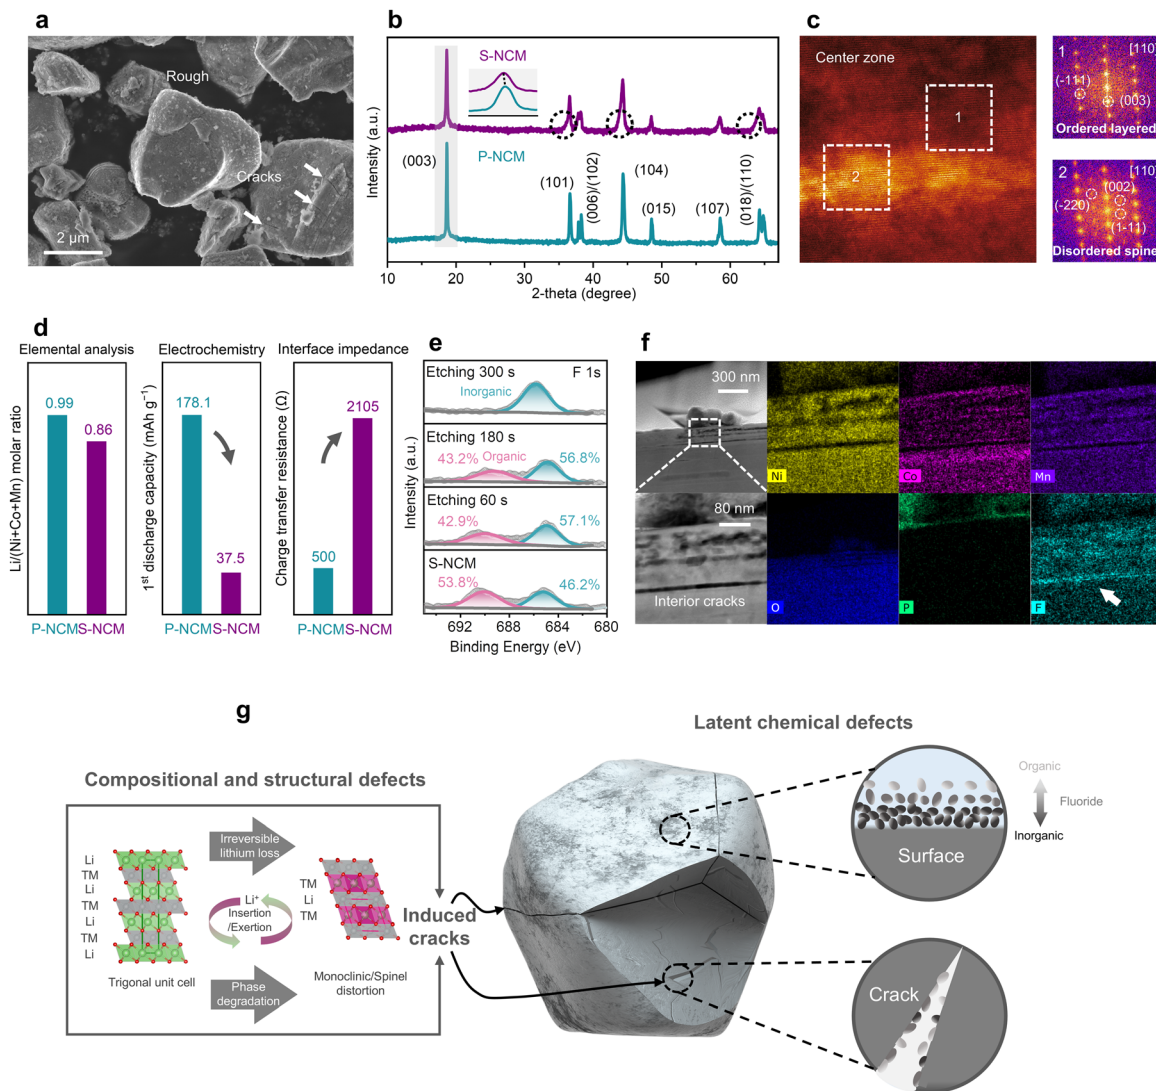
**Fig. 1** Neglected chemical residuals on the 250k-miles-serviced cathode. (a) SEM image and (b) XRD pattern of the degraded S-NCM. The black dotted circle accentuates the subtle peaks that do not belong to the layered structure; (c) high-resolution HAADF-STEM images on the central area of the S-NCM particle and the FFT patterns of the selected dark and bright regions; (d) comprehensive comparison of lithium loss in degraded powders measured by ICP-OES, electrochemical capacity, and charge-transfer resistance analyses in the half-cell using S-NCM and P-NCM powders as cathode active materials; (e) F 1s XPS patterns of S-NCM powders for different sputtering times using an ion-beam. Based on the calculated integral area, the proportional values of the organics and inorganics in fluoride are presented in the patterns; (f) HAADF-STEM images based on focused ion beam cutting and an enlarged view displaying the interior microcracks. Corresponding EDS mapping analysis indicates the presence of F elements along these microcracks pointed out by a white arrow. (g) Deficiencies of S-NCM addressed before direct regeneration, including the compositional and structural aspects (e.g., irreversible lithium-ionic loss, phase degradation, internal and external cracks) and latent chemical defects (e.g., surface and crack-edge impurities enriching the F element).

As shown in the Materials and methods and Fig. S1 (ESI†), a series of pretreatments, such as sorting, dismantling, crushing, and shredding, were employed to collect the spent NCM cathode (denoted as S-NCM) with minor metal and polyvinylidene fluoride (PVDF) binder (Table S3 and Fig. S2, ESI†). First, a comprehensive comparison between S-NCM and pristine NCM cathodes (P-NCM) was conducted to identify the failure mechanism of the S-NCM materials. As shown in scanning electron microscope (SEM) images (Fig. 1a and Fig. S3, ESI†), the end-of-life battery S-NCM cathode showed intensive rough surface residuals with minor cracks after 250 000-mile service, with the planar gliding degradation and cracks in the single-crystal cathode consistent with previous reports.<sup>26,27</sup> The X-ray diffraction (XRD) analysis, shown in Fig. 1b, demonstrated that the S-NCM still preserved an ordered layered  $R\bar{3}m$  structure with a minor degraded phase near the (101), (104), and (018) peaks, possibly corresponding to the subtle monoclinic phase transition due to lithium loss.<sup>28</sup> According to the high angle annular dark field scanning transmission electron microscopy (HAADF-STEM) analysis and fast Fourier transform (FFT) pattern (Fig. 1c and Fig. S4, ESI†), the degraded S-NCM cathode showed a spinel phase in zone 2 and exhibited significant spatial heterogeneity. Besides the structural degradation, the inductively coupled plasma optical emission spectrometry (ICP-OES) result (Fig. 1d and Table S4, ESI†) indicated that, even after the long-term cycling, the end-of-life S-NCM cathode showed only 13.1% loss of Li inventory compared to the pristine P-NCM. Contradictorily, the specific capacity of S-NCM significantly declined to 37.5 mA h g<sup>-1</sup> compared to 178.1 mA h g<sup>-1</sup> for the P-NCM, as shown in Fig. 1d. Especially in the follow-up cycle, see Fig. S5 (ESI†), the S-NCM cathode exhibited a capacity of less than 10 mA h g<sup>-1</sup> after 100 cycles. Note that, there was only 13.1% Li deficiencies, which could not sufficiently account for the 78.9% capacity fading of S-NCM. Therefore, to further reveal the origin of the poor electrochemical performance, electrochemical impedance spectroscopy (EIS) characterization was conducted, as shown in Fig. 1d and Fig. S6 (ESI†), the charge-transfer resistance ( $R_{ct}$ ) for S-NCM steeply climbed to 2105  $\Omega$  and was

four times larger than the P-NCM of 500  $\Omega$ . The increased impedance deteriorates the  $\text{Li}^+$  diffusion, thus leading to the critical capacity decay. Therefore, the surface state of the spent cathode was recognized as the key issue limiting its capacity delivery, compared to compositional lithium loss and structural bulk defects.

To understand the surface state of the spent cathode, energy-dispersive spectroscopy (EDS) element mapping and X-ray photoelectron spectroscopy (XPS) were conducted. As shown in Fig. S7–S9, and Tables S5, S6 (ESI<sup>†</sup>), the S-NCM cathode surface residuals consisted of C, O, F, and P elements, and displayed a surface-rich gradient distribution, as revealed

by XPS with etching. The F 1s XPS peaks with etching for S-NCM are shown in Fig. 1e, where two F 1s peaks could be observed before sputtering, with the major peak centered at 685.5 eV, which was attributed to inorganic fluorides and the minor F 1s peak centered at 690.4 eV, which could be assigned to organic fluorides, with the ratio of 53.8% for organic fluorides.<sup>29</sup> However, the organic-related F peak declined significantly after sputtering, and completely disappeared after 300 s  $\text{Ar}^+$  sputtering. The surface-rich distribution of organic fluoride was consistent with the cathode electrolyte interphase (CEI) composition previously reported.<sup>29,30</sup>

To further reveal the microscopic distribution of those F-rich residuals, SEM combined with time-of-flight secondary ion mass spectrometry (SEM-ToF-SIMS) characterization was conducted for the cycled cathode. The results are shown in Fig. S10 and Videos S1, S2 (ESI<sup>†</sup>). Based on the spatial distribution of F<sup>-</sup> secondary ion fragments, it was confirmed that fluoride impurities were primarily deposited on the particle surface. Moreover, during the long-time battery service, it could be observed from the HAADF-STEM image and corresponding element mapping (see Fig. 1f) that, in the S-NCM cathode, the fluorides could spread into the interior of the cathode along the intragranular cracks. Coincidentally, from the selected FFT figure shown in Fig. S4 (ESI<sup>†</sup>), the existence of an amorphous ring was observed along the intragranular cracking, which may be related to the fluorides also observed in the bulk. To sum up, the collected S-NCM exhibited limited structural and compositional degradation, while preserving the fluoride-containing impurities aggregated on the surface and along the intragranular cracks, as illustrated in Fig. 1g.

Furthermore, it was previously widely accepted that the source of F-rich impurities in the spent cathode was due to decomposition of the PVDF binder during the heat delamination process at around 350 °C;<sup>11,23–25,31</sup> however, during the thermal decomposition of PVDF, most the fluoride-containing products were gas species (*i.e.*, HF) and fragments (–CF– and –CH–CF–),<sup>32–34</sup> which are subject to ejection instead of propagating along the cathode intragranular cracks. To confirm the source of those observed residual impurities, four kinds of cathodes with varying cycling conditions were collected and examined, namely cathode laminates with/without electrolyte filling, and laminates from 125k and 250k miles-serviced batteries, as listed in Table S7 (ESI<sup>†</sup>). The SEM images and electrochemical performance are shown in Fig. S11 and S12 (ESI<sup>†</sup>). Compared with the pristine one (sample A), the other spent cathodes from battery formation and cycling exhibited a rough surface and limited discharge capacity. Notably, the laminate from formation only but with no cycling (sample B), which it was believed would retain the full lithium inventory and show negligible structural degradation since it had not undergone charge/discharge cycling, showed a poor discharge capacity, which was the same as the other long-cycled ones. Moreover, the heat exfoliation used to pyrolyze the adhesive binders deteriorated the original CEI layer on the spent cathodes and generated more harmful byproducts (*e.g.*, Li<sub>2</sub>CO<sub>3</sub>, Li<sub>3</sub>PO<sub>4</sub>, LiF). This, combined with electrolyte decomposition during electrochemical cycling, exacerbates chemical degradation, resulting in a significant capacity decline. Therefore, the above comparison revealed that the cathode residual impurities should originate from the electrolyte components (such as LiPF<sub>6</sub>, DMC, ethylene carbonate (EC)) decomposition during battery formation, cycling, and common heat exfoliation, leading to severe capacity loss in spent cathodes (Fig. 1d).

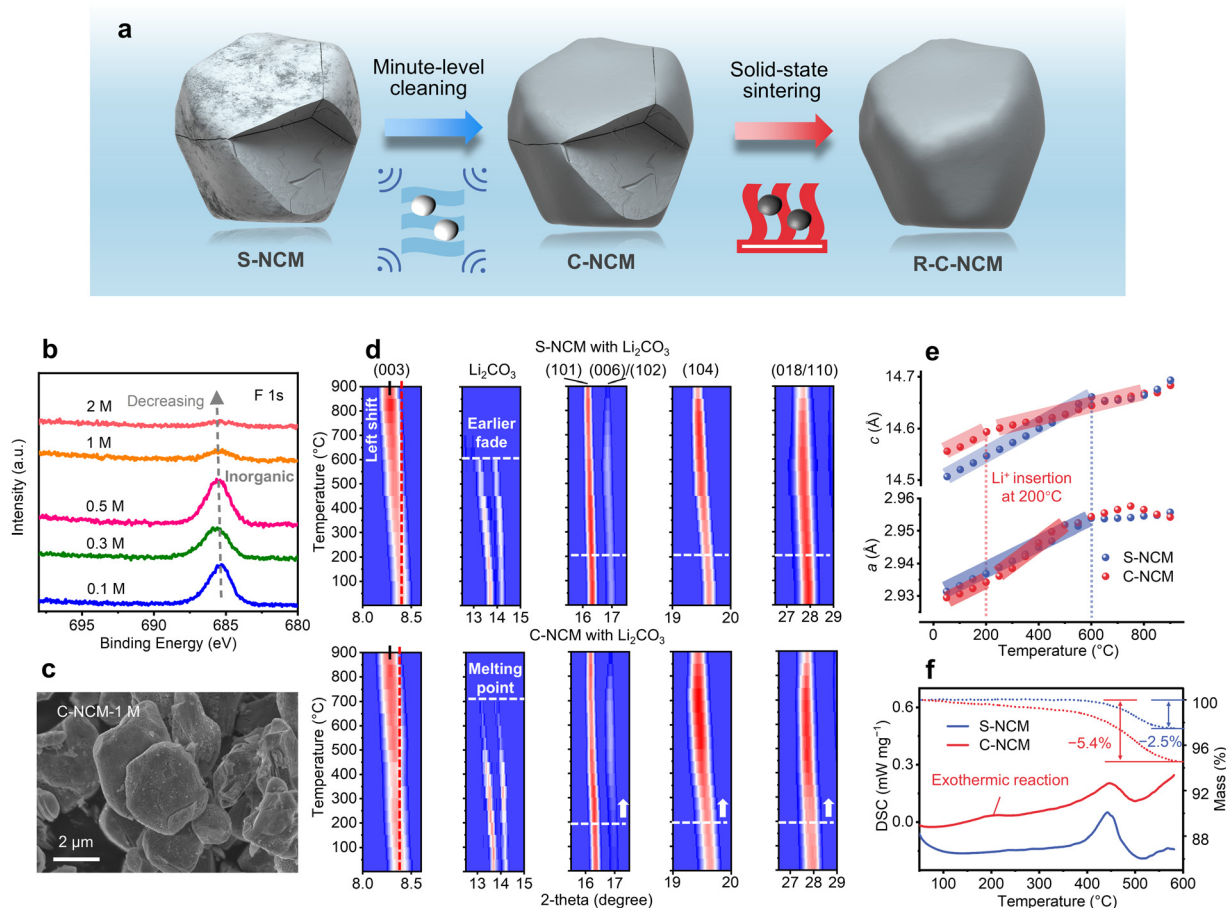
**Fig. 2** Removal of the impurities and change in the crystal structure during the direct regeneration process combined with pretreatment. (a) Traditional direct regeneration path using solid-state sintering and the minute-level pretreatment introduced in an advanced path targeted to the critical obstacles within degraded cathode materials; (b) F 1s XPS fine patterns of C-NCM undergoing ultrasonic stirring in solutions with different concentrations; (c) SEM image of C-NCM obtained by soaking S-NCM in 1 M  $\text{HNO}_3$  solution; (d) partial *in situ* XRD patterns of S-NCM and C-NCM mixed with a Li resource, keeping a constant heating rate ( $20\text{ }^\circ\text{C min}^{-1}$ ) and holding the temperature for diffraction at  $50\text{ }^\circ\text{C}$  intervals; (e) evolution of the unit cell parameters  $a$  and  $c$  for S-NCM (blue symbols) and C-NCM (red symbols) mixed with Li slate through Rietveld refinement. The earlier  $\text{Li}^+$  insertion at  $200\text{ }^\circ\text{C}$  changed the variation tendency of the unit parameters for the sample after cleaning. (f) Heat generation measured by DSC from mixtures.

morphology of the cathode remained unchanged, which may be related to the  $\text{Li}^+/\text{H}^+$  exchange mechanism with the stabilizing lattice structure.<sup>40,41</sup> Moreover, as shown in Fig. 2b and Fig. S22 (ESI<sup>†</sup>), based on the charge/discharge efficiency, we further optimized the solution concentration as 1 M in the following investigations.

To reveal the effect of the residuals during the direct regeneration of the recycled cathode, *in situ* XRD characterizations were compared following the regeneration of S-NCM and C-NCM. During the heating, the unit cell lattice first nearly linearly expanded until there was a differentiation of the expansion ratio caused by the lithium insertion. As shown in Fig. 2d, the shift of the (003) peak of C-NCM was less pronounced than that of S-NCM when heating to  $900\text{ }^\circ\text{C}$ , indicating its unit cell lattice  $c$  was not expanded as much as for the S-NCM due to its more efficient lithium insertion. Therefore, more lithium insertion was observed for the C-NCM cathode. Correspondingly, the  $\text{Li}_2\text{CO}_3$  in the mixture of S-NCM and C-NCM also performed differently, whereby the  $\text{Li}_2\text{CO}_3$  in the

C-NCM cathode was consumed gradually until it disappeared at its melting point around  $730\text{ }^\circ\text{C}$ , while the  $\text{Li}_2\text{CO}_3$  in the S-NCM cathode completely vanished at around only  $600\text{ }^\circ\text{C}$ , and this earlier consumption of the lithium source may be attributed to the reaction between  $\text{Li}_2\text{CO}_3$  and the residual impurities (such as  $\text{LiF}$ ,  $\text{LiOH}$ , and  $\text{Li}_3\text{PO}_4$ ) by co-melting, vaporizing, and replenishing in S-NCM.<sup>42</sup> Equivalently, the high angle reflection peak intensity spanning from (006) to (110), representing the layered structure, significantly increased starting from around  $200\text{ }^\circ\text{C}$  for the C-NCM cathode after the purifying treatment compared to there being no obvious enhancement for S-NCM, indicating the better repair of the layered structure during heating. To further unveil the underlying mechanism, Rietveld refinement of each XRD pattern was conducted, which can depict the continuous change of the unit cell parameters during regeneration. Generally, the unit cell parameter  $c$  decreases and  $a$  increases with the insertion of Li ions into a layered structure, similar to in the discharge process.<sup>28</sup> As shown in Fig. 2e, the lattice evolution of the S- and C-NCM

cathodes were compared. For C-NCM, the lattice  $c$  expansion slope became obviously flatter at 200 °C, denoting a lattice  $c$  shrinkage at this temperature induced by the Li-ion insertion and repairing. However, for the S-NCM without undergoing purifying treatment for the residuals, the lattice expanded still nearly linearly with no obvious lithium insertion until 600 °C. Concurrently, the lattice  $a$  expansion slope became steeper at 200 °C for C-NCM. Last but not least, Differential scanning calorimetry (DSC) characterization was also conducted during the regeneration process to confirm the lithium insertion pattern for the S- and C-NCM cathodes, which can trace the lithium replenishment associated with the exothermic reaction as reported by others.<sup>43</sup> As shown in Fig. 2f, the characteristic exothermic reaction at around 200 °C was only observed for C-NCM, confirmed the earlier lithium insertion after the purifying treatment. The earlier lithium insertion was also supported by the CO<sub>2</sub> gas release observed during Li<sub>2</sub>CO<sub>3</sub> decomposition to supply the lithium source for the C-NCM cathode, as shown Fig. S23 (ESI<sup>†</sup>). Moreover, from the thermogravimetric results

shown in Fig. 2f, the weight loss of C-NCM was 5.4%, which was significantly larger than that of S-NCM of 2.5%, indicating that more Li<sub>2</sub>CO<sub>3</sub> was activated and decomposed to provide the lithium source for C-NCM.<sup>43,44</sup> To sum up, through multiple *in situ* and *ex situ* characterizations, we proved that, with a purifying pretreatment, the direct regeneration could be facilitated to start at a lower temperature of 200 °C from the spent cathode.

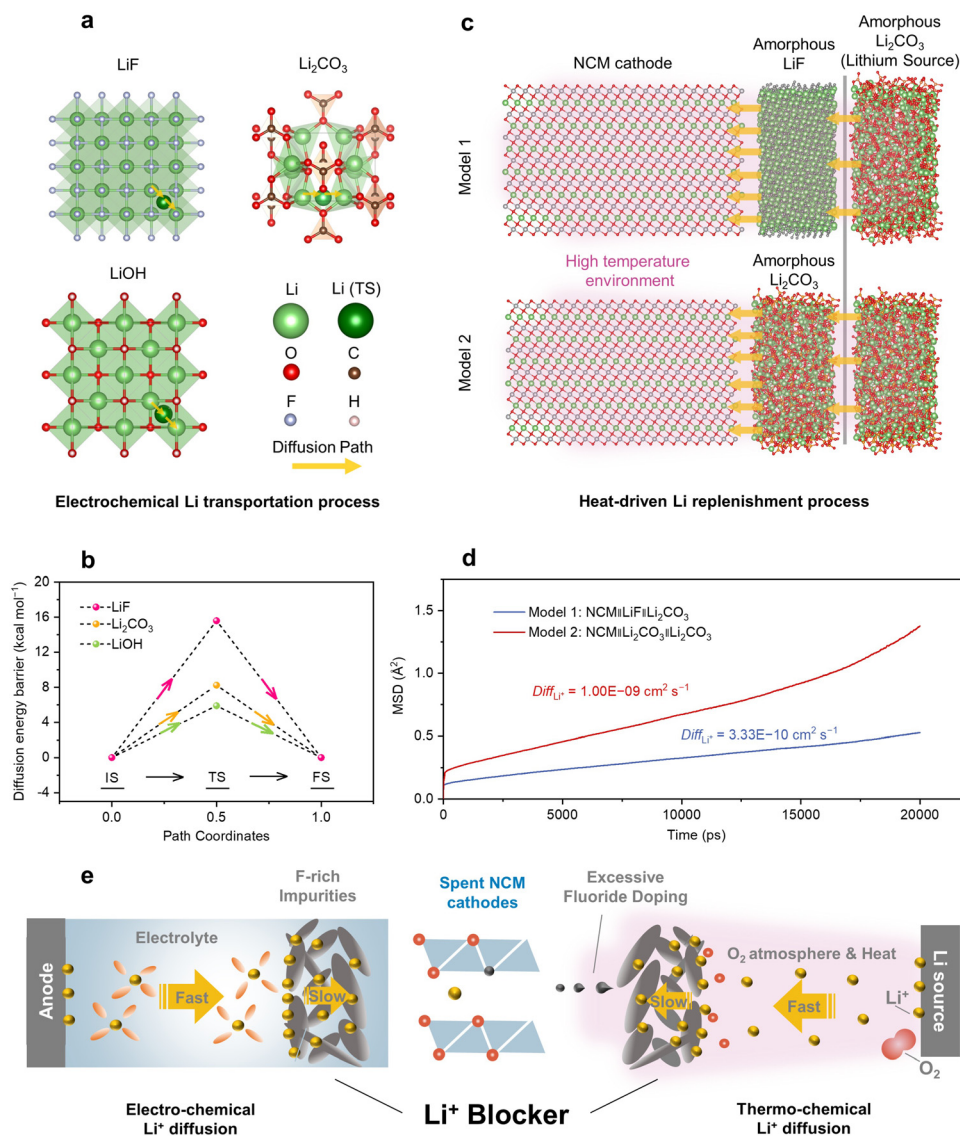
**Fig. 5** Role of the F-rich impurities as a blocker in electrochemical and thermochemical  $\text{Li}^+$  diffusion as ascertained from thermodynamic and kinetic simulations. (a) Illustrations of the selected migration pathways with a similar distance for  $\text{Li}^+$  inside the crystal lattice of three common components. The initial state, transition state, and final state of  $\text{Li}^+$  transportation are denoted as IS, TS, and FS, respectively. (b) Calculated energy diffusion barrier for Li ions in selected phases. (c) Two models for stimulating the kinetics of Li transportation in direct regeneration. Model 1 consists of the NCM cathode substrate, the amorphous LiF layer, and  $\text{Li}_2\text{CO}_3$  as a lithium source in direct regeneration, which is denoted as  $\text{NCM}||\text{LiF}||\text{Li}_2\text{CO}_3$ . In Model 2 ( $\text{NCM}||\text{Li}_2\text{CO}_3||\text{Li}_2\text{CO}_3$  in short), the middle LiF layer is replaced by a common residual alkali ( $\text{Li}_2\text{CO}_3$ ), which is used to simulate the regeneration of NCM cathodes after cleaning pretreatment. Each shape symbol is the same as for Fig. 5a. (d) MSD of the Li atoms in 20 ns and calculated  $\text{Li}^+$  diffusivity based on the above model. “E – 9” means  $10^{-9}$ . (e) Mechanism diagram for preventing the NCM cathodes from reusing and directly regenerating under the influence of impurities.

According to the above results (Fig. 1d, Fig. S6, S16 (ESI†), and Fig. 4h, i), the migration rate of lithium ions was significantly influenced by the residual impurities; therefore it was crucial to theoretically investigate their influence on capacity delivery in the reuse case and during direct regeneration. Considering the impurities were mostly concentrated at the surface before and after regeneration, and that F-rich residuals could be observed, as shown in Fig. S9 and S10 (ESI†) and Fig. 3c, we chose three representative inorganic components ( $\text{LiF}$ ,  $\text{Li}_2\text{CO}_3$ , and  $\text{LiOH}$ ) in the CEI layer<sup>48</sup> or residual alkali<sup>49</sup> to calculate the  $\text{Li}^+$  diffusion from a thermodynamic perspective, and their structures are shown in Fig. 5a. By maintaining a similar distance and concentration of mobile Li-ions, the diffusion energy barrier of lithium ions ( $\Delta E_{\text{Li}^+}$ ) during the cycling of spent cathodes within the different crystal structures (Fig. 5b) allowed valid comparisons. We found that the  $\Delta E_{\text{Li}^+}$  of the  $\text{LiF}$  phase, as a common inorganic component from CEI, was about 2 and 3 times higher than that of the  $\text{LiOH}$  and  $\text{Li}_2\text{CO}_3$  phases from

Fig. 5b. Therefore, this result confirmed that the presence of fluoride-rich impurity residuals on the cathode surface significantly increased the diffusion resistance of Li ions when cycling, ultimately exacerbating the cell impedance and interfacial parasitic reactions (Fig. 1d). To comprehend the larger-scale kinetic characteristics and understand the effect of impurity coatings during heating for regeneration of the spent cathodes, two molecular dynamics models were established for simulating  $\text{Li}^+$  transportation at 1000 K over 20 ns. Specifically, Model 1 was devised to include an impurity barrier consisting of a  $\text{LiF}$  layer (Fig. 5c and Fig. S33, ESI†). Through computing the mean square displacement (MSD) of Li atoms and fitting curves (Fig. 5d), we determined that the Li diffusivity ( $\text{Diff}_{\text{Li}^+}$ ) of Model 1 was  $3.33 \times 10^{-10}$ , which was an order of magnitude lower than that of Model 2 ( $1.00 \times 10^{-9}$ ). The differences in molecular dynamics models under practical conditions suggest that fluoride-rich impurity coatings increase the resistance to Li-ion diffusion into spent cathodes with Li deficiencies during thermo-driven regeneration, leading to inadequate compositional and structural recovery.

As illustrated in Fig. 5e, the impurity phase containing the F element served as an electro- and thermo-diffusion blocker of Li ions hindering the reuse and direct regeneration of the spent cathode. In the spent cathodes collected by physical pretreatment and collection from used lithium-ion batteries, the ubiquitous electrolyte was decomposed to form an ion barrier with slow ion diffusivity. However, these impurities have long been overlooked in most studies (Table S2, ESI†), mainly due to the use of lab-scale degraded cathodes and fine manual separation pretreatment. In previous studies,<sup>12-16,42</sup> the latent impact of the residual impurities on direct regeneration remains untouched because impurities are easily converted into other inconspicuous matter in extreme physical or chemical regeneration environments. Looking ahead, the direct regeneration of next-generation sensitive cathode materials, such as Li-rich Mn-based, Co-free, and ultra-high-Ni cathode materials, faces serious challenges from these latent impurities if they enter the recycling circle. From another perspective, establishing the controlling law for the inherent impurities doping within the closed-loop material flow could instructively enhance the performance of such recycled materials in the future. Moreover, only by revealing the effect of the overlooked impurities or by getting rid of impurities, can evolving technologies and mechanisms for direct regeneration and upcycling be reasonably evaluated.<sup>50</sup>
