Cite this: *Energy Environ. Sci.*, 2025, 18, 264

# Removal of residual contaminants by minute-level washing facilitates the direct regeneration of spent cathodes from retired EV Li-ion batteries†

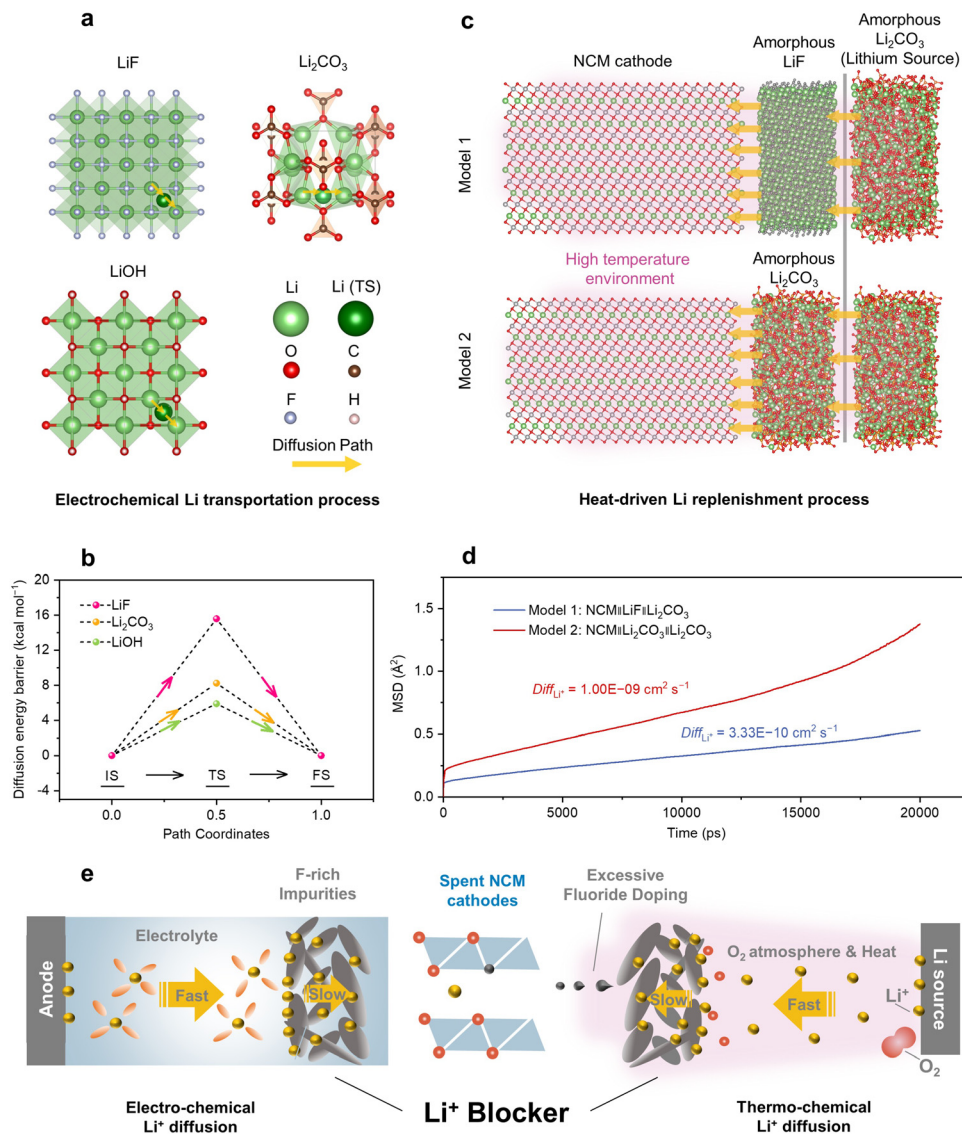
**Fig. 5** Role of the F-rich impurities as a blocker in electrochemical and thermochemical  $\text{Li}^+$  diffusion as ascertained from thermodynamic and kinetic simulations. (a) Illustrations of the selected migration pathways with a similar distance for  $\text{Li}^+$  inside the crystal lattice of three common components. The initial state, transition state, and final state of  $\text{Li}^+$  transportation are denoted as IS, TS, and FS, respectively. (b) Calculated energy diffusion barrier for Li ions in selected phases. (c) Two models for stimulating the kinetics of Li transportation in direct regeneration. Model 1 consists of the NCM cathode substrate, the amorphous LiF layer, and  $\text{Li}_2\text{CO}_3$  as a lithium source in direct regeneration, which is denoted as  $\text{NCM} \parallel \text{LiF} \parallel \text{Li}_2\text{CO}_3$ . In Model 2 ( $\text{NCM} \parallel \text{Li}_2\text{CO}_3 \parallel \text{Li}_2\text{CO}_3$  in short), the middle LiF layer is replaced by a common residual alkali ( $\text{Li}_2\text{CO}_3$ ), which is used to simulate the regeneration of NCM cathodes after cleaning pretreatment. Each shape symbol is the same as for Fig. 5a. (d) MSD of the Li atoms in 20 ns and calculated  $\text{Li}^+$  diffusivity based on the above model. "E – 9" means  $10^{-9}$ . (e) Mechanism diagram for preventing the NCM cathodes from reusing and directly regenerating under the influence of impurities.

According to the above results (Fig. 1d, Fig. S6, S16 (ESI†), and Fig. 4h, i), the migration rate of lithium ions was significantly influenced by the residual impurities; therefore it was crucial to theoretically investigate their influence on capacity delivery in the reuse case and during direct regeneration. Considering the impurities were mostly concentrated at the surface before and after regeneration, and that F-rich residuals could be observed, as shown in Fig. S9 and S10 (ESI†) and Fig. 3c, we chose three representative inorganic components ( $\text{LiF}$ ,  $\text{Li}_2\text{CO}_3$ , and  $\text{LiOH}$ ) in the CEI layer<sup>48</sup> or residual alkali<sup>49</sup> to calculate the  $\text{Li}^+$  diffusion from a thermodynamic perspective, and their structures are shown in Fig. 5a. By maintaining a similar distance and concentration of mobile Li-ions, the diffusion energy barrier of lithium ions ( $\Delta E_{\text{Li}^+}$ ) during the cycling of spent cathodes within the different crystal structures (Fig. 5b) allowed valid comparisons. We found that the  $\Delta E_{\text{Li}^+}$  of the  $\text{LiF}$  phase, as a common inorganic component from CEI, was about 2 and 3 times higher than that of the  $\text{LiOH}$  and  $\text{Li}_2\text{CO}_3$  phases from

Fig. 5b. Therefore, this result confirmed that the presence of fluoride-rich impurity residuals on the cathode surface significantly increased the diffusion resistance of Li ions when cycling, ultimately exacerbating the cell impedance and interfacial parasitic reactions (Fig. 1d). To comprehend the larger-scale kinetic characteristics and understand the effect of impurity coatings during heating for regeneration of the spent cathodes, two molecular dynamics models were established for simulating  $\text{Li}^+$  transportation at 1000 K over 20 ns. Specifically, Model 1 was devised to include an impurity barrier consisting of a  $\text{LiF}$  layer (Fig. 5c and Fig. S33, ESI†). Through computing the mean square displacement (MSD) of Li atoms and fitting curves (Fig. 5d), we determined that the Li diffusivity ( $\text{Diff}_{\text{Li}^+}$ ) of Model 1 was  $3.33 \times 10^{-10}$ , which was an order of magnitude lower than that of Model 2 ( $1.00 \times 10^{-9}$ ). The differences in molecular dynamics models under practical conditions suggest that fluoride-rich impurity coatings increase the resistance to Li-ion diffusion into spent cathodes with Li deficiencies during thermo-driven regeneration, leading to inadequate compositional and structural recovery.

As illustrated in Fig. 5e, the impurity phase containing the F element served as an electro- and thermo-diffusion blocker of Li ions hindering the reuse and direct regeneration of the spent cathode. In the spent cathodes collected by physical pretreatment and collection from used lithium-ion batteries, the ubiquitous electrolyte was decomposed to form an ion barrier with slow ion diffusivity. However, these impurities have long been overlooked in most studies (Table S2, ESI†), mainly due to the use of lab-scale degraded cathodes and fine manual separation pretreatment. In previous studies,<sup>12–16,42</sup> the latent impact of the residual impurities on direct regeneration remains untouched because impurities are easily converted into other inconspicuous matter in extreme physical or chemical regeneration environments. Looking ahead, the direct regeneration of next-generation sensitive cathode materials, such as Li-rich Mn-based, Co-free, and ultra-high-Ni cathode materials, faces serious challenges from these latent impurities if they enter the recycling circle. From another perspective, establishing the controlling law for the inherent impurities doping within the closed-loop material flow could instructively enhance the performance of such recycled materials in the future. Moreover, only by revealing the effect of the overlooked impurities or by getting rid of impurities, can evolving technologies and mechanisms for direct regeneration and upcycling be reasonably evaluated.<sup>50</sup>
