Cite this: *Energy Environ. Sci.*, 2025, 18, 264

# Removal of residual contaminants by minute-level washing facilitates the direct regeneration of spent cathodes from retired EV Li-ion batteries†

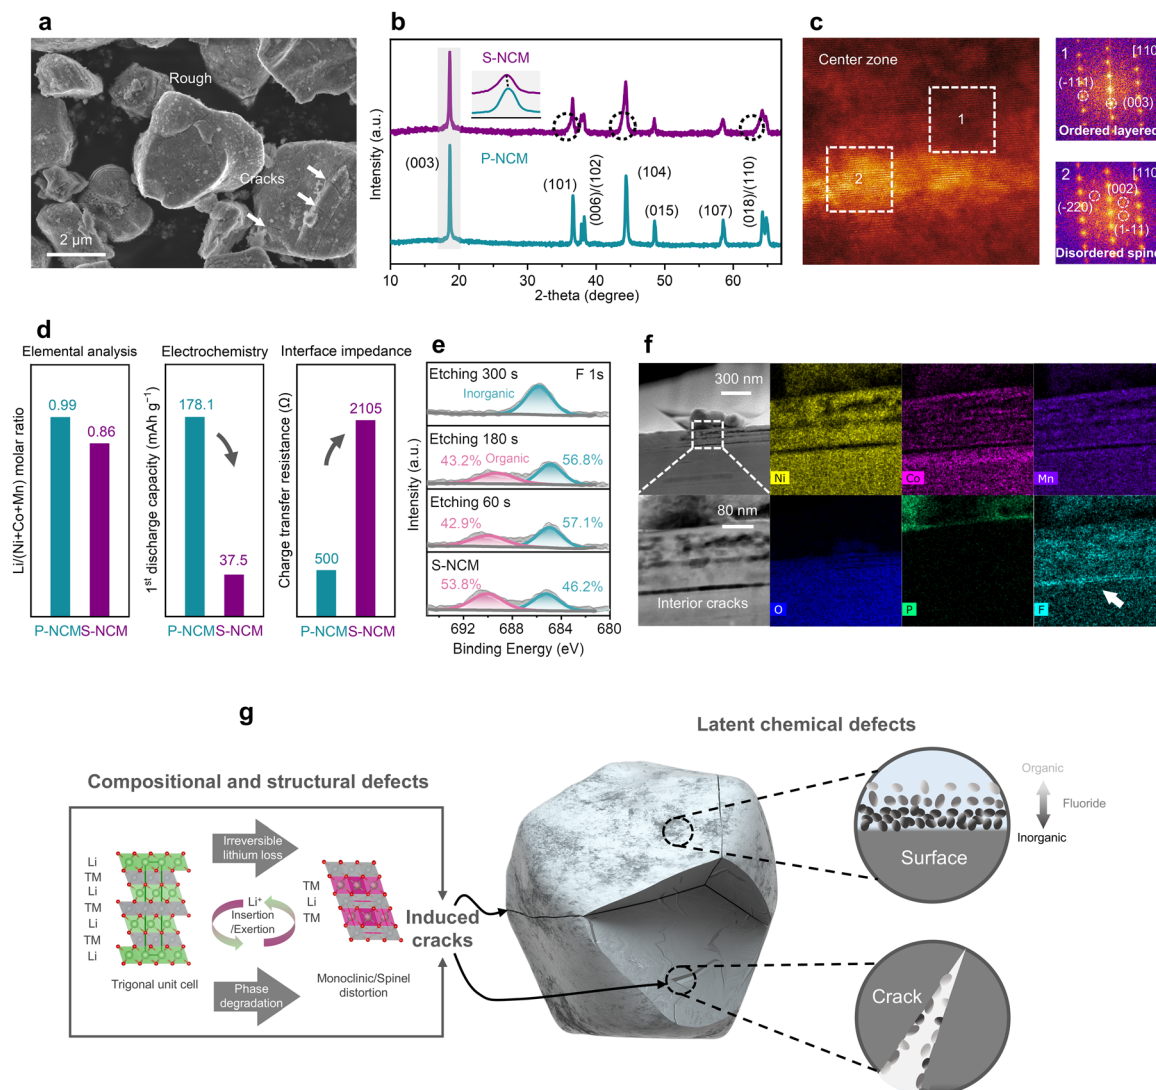
**Fig. 1** Neglected chemical residuals on the 250k-miles-serviced cathode. (a) SEM image and (b) XRD pattern of the degraded S-NCM. The black dotted circle accentuates the subtle peaks that do not belong to the layered structure; (c) high-resolution HAADF-STEM images on the central area of the S-NCM particle and the FFT patterns of the selected dark and bright regions; (d) comprehensive comparison of lithium loss in degraded powders measured by ICP-OES, electrochemical capacity, and charge-transfer resistance analyses in the half-cell using S-NCM and P-NCM powders as cathode active materials; (e) F 1s XPS patterns of S-NCM powders for different sputtering times using an ion-beam. Based on the calculated integral area, the proportional values of the organics and inorganics in fluoride are presented in the patterns; (f) HAADF-STEM images based on focused ion beam cutting and an enlarged view displaying the interior microcracks. Corresponding EDS mapping analysis indicates the presence of F elements along these microcracks pointed out by a white arrow. (g) Deficiencies of S-NCM addressed before direct regeneration, including the compositional and structural aspects (e.g., irreversible lithium-ionic loss, phase degradation, internal and external cracks) and latent chemical defects (e.g., surface and crack-edge impurities enriching the F element).

To understand the surface state of the spent cathode, energy-dispersive spectroscopy (EDS) element mapping and X-ray photoelectron spectroscopy (XPS) were conducted. As shown in Fig. S7–S9, and Tables S5, S6 (ESI<sup>†</sup>), the S-NCM cathode surface residuals consisted of C, O, F, and P elements, and displayed a surface-rich gradient distribution, as revealed

by XPS with etching. The F 1s XPS peaks with etching for S-NCM are shown in Fig. 1e, where two F 1s peaks could be observed before sputtering, with the major peak centered at 685.5 eV, which was attributed to inorganic fluorides and the minor F 1s peak centered at 690.4 eV, which could be assigned to organic fluorides, with the ratio of 53.8% for organic fluorides.<sup>29</sup> However, the organic-related F peak declined significantly after sputtering, and completely disappeared after 300 s Ar<sup>+</sup> sputtering. The surface-rich distribution of organic fluoride was consistent with the cathode electrolyte interphase (CEI) composition previously reported.<sup>29,30</sup>

To further reveal the microscopic distribution of those F-rich residuals, SEM combined with time-of-flight secondary ion mass spectrometry (SEM-ToF-SIMS) characterization was conducted for the cycled cathode. The results are shown in Fig. S10 and Videos S1, S2 (ESI†). Based on the spatial distribution of F<sup>−</sup> secondary ion fragments, it was confirmed that fluoride impurities were primarily deposited on the particle surface. Moreover, during the long-time battery service, it could be observed from the HAADF-STEM image and corresponding element mapping (see Fig. 1f) that, in the S-NCM cathode, the fluorides could spread into the interior of the cathode along the intragranular cracks. Coincidentally, from the selected FFT figure shown in Fig. S4 (ESI†), the existence of an amorphous ring was observed along the intragranular cracking, which may be related to the fluorides also observed in the bulk. To sum up, the collected S-NCM exhibited limited structural and compositional degradation, while preserving the fluoride-containing impurities aggregated on the surface and along the intragranular cracks, as illustrated in Fig. 1g.

Furthermore, it was previously widely accepted that the source of F-rich impurities in the spent cathode was due to decomposition of the PVDF binder during the heat delamination process at around 350 °C;<sup>11,23–25,31</sup> however, during the thermal decomposition of PVDF, most the fluoride-containing products were gas species (*i.e.*, HF) and fragments (−CF− and −CH−CF−),<sup>32–34</sup> which are subject to ejection instead of propagating along the cathode intragranular cracks. To confirm the source of those observed residual impurities, four kinds of cathodes with varying cycling conditions were collected and examined, namely cathode laminates with/without electrolyte filling, and laminates from 125k and 250k miles-serviced batteries, as listed in Table S7 (ESI†). The SEM images and electrochemical performance are shown in Fig. S11 and S12 (ESI†). Compared with the pristine one (sample A), the other spent cathodes from battery formation and cycling exhibited a rough surface and limited discharge capacity. Notably, the laminate from formation only but with no cycling (sample B), which it was believed would retain the full lithium inventory and show negligible structural degradation since it had not undergone charge/discharge cycling, showed a poor discharge capacity, which was the same as the other long-cycled ones. Moreover, the heat exfoliation used to pyrolyze the adhesive binders deteriorated the original CEI layer on the spent cathodes and generated more harmful byproducts (*e.g.*, Li<sub>2</sub>CO<sub>3</sub>, Li<sub>3</sub>PO<sub>4</sub>, LiF). This, combined with electrolyte decomposition during electrochemical cycling, exacerbates chemical degradation, resulting in a significant capacity decline. Therefore, the above comparison revealed that the cathode residual impurities should originate from the electrolyte components (such as LiPF<sub>6</sub>, DMC, ethylene carbonate (EC)) decomposition during battery formation, cycling, and common heat exfoliation, leading to severe capacity loss in spent cathodes (Fig. 1d).
