# Energy & Environmental Science

Removal of residual contaminants by minute-level washing facilitates the direct regeneration of spent cathodes from retired EV Li-ion batteries;

DOI: 10.1039/d4ee03021d

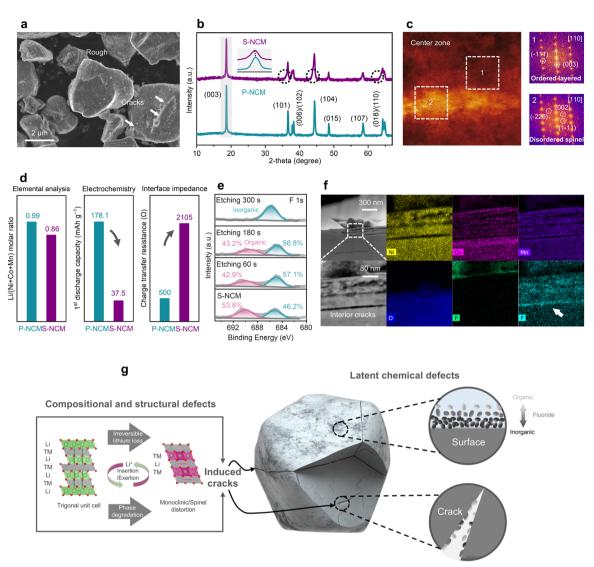
**Fig. 1** Neglected chemical residuals on the 250k-miles-serviced cathode. (a) SEM image and (b) XRD pattern of the degraded S-NCM. The black dotted circle accentuates the subtle peaks that do not belong to the layered structure; (c) high-resolution HAADF-STEM images on the central area of the S-NCM particle and the FFT patterns of the selected dark and bright regions; (d) comprehensive comparison of lithium loss in degraded powders measured by ICP-OES, electrochemical capacity, and charge-transfer resistance analyses in the half-cell using S-NCM and P-NCM powders as cathode active materials; (e) F 1s XPS patterns of S-NCM powders for different sputtering times using an ion-beam. Based on the calculated integral area, the proportional values of the organics and inorganics in fluoride are presented in the patterns; (f) HAADF-STEM images based on focused ion beam cutting and an enlarged view displaying the interior microcracks. Corresponding EDS mapping analysis indicates the presence of F elements along these microcracks pointed out by a white arrow. (g) Deficiencies of S-NCM addressed before direct regeneration, including the compositional and structural aspects (*e.g.*, irreversible lithium-ionic loss, phase degradation, internal and external cracks) and latent chemical defects (*e.g.*, surface and crack-edge impurities enriching the F element).

As shown in the Materials and methods and Fig. S1 (ESI<sup>+</sup>), a series of pretreatments, such as sorting, dismantling, crushing, and shredding, were employed to collect the spent NCM cathode (denoted as S-NCM) with minor metal and polyvinylidene fluoride (PVDF) binder (Table S3 and Fig. S2, ESI†). First, a comprehensive comparison between S-NCM and pristine NCM cathodes (P-NCM) was conducted to identify the failure mechanism of the S-NCM materials. As shown in scanning electron microscope (SEM) images (Fig. 1a and Fig. S3, ESI<sup>+</sup>), the end-oflife battery S-NCM cathode showed intensive rough surface residuals with minor cracks after 250 000-mile service, with the planar gliding degradation and cracks in the single-crystal cathode consistent with previous reports.<sup>26,27</sup> The X-ray diffraction (XRD) analysis, shown in Fig. 1b, demonstrated that the S-NCM still preserved an ordered layered  $R\bar{3}m$  structure with a minor degraded phase near the (101), (104), and (018) peaks, possibly corresponding to the subtle monoclinic phase transition due to lithium loss.<sup>28</sup> According to the high angle annular dark field scanning transmission electron microscopy (HAADF-STEM) analysis and fast Fourier transform (FFT) pattern (Fig. 1c and Fig. S4, ESI<sup>†</sup>), the degraded S-NCM cathode showed a spinel phase in zone 2 and exhibited significant spatial heterogeneity. Besides the structural degradation, the inductively coupled plasma optical emission spectrometry (ICP-OES) result (Fig. 1d and Table S4, ESI<sup>+</sup>) indicated that, even after the longterm cycling, the end-of-life S-NCM cathode showed only 13.1% loss of Li inventory compared to the pristine P-NCM. Contradictorily, the specific capacity of S-NCM significantly declined to 37.5 mA h  $g^{-1}$  compared to 178.1 mA h  $g^{-1}$  for the P-NCM, as shown in Fig. 1d. Especially in the follow-up cycle, see Fig. S5 (ESI<sup>†</sup>), the S-NCM cathode exhibited a capacity of less than 10 mA h  $g^{-1}$  after 100 cycles. Note that, there was only 13.1% Li deficiencies, which could not sufficiently account for the 78.9% capacity fading of S-NCM. Therefore, to further reveal the origin of the poor electrochemical performance, electrochemical impedance spectroscopy (EIS) characterization was conducted, as shown in Fig. 1d and Fig. S6 (ESI<sup>†</sup>), the charge-transfer resistance  $(R_{ct})$  for S-NCM steeply climbed to 2105  $\Omega$  and was

four times larger than the P-NCM of 500  $\Omega$ . The increased impedance deteriorates the Li<sup>+</sup> diffusion, thus leading to the critical capacity decay. Therefore, the surface state of the spent cathode was recognized as the key issue limiting its capacity delivery, compared to compositional lithium loss and structural bulk defects.

To further reveal the microscopic distribution of those F-rich residuals, SEM combined with time-of-flight secondary ion mass spectrometry (SEM-ToF-SIMS) characterization was conducted for the cycled cathode. The results are shown in Fig. S10 and Videos S1, S2 (ESI<sup>+</sup>). Based on the spatial distribution of F<sup>-</sup> secondary ion fragments, it was confirmed that fluoride impurities were primarily deposited on the particle surface. Moreover, during the long-time battery service, it could be observed from the HAADF-STEM image and corresponding element mapping (see Fig. 1f) that, in the S-NCM cathode, the fluorides could spread into the interior of the cathode along the intragranular cracks. Coincidentally, from the selected FFT figure shown in Fig. S4 (ESI<sup>+</sup>), the existence of an amorphous ring was observed along the intragranular cracking, which may be related to the fluorides also observed in the bulk. To sum up, the collected S-NCM exhibited limited structural and compositional degradation, while preserving the fluoride-containing impurities aggregated on the surface and along the intragranular cracks, as illustrated in Fig. 1g.

Furthermore, it was previously widely accepted that the source of F-rich impurities in the spent cathode was due to decomposition of the PVDF binder during the heat delamination process at around 350 °C;<sup>11,23-25,31</sup> however, during the thermal decomposition of PVDF, most the fluoride-containing products were gas species (i.e., HF) and fragments (-CF- and -CH-CF-),<sup>32-34</sup> which are subject to ejection instead of propagating along the cathode intragranular cracks. To confirm the source of those observed residual impurities, four kinds of cathodes with varying cycling conditions were collected and examined, namely cathode laminates with/without electrolyte filling, and laminates from 125k and 250k miles-serviced batteries, as listed in Table S7 (ESI<sup>†</sup>). The SEM images and electrochemical performance are shown in Fig. S11 and S12 (ESI<sup>+</sup>). Compared with the pristine one (sample A), the other spent cathodes from battery formation and cycling exhibited a rough surface and limited discharge capacity. Notably, the laminate from formation only but with no cycling (sample B), which it was believed would retain the full lithium inventory and show negligible structural degradation since it had not undergone charge/discharge cycling, showed a poor discharge capacity, which was the same as the other long-cycled ones. Moreover, the heat exfoliation used to pyrolyze the adhesive binders deteriorated the original CEI layer on the spent cathodes and generated more harmful byproducts (e.g., Li<sub>2</sub>CO<sub>3</sub>, Li<sub>3</sub>PO<sub>4</sub>, LiF). This, combined with electrolyte decomposition during electrochemical cycling, exacerbates chemical degradation, resulting in a significant capacity decline. Therefore, the above comparison revealed that the cathode residual impurities should originate from the electrolyte components (such as LiPF<sub>6</sub>, DMC, ethylene carbonate (EC)) decomposition during battery formation, cycling, and common heat exfoliation, leading to severe capacity loss in spent cathodes (Fig. 1d).

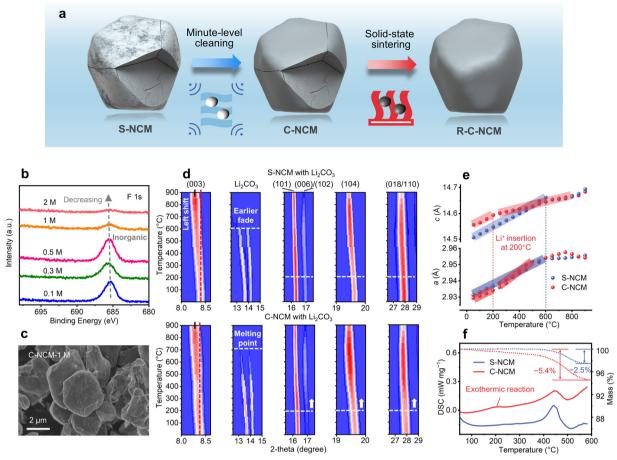
**Fig. 2** Removal of the impurities and change in the crystal structure during the direct regeneration process combined with pretreatment. (a) Traditional direct regeneration path using solid-state sintering and the minute-level pretreatment introduced in an advanced path targeted to the critical obstacles within degraded cathode materials; (b) F 1s XPS fine patterns of C-NCM undergoing ultrasonic stirring in solutions with different concentrations; (c) SEM image of C-NCM obtained by soaking S-NCM in 1 M HNO<sub>3</sub> solution; (d) partial *in situ* XRD patterns of S-NCM and C-NCM mixed with a Li resource, keeping a constant heating rate (20 °C min<sup>-1</sup>) and holding the temperature for diffraction at 50 °C intervals; (e) evolution of the unit cell parameters *a* and *c* for S-NCM (blue symbols) and C-NCM (red symbols) mixed with Li slate through Rietveld refinement. The earlier Li<sup>+</sup> insertion at 200 °C changed the variation tendency of the unit parameters for the sample after cleaning. (f) Heat generation measured by DSC from mixtures.

morphology of the cathode remained unchanged, which may be related to the  $\text{Li}^+/\text{H}^+$  exchange mechanism with the stabilizing lattice structure.<sup>40,41</sup> Moreover, as shown in Fig. 2b and Fig. S22 (ESI†), based on the charge/discharge efficiency, we further optimized the solution concentration as 1 M in the following investigations.

To reveal the effect of the residuals during the direct regeneration of the recycled cathode, *in situ* XRD characterizations were compared following the regeneration of S-NCM and C-NCM. During the heating, the unit cell lattice first nearly linearly expanded until there was a differentiation of the expansion ratio caused by the lithium insertion. As shown in Fig. 2d, the shift of the (003) peak of C-NCM was less pronounced than that of S-NCM when heating to 900 °C, indicating its unit cell lattice *c* was not expanded as much as for the S-NCM due to its more efficient lithium insertion. Therefore, more lithium insertion was observed for the C-NCM cathode. Correspondingly, the Li<sub>2</sub>CO<sub>3</sub> in the mixture of S-NCM and C-NCM also performed differently, whereby the Li<sub>2</sub>CO<sub>3</sub> in the

C-NCM cathode was consumed gradually until it disappeared at its melting point around 730 °C, while the Li<sub>2</sub>CO<sub>3</sub> in the S-NCM cathode completely vanished at around only 600 °C, and this earlier consumption of the lithium source may be attributed to the reaction between Li<sub>2</sub>CO<sub>3</sub> and the residual impurities (such as LiF, LiOH, and  $Li_3PO_4$ ) by co-melting, vaporizing, and replenishing in S-NCM.<sup>42</sup> Equivalently, the high angle reflection peak intensity spanning from (006) to (110), representing the layered structure, significantly increased starting from around 200 °C for the C-NCM cathode after the purifying treatment compared to there being no obvious enhancement for S-NCM, indicting the better repair of the layered structure during heating. To further unveil the underlying mechanism, Rietveld refinement of each XRD pattern was conducted, which can depict the continuous change of the unit cell parameters during regeneration. Generally, the unit cell parameter cdecreases and a increases with the insertion of Li ions into a layered structure, similar to in the discharge process.<sup>28</sup> As shown in Fig. 2e, the lattice evolution of the S- and C-NCM

cathodes were compared. For C-NCM, the lattice c expansion slope became obviously flatter at 200  $^{\circ}$ C, denoting a lattice *c* shrinkage at this temperature induced by the Li-ion insertion and repairing. However, for the S-NCM without undergoing purifying treatment for the residuals, the lattice expanded still nearly linearly with no obvious lithium insertion until 600 °C. Concurrently, the lattice *a* expansion slope became steeper at 200 °C for C-NCM. Last but not least. Differential scanning calorimetry (DSC) characterization was also conducted during the regeneration process to confirm the lithium insertion pattern for the S- and C-NCM cathodes, which can trace the lithium replenishment associated with the exothermic reaction as reported by others.<sup>43</sup> As shown in Fig. 2f, the characteristic exothermic reaction at around 200 °C was only observed for C-NCM, confirmed the earlier lithium insertion after the purifying treatment. The earlier lithium insertion was also supported by the CO<sub>2</sub> gas release observed during Li<sub>2</sub>CO<sub>3</sub> decomposition to supply the lithium source for the C-NCM cathode, as shown Fig. S23 (ESI<sup>†</sup>). Moreover, from the thermogravimetric results shown in Fig. 2f, the weight loss of C-NCM was 5.4%, which was significantly larger than that of S-NCM of 2.5%, indicating that more  $\text{Li}_2\text{CO}_3$  was activated and decomposed to provide the lithium source for C-NCM.<sup>43,44</sup> To sum up, through multiple *in situ* and *ex situ* characterizations, we proved that, with a purifying pretreatment, the direct regeneration could be facilitated to start at a lower temperature of 200 °C from the spent cathode.

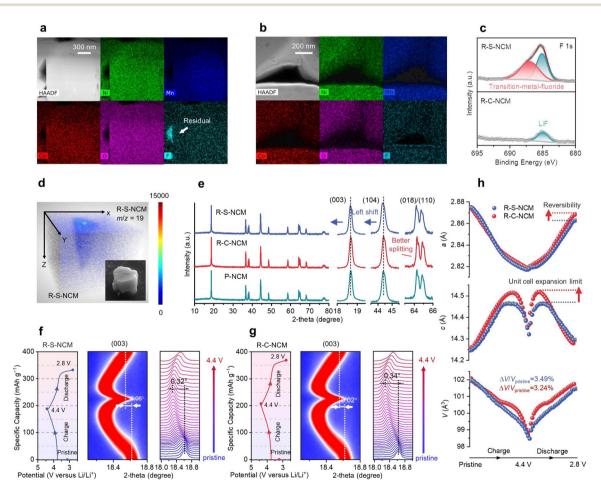
**Fig. 3** Chemical and structural details of the regenerated cathode materials under the influence of impurities. (a) HAADF-STEM images and (b) corresponding EDS element mappings of R-S-NCM and R-C-NCM particles, focusing on the pores of the packing particles. (c) F 1s XPS high-resolution patterns of R-S-NCM and R-C-NCM powders. (d) Pseudo-three-dimensional distribution of F element and SEM image of the corresponding R-S-NCM particle. (e) Full patterns and characteristic peak comparison of the regenerated and pristine NCM cathodes with Cu K $\alpha$  radiation at a scan rate of 8° min<sup>-1</sup>. (f) 1st charge–discharge curves, corresponding XRD patterns of R-S-NCM, and (g) (003) peak position variation when the cell charge from pristine to 4.4 V and comparison with R-C-NCM. (h) Lattice parameters *a*, *c*, and the unit cell volume *V* of R-S-NCM and R-C-NCM in the 1st charge–discharge test according to the refinement.

the spent cathode could completely decompose in air with an  $O_2$  atmosphere at 550 °C and 750 °C, which suggested these additives led to only minor residuals for the regenerated cathode after the high-temperature regeneration. Comparing the morphology (Fig. S25, ESI<sup>+</sup>) and element composition (Table S4, ESI<sup>†</sup>) showed that both the regenerated cathodes exhibited a smooth surface without cracks and possessed a similar composition as pristine P-NCM. However, the element distribution was distinct, as indicated by the corresponding EDS mapping shown in Fig. 3a and b, where it could be clearly seen that there were fluorine residuals aggregated in the nanopores inside the R-S-NCM cathode, while the R-C-NCM cathode did not show a F-rich area. Meanwhile, the XPS (Fig. 3c and Fig. S26, ESI<sup>†</sup>) results showed that the R-C-NCM cathode exhibited a much less intense F 1s characteristic peak and more similar C 1s and O 2p peaks with the P-NCM one compared with R-S-NCM without the purifying treatment. The SEM-ToF-SIMS results (Fig. 3d and Fig. S27 and Videos S5, S6, ESI<sup>†</sup>) also demonstrated that even though long-time calcination was applied, the F-rich residual impurities in R-S-NCM had hardly vaporized and were still concentrated on the surface and in the bulk due to their strong electronegativity.<sup>45</sup>

Furthermore, the crystal structure of the regenerated cathode could also be affected by the residual impurities. As shown in Fig. 3e and Fig. S28 (ESI<sup>+</sup>), the XRD pattern indicated a layered structure with no impurities phase for both the R-S-NCM and R-C-NCM cathodes. However, the R-C-NCM cathode had a higher (003)/(104) intensity ratio and larger splitting degree for the (018)/(110) peaks compared to R-S-NCM, suggesting its more ideal layered structure similar to P-NCM cathodes. After regeneration accompanied by impurities, the diffraction peaks of R-S-NCM were shifted toward a low-angle direction, indicating the lattice expansion, as supported by the refined parameters (Table S11, ESI<sup>†</sup>) and in situ experiments (Fig. 2d). Furthermore, in situ XRD was performed during the 1st charge/ discharge process for both regenerated cathodes (see Fig. 3f and g). The R-C-NCM cathode showed a higher capacity with a smaller offset  $(0.02^{\circ})$  of the (003) peak position than the

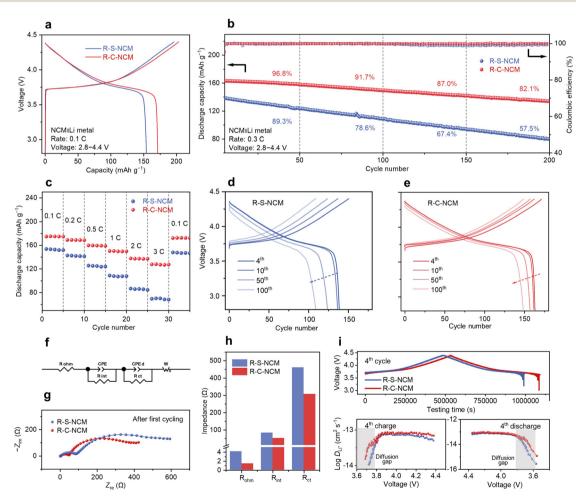
**Fig. 4** Electrochemical deterioration for the regenerated NCM cathodes with impurity residue. (a) Initial galvanostatic charge–discharge curves of R-S-NCM and R-C-NCM at 0.1C (1C = 150 mA h g<sup>-1</sup>) and (b) long cycling test and capacity retention in a half-cell. (c) Rate capabilities of R-S-NCM and R-C-NCM. Charge–discharge curves of (d) R-S-NCM, (e) R-C-NCM in the voltage range of 2.8-4.4 V (vs. Li/Li<sup>+</sup>) at different cycles. (f) Equivalent circuit applied in the EIS measurements. Nyquist plots of (g) R-S-NCM and R-C-NCM and (h) fitting results showing the Ohmic resistance ( $R_{ohm}$ ), interface resistance ( $R_{int}$ ), and charge–transfer resistance ( $R_{ct}$ ). (i) GITT curves and the calculated Li<sup>+</sup>-diffusion rate of R-S-NCM and R-C-NCM for the 4th cycle number after activation in the same charge–discharge period. The shadow area indicates low Li<sup>+</sup> diffusion in a certain voltage range.

As shown in Fig. 4a and Fig. S30 (ESI<sup>†</sup>), the initial discharge capacity increased from 154.1 mA h g<sup>-1</sup> for R-S-NCM to 171.4 mA h g<sup>-1</sup> for R-C-NCM after the purifying treatment, although this was slightly lower than for P-NCM. In Fig. 4b and Fig. S31 (ESI<sup>†</sup>), the R-C-NCM cathode exhibit 91.7% and 82.1% capacity retention after 100 cycles and 200 cycles, respectively, compared with 91.6% and 78.3% for P-NCM, and 78.6% and

57.5% for R-S-NCM, indicating the R-C-NCM cathode had better cycling stability, even compared to the pristine one. As for the rate performance, the R-C-NCM cathode demonstrated a better high-rate capability (Fig. 4c and Fig. S30, ESI†) at 3C (127.8 mA h  $g^{-1}$ ) compared to R-S-NCM (69.8 mA h  $g^{-1}$ ) and P-NCM (108.9 mA h g<sup>-1</sup>), which was commonly observed on the regenerated NCM cathodes and may be attributed to appropriate F element doping.<sup>12,47</sup> The plateau at  $\sim$  3.6 V in the voltage profiles (Fig. 4d and e and Fig. S30, ESI<sup>†</sup>) for R-S-NCM nearly disappears after 100 cycles, suggesting that R-S-NCM had a rising polarization after long-term cycling. Based on the cyclic voltammetry curves at different scan rates and calculations (Fig. S31 and Table S12, ESI<sup>+</sup>), the fitting line slope for R-S-NCM was found to be the lowest among all the samples. According to the equivalent circuit (Fig. 4f), the calculated impedance values (Rohm, Rint, and Rct) of R-C-NCM (Fig. 4g and h) were 1.4, 51.1, and 307.1  $\Omega$ , respectively, and were smaller than that of R-S-NCM. These results indicate the deteriorated kinetics of Li<sup>+</sup> transportation due to the residual impurities, especially on the surfaces of the regenerated cathodes. According to the chemical state of the electrode surface (Fig. S32, ESI<sup>†</sup>), R-C-NCM exposed less inorganic fluoride and more lattice oxide, leading to the suppressed interfacial resistance growing during the long-term cycling. Furthermore, the galvanostatic intermittent titration technique (GITT) test also revealed the kinetic characteristics of the solid phase. The current pulse profile and calculated Li-ion diffusion coefficient  $(D_{\text{L}i^+})$  after activation are shown in Fig. 4i. The average  $D_{\text{L}i^+}$ values of R-C-NCM and R-S-NCM were calculated to be 5.78  $\times$  $10^{-14}$  and 2.99  $\times$   $10^{-14}$  for the charge process (and 4.56  $\times$   $10^{-14}$ and 4.29  $\times$  10<sup>-14</sup> for the discharge process), suggesting that residual impurities penetrating the interior bulk after regeneration hamper Li<sup>+</sup> hopping within the lattice of the NCM cathode, as supported by the observed F element (Fig. 3c and Fig. S27, ESI<sup>†</sup>).

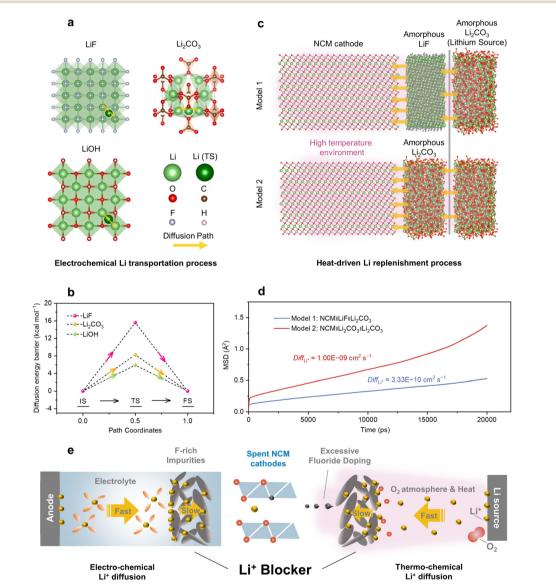
**Fig. 5** Role of the F-rich impurities as a blocker in electrochemical and thermochemical Li<sup>+</sup> diffusion as ascertained from thermodynamic and kinetic simulations. (a) Illustrations of the selected migration pathways with a similar distance for Li<sup>+</sup> inside the crystal lattice of three common components. The initial state, transition state, and final state of Li<sup>+</sup> transportation are denoted as IS, TS, and FS, respectively. (b) Calculated energy diffusion barrier for Li ions in selected phases. (c) Two models for stimulating the kinetics of Li transportation in direct regeneration. Model 1 consists of the NCM cathode substrate, the amorphous LiF layer, and Li<sub>2</sub>CO<sub>3</sub> as a lithium source in direct regeneration, which is denoted as NCM  $\|LiF\|Li_2CO_3$ . In Model 2 (NCM  $\|Li_2CO_3\|Li_2CO_3\|Li_2CO_3$  in short), the middle LiF layer is replaced by a common residual alkali (Li<sub>2</sub>CO<sub>3</sub>), which is used to simulate the regeneration of NCM cathodes after cleaning pretreatment. Each shape symbol is the same as for Fig. 5a. (d) MSD of the Li atoms in 20 ns and calculated Li<sup>+</sup> diffusivity based on the above model. "E – 9" means 10<sup>-9</sup>. (e) Mechanism diagram for preventing the NCM cathodes from reusing and directly regenerating under the influence of impurities.

According to the above results (Fig. 1d, Fig. S6, S16 (ESI<sup>†</sup>), and Fig. 4h, i), the migration rate of lithium ions was significantly influenced by the residual impurities; therefore it was crucial to theoretically investigate their influence on capacity delivery in the reuse case and during direct regeneration. Considering the impurities were mostly concentrated at the surface before and after regeneration, and that F-rich residuals could be observed, as shown in Fig. S9 and S10 (ESI<sup>†</sup>) and Fig. 3c, we chose three representative inorganic components (LiF, Li<sub>2</sub>CO<sub>3</sub>, and LiOH) in the CEI layer<sup>48</sup> or residual alkali<sup>49</sup> to calculate the Li<sup>+</sup> diffusion from a thermodynamic perspective, and their structures are shown in Fig. 5a. By maintaining a similar distance and concentration of mobile Li-ions, the diffusion energy barrier of lithium ions  $(\Delta E_{\rm Li^+})$  during the cycling of spent cathodes within the different crystal structures (Fig. 5b) allowed valid comparisons. We found that the  $\Delta E_{\text{Li}^+}$  of the LiF phase, as a common inorganic component from CEI, was about 2 and 3 times higher than that of the LiOH and Li<sub>2</sub>CO<sub>3</sub> phases from

Fig. 5b. Therefore, this result confirmed that the presence of fluoride-rich impurity residuals on the cathode surface significantly increased the diffusion resistance of Li ions when cycling, ultimately exacerbating the cell impedance and interfacial parasitic reactions (Fig. 1d). To comprehend the largerscale kinetic characteristics and understand the effect of impurity coatings during heating for regeneration of the spent cathodes, two molecular dynamics models were established for simulating Li<sup>+</sup> transportation at 1000 K over 20 ns. Specifically, Model 1 was devised to include an impurity barrier consisting of a LiF layer (Fig. 5c and Fig. S33, ESI<sup>†</sup>). Through computing the mean square displacement (MSD) of Li atoms and fitting curves (Fig. 5d), we determined that the Li diffusivity (Diff<sub>Li<sup>+</sup></sub>) of Model 1 was 3.33  $\times$  10<sup>-10</sup>, which was an order of magnitude lower than that of Model 2 ( $1.00 \times 10^{-9}$ ). The differences in molecular dynamics models under practical conditions suggest that fluoride-rich impurity coatings increase the resistance to Li-ion diffusion into spent cathodes with Li deficiencies during thermo-driven regeneration, leading to inadequate compositional and structural recovery.

As illustrated in Fig. 5e, the impurity phase containing the F element served as an electro- and thermo-diffusion blocker of Li ions hindering the reuse and direct regeneration of the spent cathode. In the spent cathodes collected by physical pretreatment and collection from used lithium-ion batteries, the ubiquitous electrolyte was decomposed to form an ion barrier with slow ion diffusivity. However, these impurities have long been overlooked in most studies (Table S2, ESI<sup>+</sup>), mainly due to the use of lab-scale degraded cathodes and fine manual separation pretreatment. In previous studies,<sup>12-16,42</sup> the latent impact of the residual impurities on direct regeneration remains untouched because impurities are easily converted into other inconspicuous matter in extreme physical or chemical regeneration environments. Looking ahead, the direct regeneration of nextgeneration sensitive cathode materials, such as Li-rich Mnbased, Co-free, and ultra-high-Ni cathode materials, faces serious challenges from these latent impurities if they enter the recycling circle. From another perspective, establishing the controlling law for the inherent impurities doping within the closed-loop material flow could instructively enhance the performance of such recycled materials in the future. Moreover, only by revealing the effect of the overlooked impurities or by getting rid of impurities, can evolving technologies and mechanisms for direct regeneration and upcycling be reasonably evaluated.<sup>50</sup>
